Case Study for Structural Condition Assessment Report for Twenty-Five (25) IAY Houses at Chandraiahpalem Village, Sathupally Mandal, Khammam District, Telangana State, India

¹Er. Satheeshkumar Boda, AVP (Projects), Reinforge, JV Ventures, Hyderabad

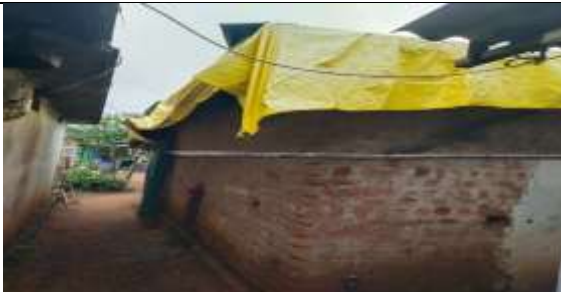
Sr.No	Name of Beneficiary	Issues	Photos
1	Pandla Subbalu.	Slab Leakage and No Plastering inside and outside and flooring works

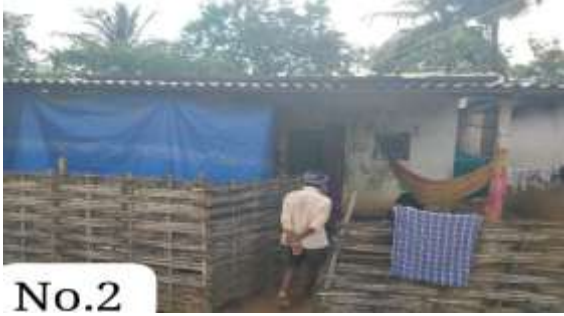
2	Matta.Rajamma	Slab Leakage and flooring works

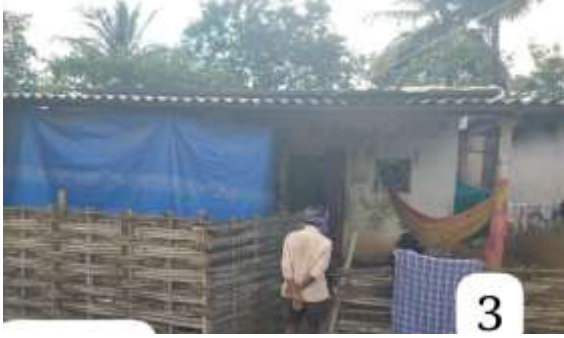
3	Matta. Bucchal	Slab Leakage and flooring works

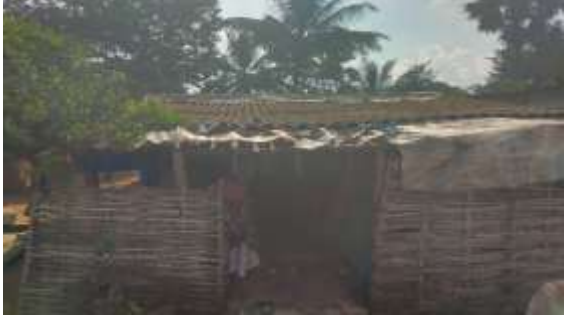
4	Yatagani. Venkateswararao	Slab Leakage and No Plastering inside and outside and flooring works

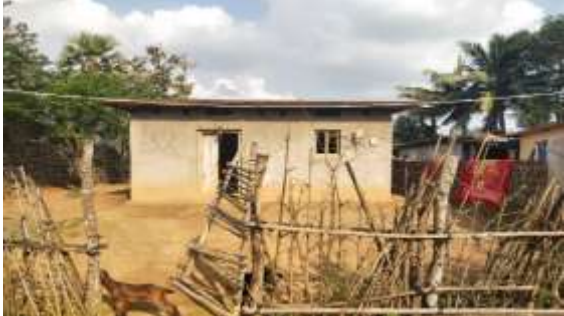
5	Muthina Arjunarao	Slab Leakage and No Plastering inside and outside and flooring works

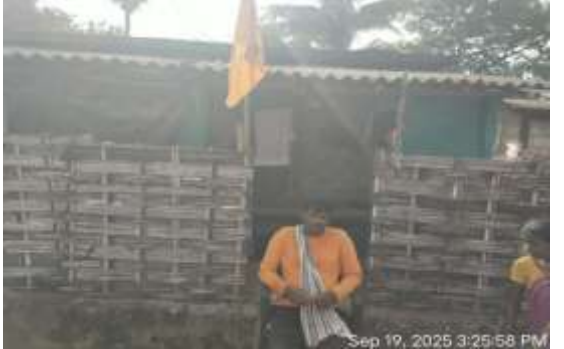
6	Yatagani Korrajulu	Inside Plastering Issue

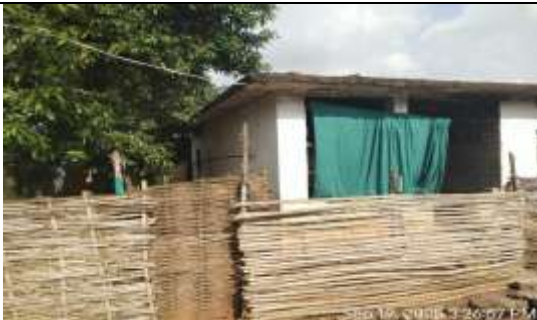
7	Pandla Subbalu	Slab Leakage and No Plastering inside and outside and flooring works

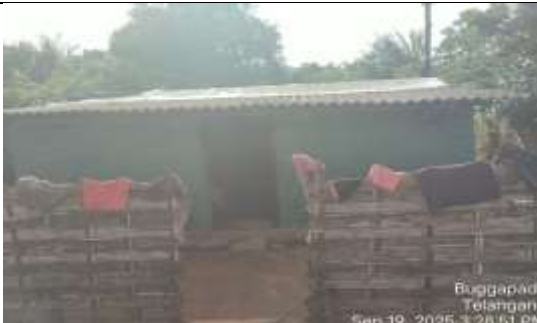
8	Pandla Rambayamma	Slab Leakage and No Plastering inside and outside and flooring works

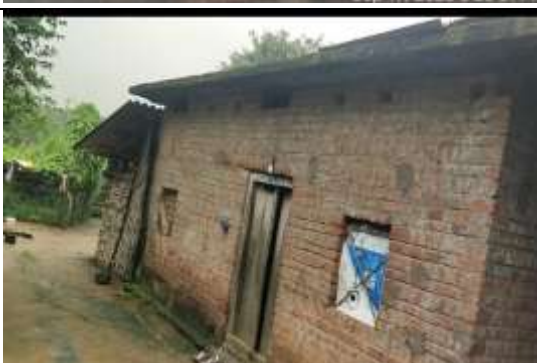
9	Muthina Krishnaiah	Slab Leakage and No Plastering inside and outside and flooring works

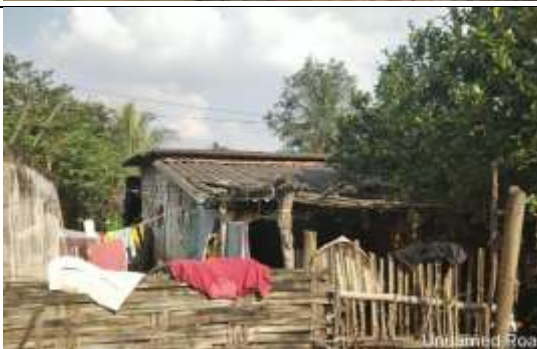
10	Kunta Shivaji	Slab Leakage and No Plastering inside and outside and flooring works

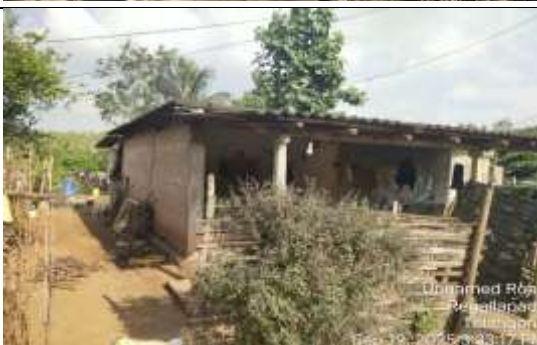
11	Regula Hanumanth	Slab Leakage and No Plastering inside and outside and flooring works

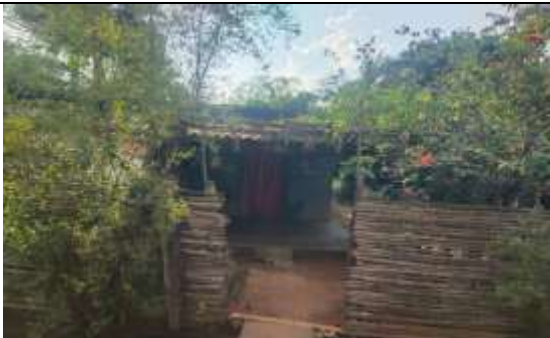
12	Thota Venkateswarao	Slab Leakages

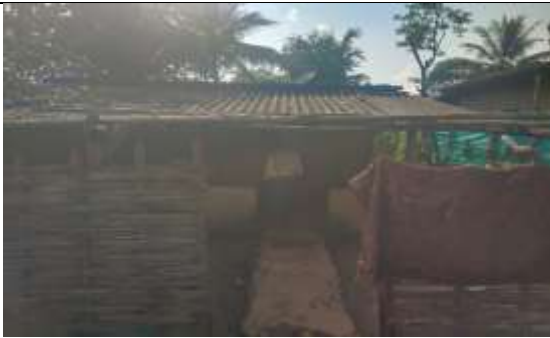
13	Pattela Venkateswararao	Slab Leakage and No Plastering inside and outside and flooring works

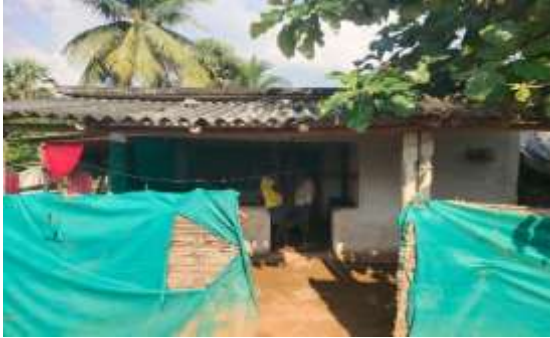
14	Nallabothula Laxminarayana	Slab Leakage and No Plastering inside and outside and flooring works 4 rooms

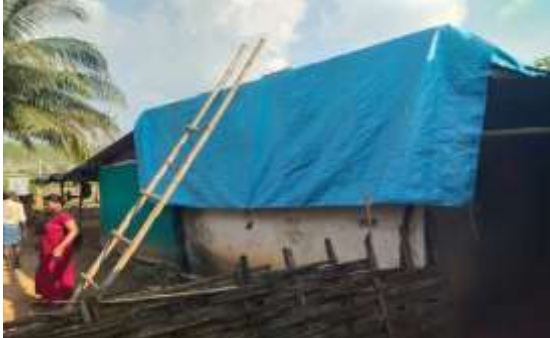
15	Nallabothula Pentaiah	Slab Leakage and No Plastering inside and outside and flooring works No toilets

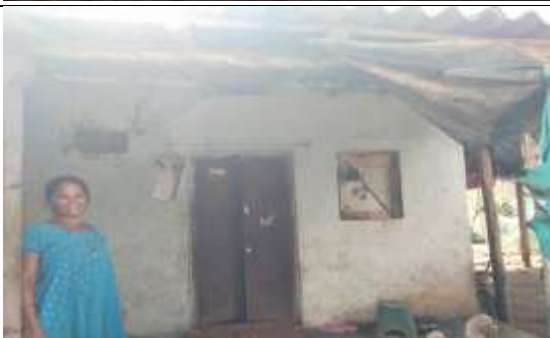
16	Rajani Suresh	Slab Leakage Flooring works

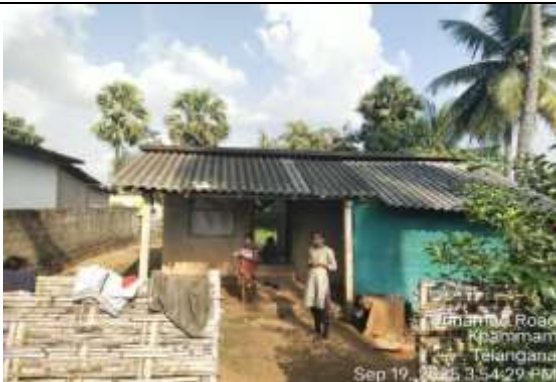
17	Pittala Thulasamma	Slab Leakage and No Plastering inside and outside and flooring works

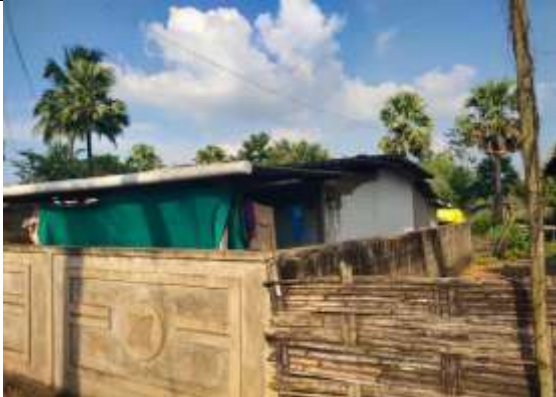
18	Poojala Govardhan	Slab Leakage and No Plastering inside and outside and flooring

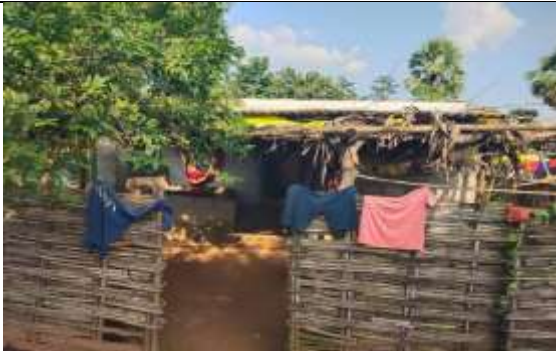
19	Muthhina Narasimha	Slab Leakage and No Plastering inside and outside and flooring

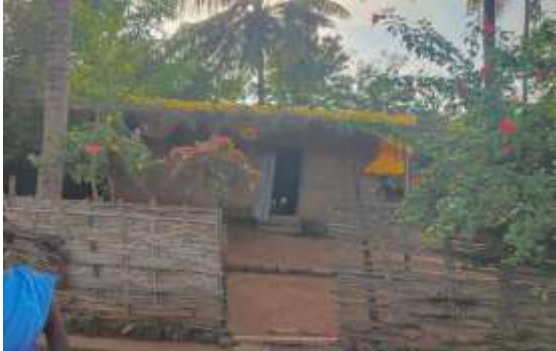
20	Pandla Babu	Slab Leakage and No Plastering inside and outside and flooring

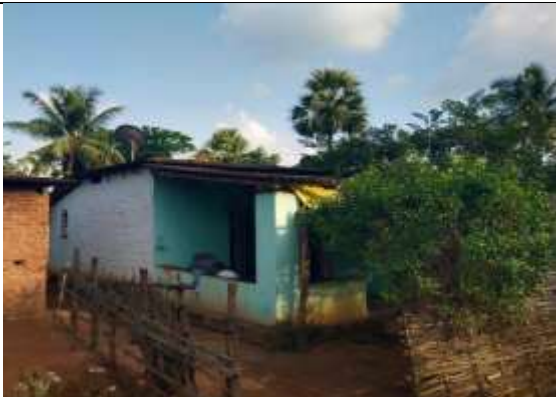
21	Yeddi Seethaiah Raju	Slab Leakage and No Plastering inside and outside and flooring

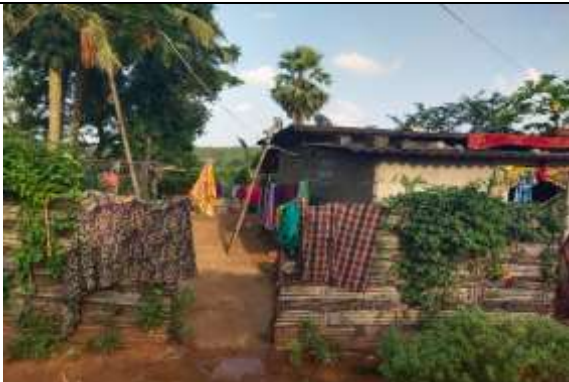
22	Yetagani Ramullamma	Slab Leakage and No Plastering inside and outside

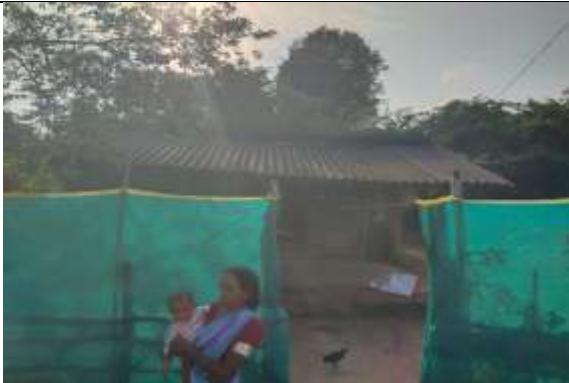
23	Sanku Rajamma	Slab Leakage and No Plastering inside and outside

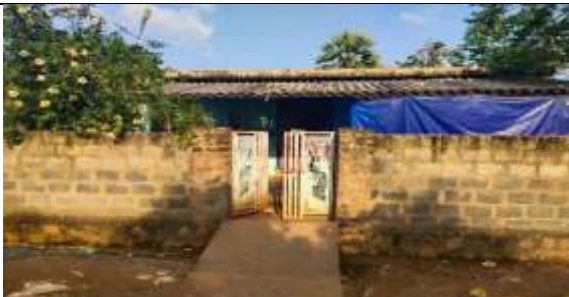
24	Matta Jogamma	No Issues

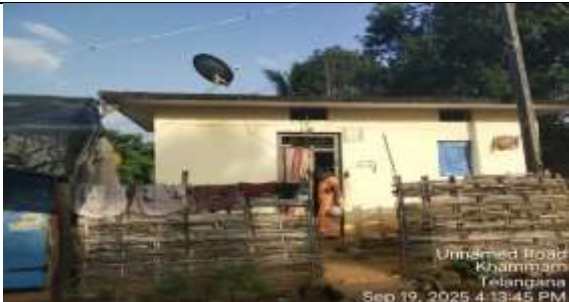
25	Jakka Chukkam	Slab Leakage (Small Patches)
