# Case Study of Structural Distress Assessment, Rehabilitation Strategy, and Post-Survey Condition Evaluation of Rural Housing: A Two-Phase Case Study of Twenty-Five Indira Awaas Yojana Houses, Khammam District, Telangana, India

Er. Satheeshkumar Boda<sup>1\*</sup>

Manuscript prepared: September 2025 (field survey) June 2026 (case study compilation)

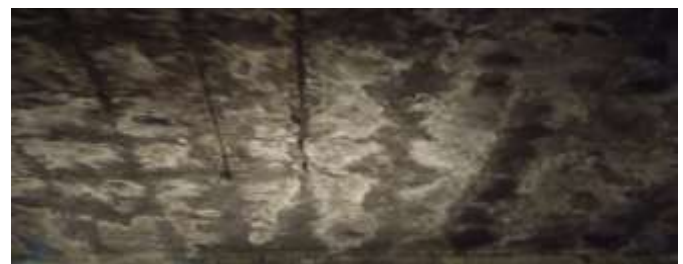
**4.1 Roof Slab and Reinforcement:** Cracking and spalling were found on the underside of the roof slabs in every house surveyed, with reinforcement left exposed and actively corroding. This is the most serious structural issue identified in the assessment. Once the concrete cover is lost, the reinforcing bars are directly exposed to moisture and to chloride and carbonation ingress, which speeds up section loss. If this is not addressed, the slab's ability to carry load will gradually be reduced.

**Figure 1.** Close-up of an RCC slab soffit showing extensive moisture staining, efflorescence, and surface deterioration consistent with long-term water ingress through an unwaterproofed terrace.

- No terrace waterproofing was provided at the time of original construction. As a result, rainwater has been entering the slab directly over many monsoon cycles.
- The slab and plaster have cracked over time due to material ageing and thermal movement. With no remedial action taken, these cracks have widened progressively as water continues to enter.
- The roof slope is inadequate or absent altogether, so water tends to pond on the roof instead of draining away.
- No preventive maintenance has been carried out over the entire service life of the houses, and there is no record of any prior repair work.
- Reinforcement corrosion is a consequence of the above, not an independent cause. Continuous moisture ingress has led to the spalling and loss of cover described in Section 4.1.

- 6.2 Stage II — Concrete and Reinforcement Restoration for RCC elements that are badly spalled or weakened, the following steps should be followed:
1. Remove all loose and damaged concrete or plaster down to the depth of carbonation. Taper the edges and square the shoulders so that a sound substrate is left behind.

2. Clean the exposed reinforcement of rust using an alkaline chemical rust remover, then wire-brush it and wash it thoroughly with water.
  3. Check the remaining sound reinforcement. Tie additional rings, lap rods, or weld mesh as needed to restore continuity.

4. Apply a rust passivator/converter to any remaining corrosion on the bars, followed by a protective rust-preventive coating.
  5. Carry out cementitious pressure grouting with a non-shrink additive to seal honeycombing and voids.

6. Restore the concrete section. For cover failures up to 25 mm deep, use polymer-modified mortar (1:5:15). For failures deeper than 25 mm, use micro-concreting with new reinforcement, a bond coat, and shear connectors, as per the consultant's design.

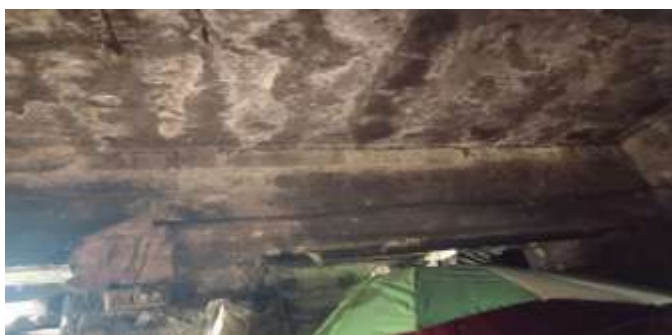
**Figure 2.** Interior room corner showing heavy fungal staining at the slab-wall junction and degraded surface-mounted electrical wiring routed through the damp zone — a combined structural and fire-safety hazard.

- 6.7 Stage VII — Interior Finishes: Openings, and Electrical Services Complete the internal structural and plaster repairs as needed, based on the consultant's site-specific advice. Apply two to three coats of approved-quality paint. Replace all doors and windows that cannot be repaired. Fully replace the degraded electrical wiring and fittings in every room to remove the fire-safety hazard that was identified.

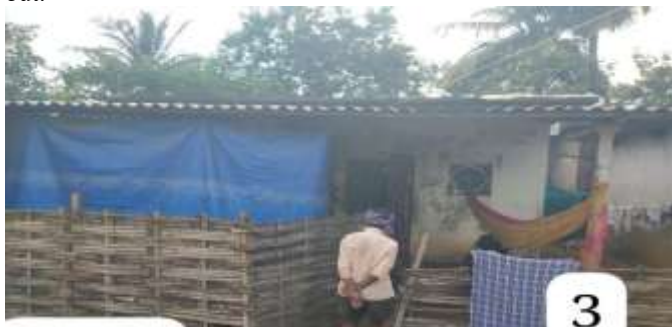
**4.2 Waterproofing and Dampness:** Not a single one of the twenty-five houses had a working terrace waterproofing system. Every household reported leakage during and after rain, and this was confirmed on site during the inspection. In several cases, residents had tied tarpaulin sheets over their roofs as a temporary fix while waiting for proper repairs to be carried out.

**Figure 3.** Temporary tarpaulin sheeting deployed over a damaged roof section by a beneficiary household as an interim measure against active slab leakage.

The terrace waterproofing itself should follow the integral cement-based brick-bat-coba system as per IS 2645. This involves a neat-cement slurry coat over the prepared slab and the adjoining wall upskirting, a brick-bat layer laid to falls in mortar admixed with waterproofing compound, a second slurry coat after curing, and a finishing 20 mm jointless cement mortar topping with embedded glass-fibre cloth, trowel-finished and pattern-cut into 300 × 300 mm panels. After completion, the terrace should be flooded and kept under a ponding test for a minimum of two weeks for curing before it is accepted.

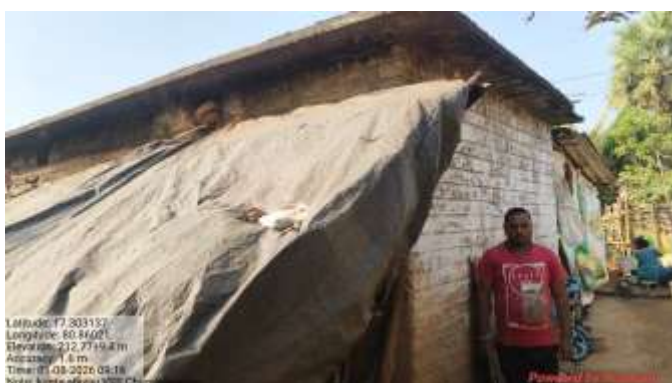
**Figure 4.** Tarpaulin-covered roof at a second affected house, illustrating the prevalence of this informal coping measure across the surveyed cluster prior to rehabilitation.

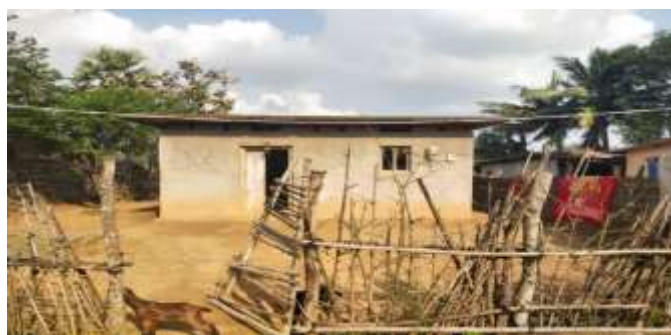
**Figure 5.** Representative external view of a surveyed IAY house, showing the single-storey load-bearing masonry construction typical of the cluster.

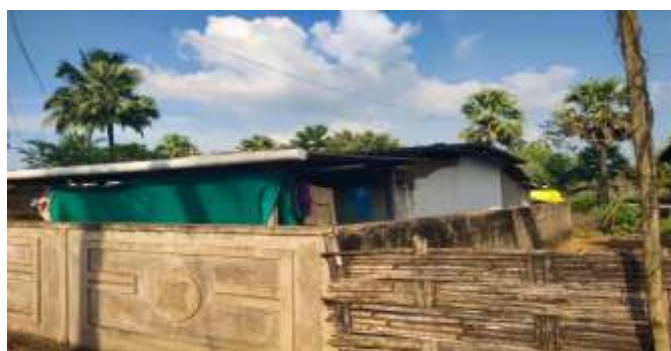
**Figure 6.** External wall and boundary masonry at a second surveyed property, showing weathering and surface staining consistent with prolonged moisture exposure.

- 6.4 Stage IV — Terrace Waterproofing, Re-plastering, and Chajja Repair Once the structural repairs (Sections 6.1–6.3) are complete, the following work should be taken up: remove all damaged external plaster and any improper waterproofing previously done on chajjas (eaves) and projections; reinstate any weak structural elements (beams, columns, lintels); inspect and repair or replace weak brick masonry; re-plaster the external and internal surfaces in

two coats, using waterproof sand-faced plaster on external areas; redo the chajja waterproofing with particular care taken to seal the masonry–concrete junction; and provide an effective brick-bat-coba layer at the chajja–wall junction.
