## Conditional Assessment of a Jetty In Mumbai Harbor.

**Abstract** - this paper describes the rehabilitation on of jetty in Mumbai harbour. The structure was constructed in early 1990's and there were no as such drawings of jetty structure available. The jetty was in a deteriorated state and as a apart of audit inspection a very thorough investigation was carried out to determine the state of deterioration and to developed a design for rehabilitation thereof. From the investigations it was found that the concrete used for jetty was of high quality and the cover depths to most areas exceeded 50 mm. however some parts of structure suffer severe chloride contamination, corrosion to reinforcement, spalling of concrete etc. over years the repairs provided have been deteriorated and are now unworthy to offer any protection to structure. The methods proposed are to be employed to rehabilitate jetty patch repair, recasting of the structural areas, replacement of reinforcement etc.

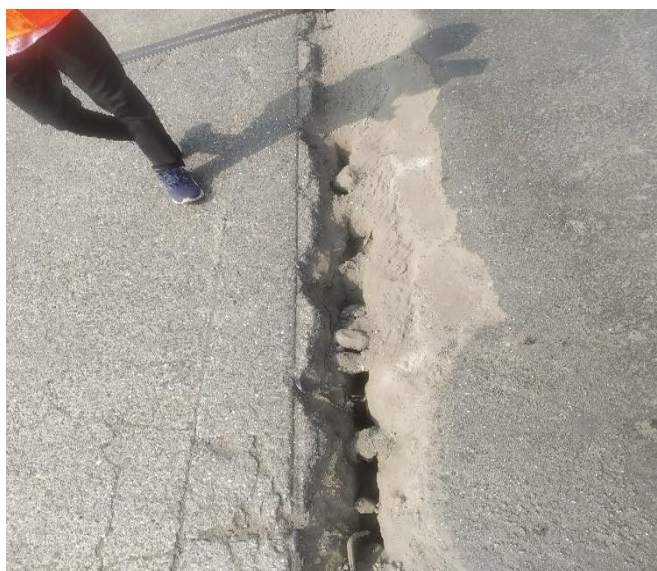
The overlay of deck slab shows severe deterioration and cracking. Map cracks are formed at various places. Also the expansion joints are completely worn out. The joints need to be filled with proper filler material. The following figure shows map cracking and exposed.

Figure 3- Worn Out Expansion Joints

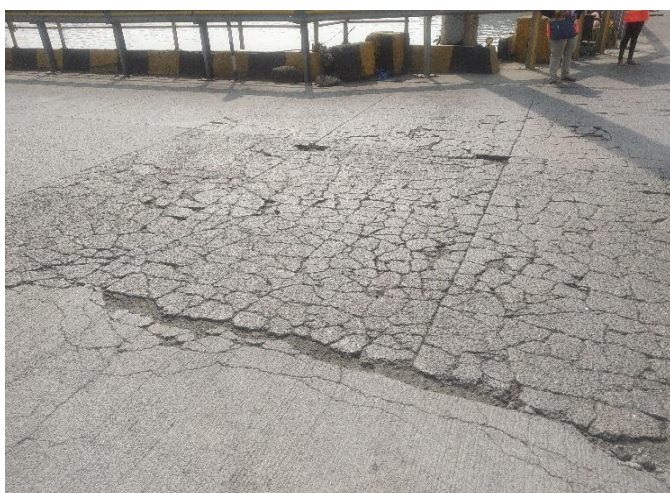
Figure 4- Map Cracking In Overlay

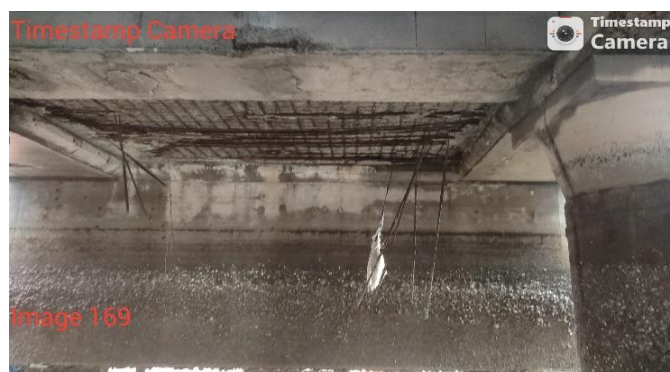
Such portions showed large cracks, corrosion of reinforcement, delamination and spalling of concrete. The survey showed that fender slabs and soffits of beams were more susceptible to such damage. These were areas that showed reduction in reinforcement greater than 40% and in some area reinforcement steel was snapped indicating higher rate of corrosion. Presence of distress in areas subjected to alternate wetting and drying process. These are the areas that needs urgent attention and should be rehabilitated as soon as possible. Following distress are shown below

Figure 5- Snapped Reinforcement Of Fender Slab

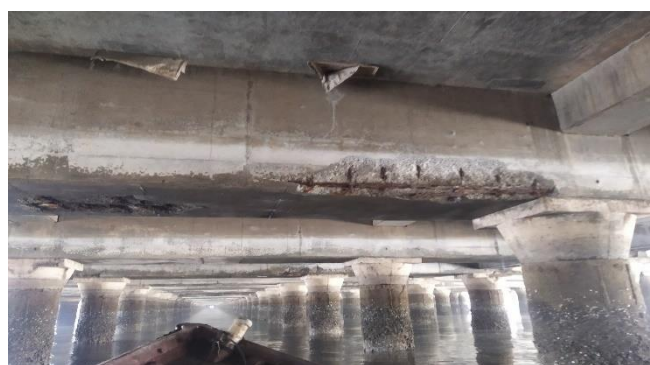
Some portions of slabs and beams were heavily contaminated with chlorides which went beyond the level of reinforcement.

Figure 6- Corrosion In Beam Soffits

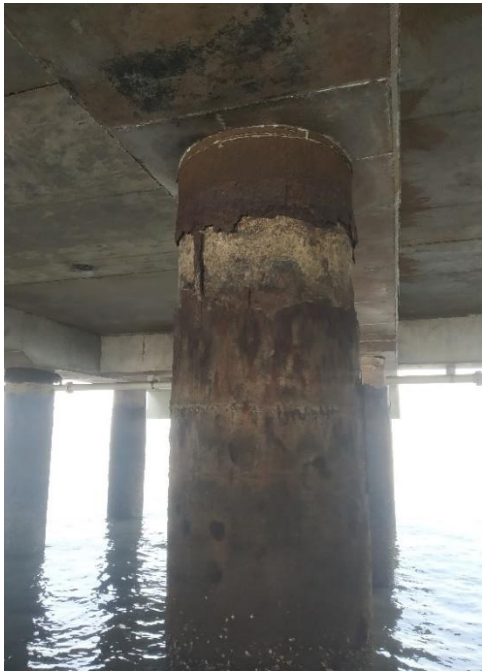
The liners of pile showed heavy corrosion damage and heavy growth of sea vegetation was noted on piles. The measurements taken suggested that piles are to be subjected to reinforcement corrosion and it is occurring even though piles are not showing any visible damages

like spalling or delamination of concrete. However, when these piles subjected to hammer test, the hammer sound did not indicate delamination of piles. Pile muffs showed corrosion cracks and corrosion marks.

Figure 7- Pile with Damaged Liner

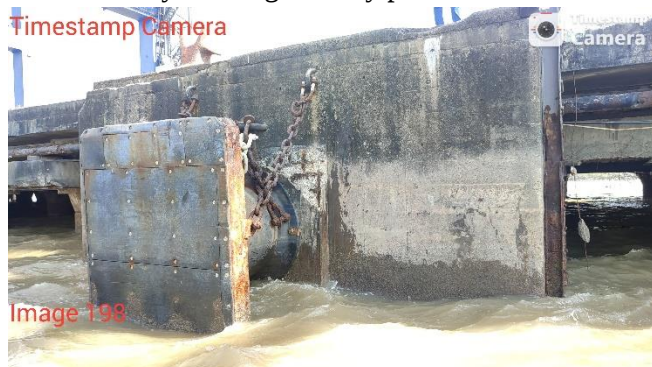
The joints of fenders shown corrosion at the surface. Old wooden fenders at some locations need to be replaced with new rubber fenders. The slabs supporting fenders showed honeycombing at many places

Figure 9- Damaged Fender

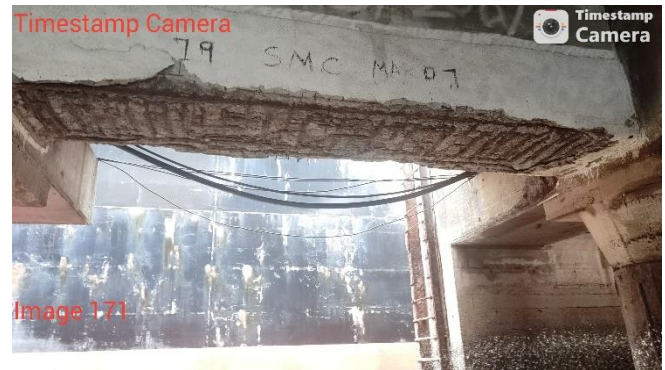
Guniting applied for previous layer was in varying thickness. At various locations shrinkage cracks were seen on guniting. The failure of guniting was most predominantly seen at the soffits of beams. Vertical faces of beams also showed significant failure of guniting. The guniting reinforcement mesh was also exposed at various places

Figure 10- Failure Of Guniting At Soffit Of Beam And Exposed Wire Mesh
