Effect of G-Phase Precipitation on Creep-Damaged SS 347H Platen Superheater Boiler Tube Failure

Dr R K Kumar¹, D Laxman Rao²

Materials Technology Division,
Central Power Research Institute, Bangalore

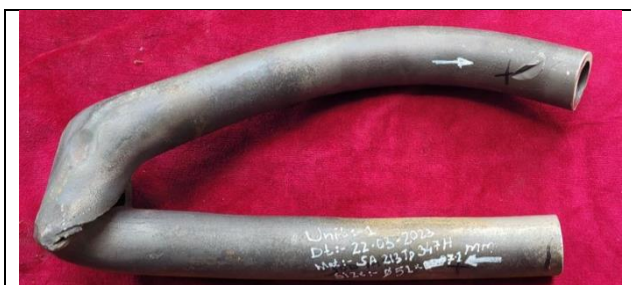
Fig. 1 Failed Platen Superheater Tube
superheaters and reheaters, operating at high steam

The failed tube exhibited a significant crack opening on the inner diameter (ID) side of the bend, along with multiple longitudinal cracks. The failure occurred at the bottom end of the “V” section of the superheater (SH) coil, with a blistered opening measuring 14 cm in length. The failed opening had shown multiple internal cracks close to the failure lip end region with a 25% reduction in wall thickness, as shown in Fig. 3. In addition, multiple longitudinal cracks adjacent to the failed opening, indicated that the tube had been subjected to excessive temperature and stress conditions

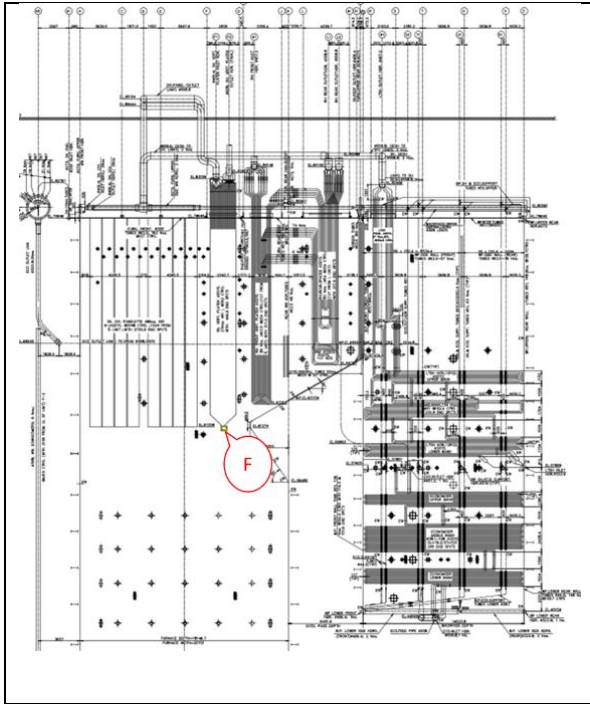
Fig 2. View of the Failed Tube location inside the Boiler tube panel

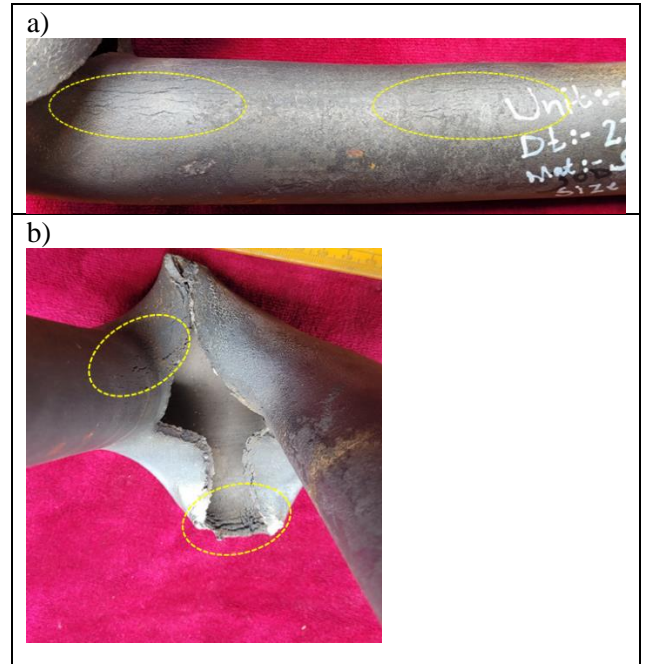
Fig. 3 Longitudinal cracks near the failure opening

To assess the possible swelling due to localized overheating, the tube thickness was measured along its length at intervals of 25 mm. The thickness of the tube in the failed opening has been observed to be 5.3 to 5.5 mm against the design thickness value of 7.0 mm. No reduction in wall thickness was observed in regions away from the failure. However, longitudinal multiple surface cracks were observed along the vertical length of the failed tube.

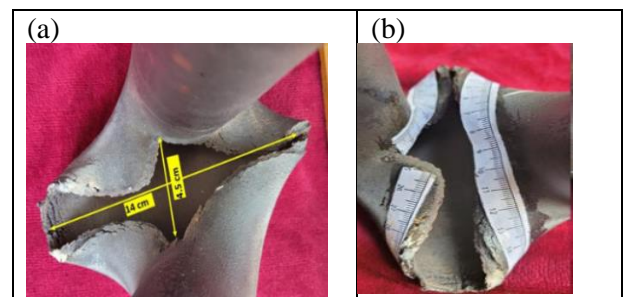
during service (Fig. 4). The failed opening coincided with the observed longitudinal crack. The length of the crack opening boundary was measured to be 30 cm (Figure 4b).

Fig. 4 Top view of Crack opening (a) outer length of the blister opening region (b) inner length of the blister opening region

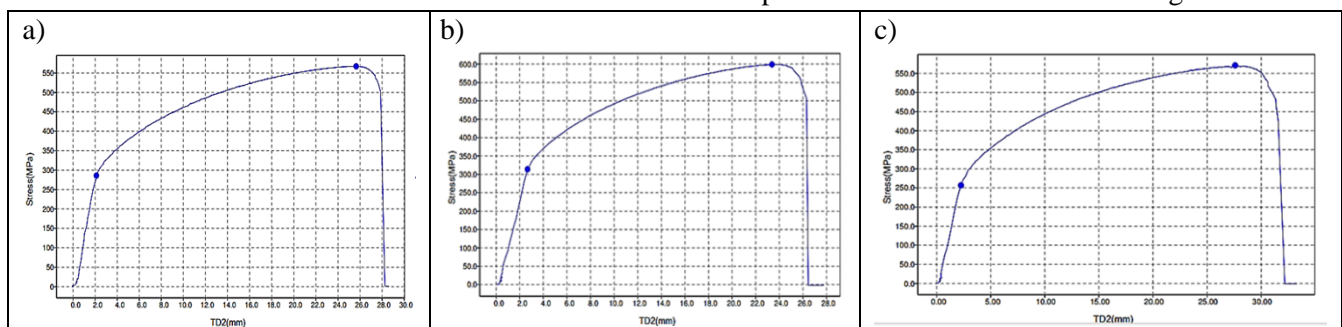
Fig 6. Stress-Displacement Graph of tensile tested samples ; Near failed Opening (a) away from failed opening (b) virgin tube (c) ; TD2 – Displacement

Tube Description	Yield Strength (MPa)	Ultimate Strength (MPa)	Elongation (%)
Near Failed Opening (T1)	286	567	31.4
Away from Failure (T2)	314	599	32.3
Virgin Tube	257	571	43.3
Ref. Values (TP347H)	> 205	> 485	> 35

The yield strength and tensile strength of the failed tube were found to be within the acceptable range specified for the material. However, a significant reduction in elongation up to 26-28% compared to the virgin tube was observed in the failed tube samples,

The yield strength and tensile strength of the failed tube were within the ASTM-specified limits. However, the elongation values of the failed tube samples showed a 26 to 28% reduction in elongation compared to the virgin tube, indicative of localized embrittlement. The optical micrograph of the virgin tube indicated the prevalence of

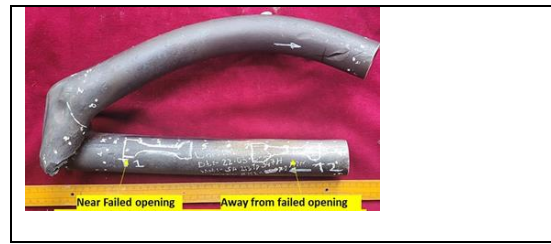
Fig . 5 Sample Location for Tensile Testing

The mechanical properties of both the failed and virgin tubes were performed. Tensile samples were taken 150 mm away from the failure opening in the straight-length region (Fig. 5) and the tests were conducted as per ASTM E-8 /E8M-22 standards including yield strength, ultimate tensile strength, and elongation properties. The results were compared with that of the virgin tube property. The Load Displacement graphs of the tensile samples are shown in Fig 6. The results of the mechanical testing are given in Table 3.

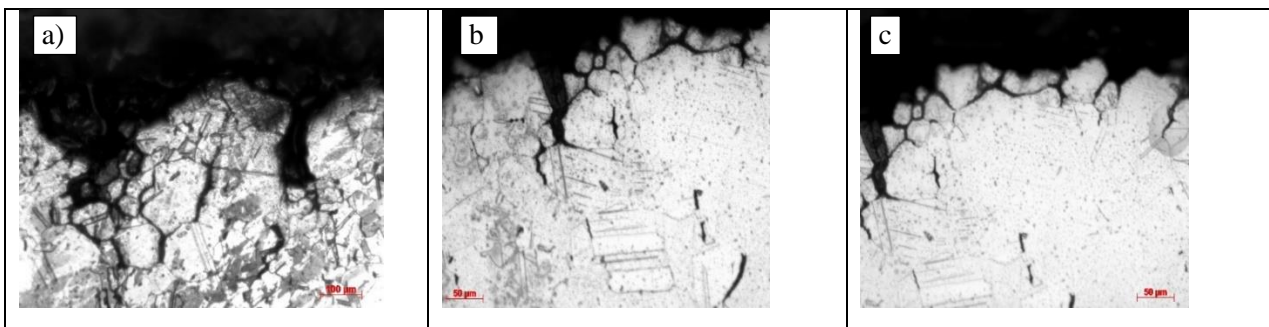
analysis at different locations. Small samples were extracted from various regions of the failed tube and prepared for optical microscopy. The specimens were polished and etched using aqua regia solution to reveal the grain boundaries, precipitates, carbide phases, and twin boundaries etc. The microstructural examination revealed the presence of austenitic grains with distinct twin boundaries and cracking from the ID side of the tube. The microstructures observed are shown in Fig. 7 and 8. The micrographs show clear evidence of intergranular cracking along the grain boundaries. Multiple cracks propagate along the grain boundaries indicating that the failure appears to be attributed to

creep-induced cracking mechanism.

Fig 7. Microstructure of the failed tube near the failure opening showing multiple cracks joined along grain boundaries (a) (b) (c)

annealing twin structures within the austenitic grains. However, the microstructure near the failure region has indicated the grain growth with voids along the grain boundaries. The SEM micrographs indicated the presence of large-sized silicide precipitates (G-phase) of size up to 60 microns, at isolated locations. The formation of silicide precipitate is due to the interaction of silicon with NbC and chromium during long-term exposure to elevated temperature. The observed macro cracks along the longitudinal direction are indicative of the creep-induced damage in specific regions of the tube material.

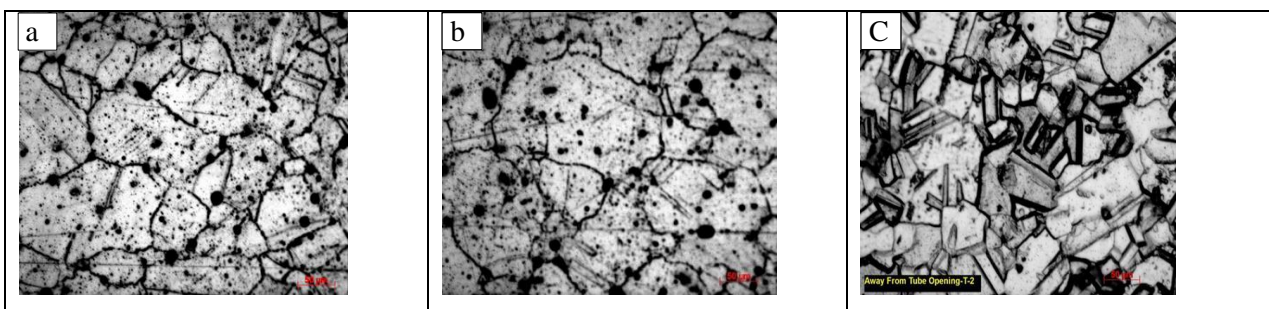
Fig 8. Microstructure of the failed tube near failed opening showing sensitized structure (a) (b) and virgin tube structure with twin (c)

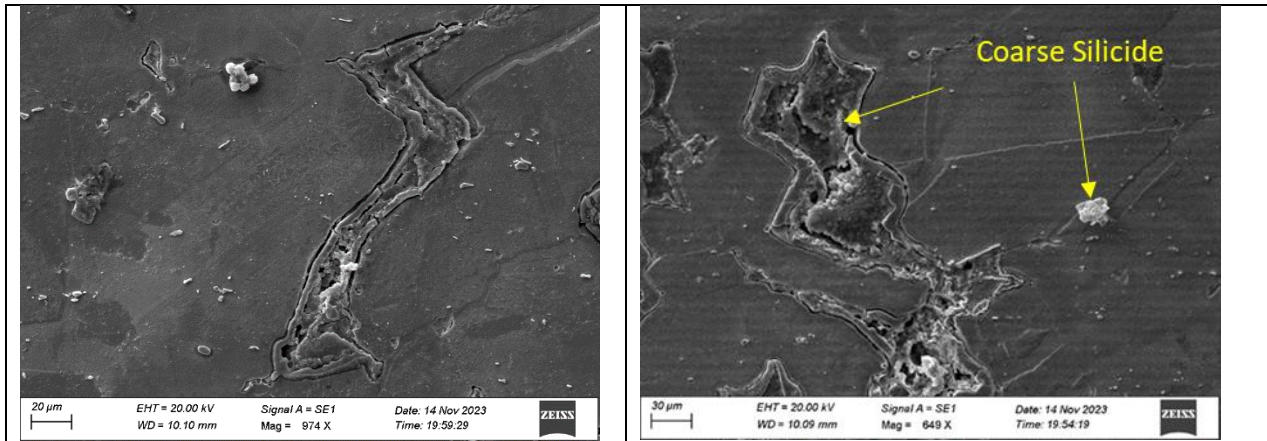
Fig. 9 Secondary Electron Micrographs of the sample near the failure opening showing thick precipitates with multiple cracks

Debonding between the precipitates and the matrix was evident, with cracks initiating at the precipitate-matrix interface. EDS analysis confirmed high silicon content (5–18%) in the precipitates, in contrast to a significantly lower silicon concentration (0.3–0.4%) inside the grains. Furthermore, EDS line mapping identified chromium depletion (<9%) near the precipitate-matrix interface and high silicon enrichment in the precipitates. Under high-temperature conditions of 600 to 800 °C, the diffusion rate of silicon is more than that of carbon. This results in faster coarsening and larger precipitate sizes for silicides. The coarse precipitates observed along the grain boundaries were identified as G-phase (complex silicides), which typically form after prolonged exposure to high temperatures.

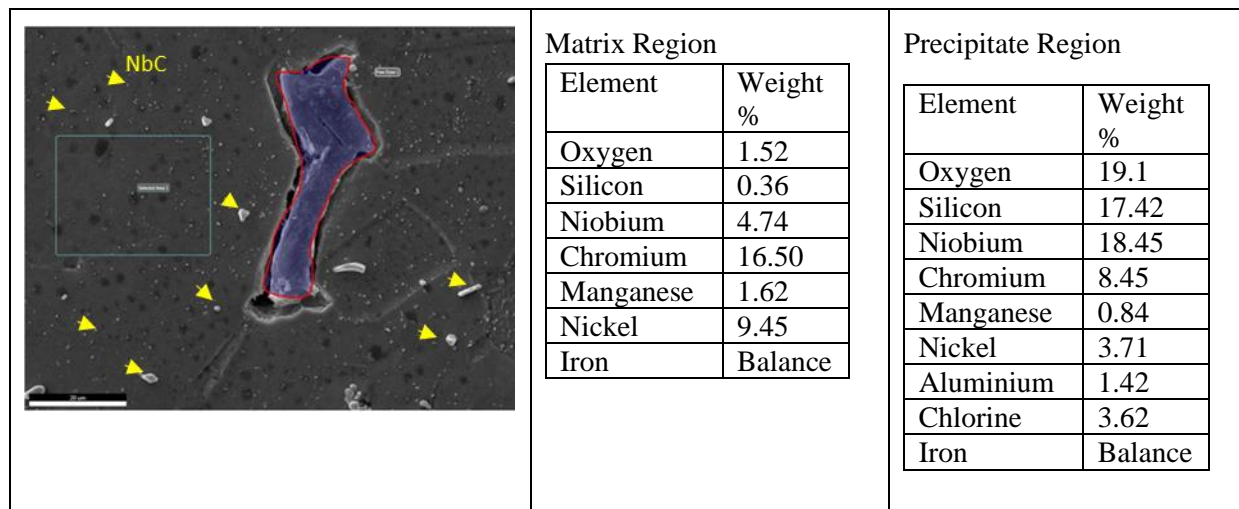
Fig.10 EDS analysis of precipitate and matrix region

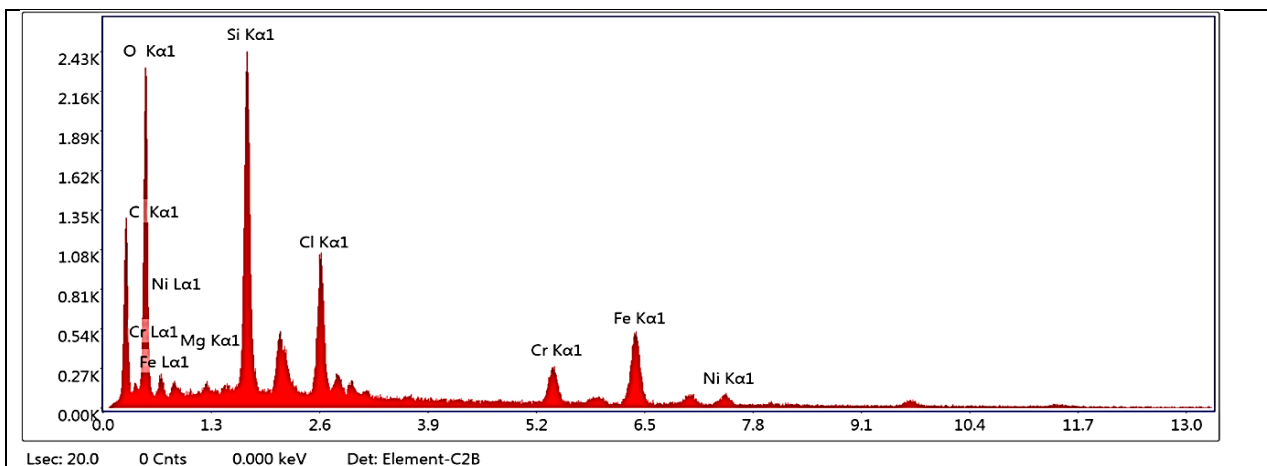
The etched sample from the failed tube was analyzed using scanning electron microscopy (SEM) coupled with Energy Dispersive X-ray (EDX) spectroscopy. The SEM analysis revealed fine precipitates distributed within the austenitic grains and larger secondary precipitates along the grain boundaries. The precipitation of fine NbC fine precipitates which are commonly found in stabilized stainless steels. The coarser precipitates of size 20 to 60 microns were also observed in the matrix region. The EDS analysis of the precipitate indicated a higher content of silicon and niobium with a reduced amount of chromium and nickel. The presence of these secondary phases suggests potential microstructural instability due to prolonged high-temperature exposure. This could contribute to localized embrittlement and increased susceptibility to high-temperature degradation. The SEM images illustrating these precipitates are shown in Fig 9. The EDS analysis of the precipitate rich in silicon is shown in Fig 10. The EDS spectrum obtained from the precipitate region rich in silicon is shown in Fig. 11. The precipitate regions exhibiting in-depth de-bonding

Fig.11 EDS Spectrum confirming the presence of high amount of silicon in precipitate

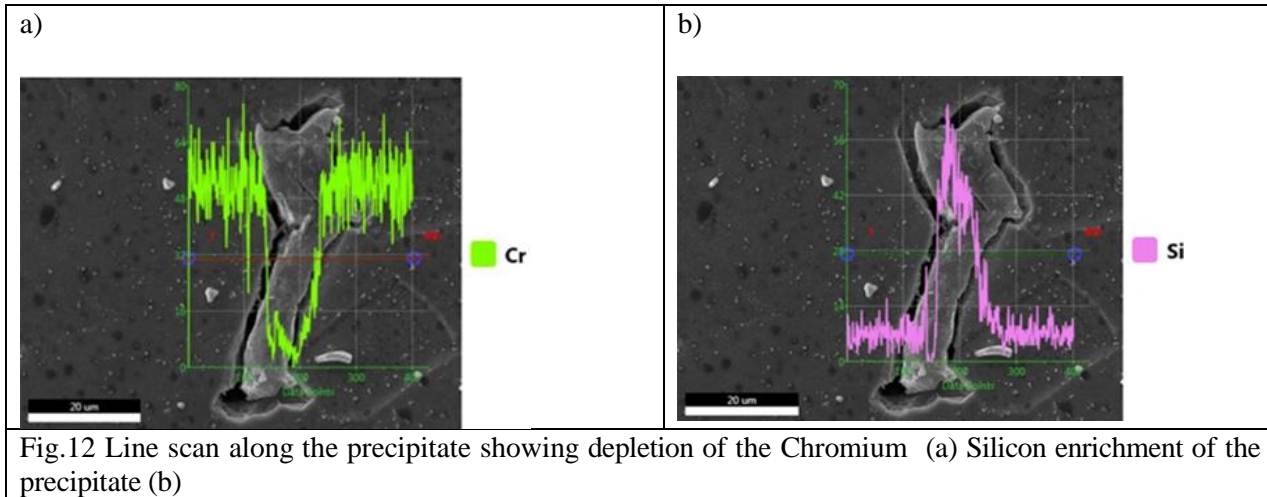
were analyzed along the length direction to identify specific phases. Chromium and silicon content variation along a line scan was observed, as shown in Figures 12 and 13.

Fig.12 Line scan along the precipitate showing depletion of the Chromium (a) Silicon enrichment of the precipitate (b)

Microstructural examination revealed G-phase silicides, with SEM-EDS confirming silicon-rich precipitates and chromium depletion near grain boundaries (Fig. 12).
