Rectification of Building Tilt (Skyscrapers)

(Millenium Tower SanFrancisco)

Harshit Srivastava¹, Anukaran Kamboj²

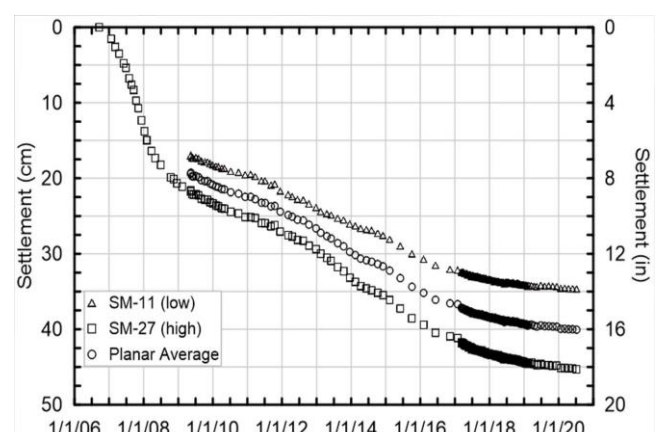
1.2 VARIATION OF SETTLEMENT WITH TIME.

- Planer average developed by fitting plane through data.

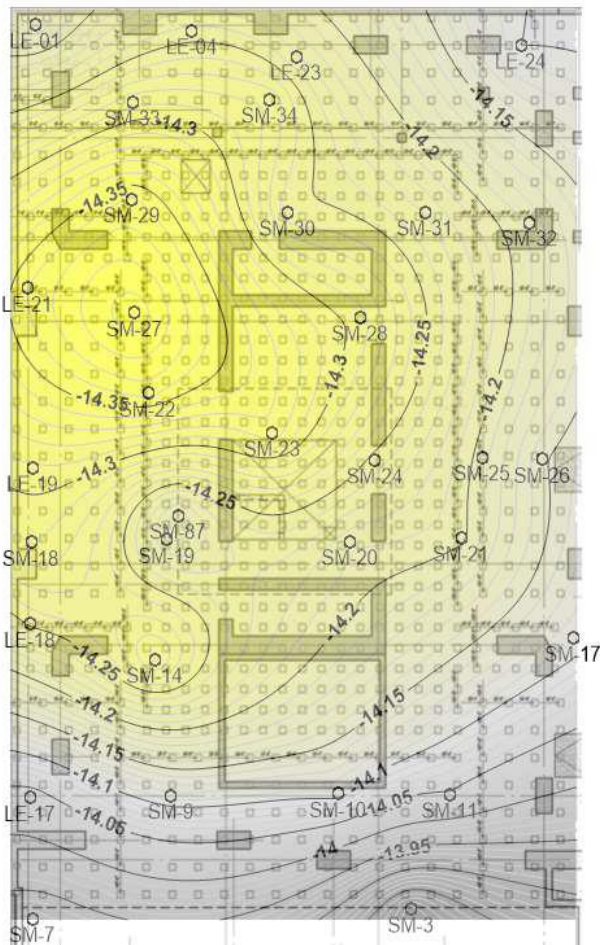
- Contour plot illustrates July 2020 elevations(NAVD88, ft)

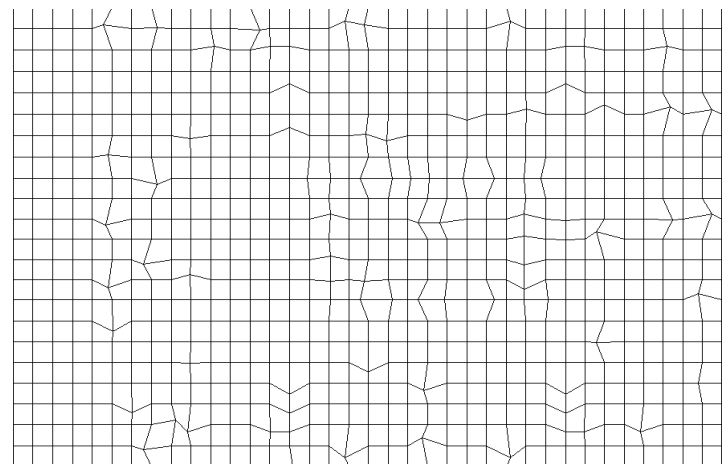
cause in the structure. This was done intentionally to provide a conservative estimate of the settlement effects. Even with this conservative approach, the calculated average flexural deformations in the mat are all less than half of the acceptance criteria of 1.0%. Condition of mat Shown below.

As expected, some flexural yielding and inelastic rotation in the mat occurs under the effects of the settlement distortion. The mat deformations increase only modest amounts under earthquake effects, which is attributed in part to the capacity design approach used in the original design of the mat (DeSimone, 2006).
