# Renovation of Boys Hostel in College Campus: Structural Assessment, Retrofitting Design and Cost Estimation

**Abstract** — This paper presents a comprehensive structural assessment and renovation study of an existing RCC G+2 Boys Hostel building at Dr. J. J. Magdum College of Engineering, Jaysingpur. The structure exhibited significant defects including beam/slab cracking, concrete spalling, reinforcement corrosion, dampness, and waterproofing failures. A systematic condition assessment was conducted through visual inspection, crack mapping, and Rebound Hammer NDT (IS 13311 Part 2:1992) on all 132 RCC columns across three floors. In-situ fck values ranged from 9 MPa to 30.5 MPa. Using IS 456:2000, columns were classified as Safe (26), Marginal (22), Deficient (47), and Severely Deficient (37). RCC column jacketing with M30 concrete and Fe 500 steel was designed for governing columns C3 and C11 (fck = 9 MPa), raising capacity from 593 kN to 3,514 kN. Second-floor slab reconstruction using AAC Panel Slab System provides 55–60% dead load reduction. Complete replanning of plumbing (CPVC/uPVC, 30,000 L storage, solar heaters) and electrification (FRLS copper, RCCB per room, BEE 5-sta

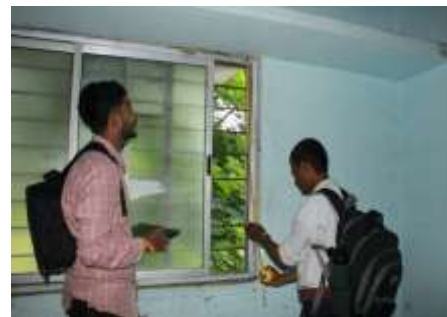
Fig. 1: Visual Inspection and Defect Documentation

A systematic visual survey was conducted floor-by-floor, room-by-room across all accessible areas: external façade, internal walls, RCC columns on all floors, beams, lintels, slabs, staircases, toilets, terrace, and parapet walls. Defects were documented through high-resolution photography, crack mapping (color-coded), and digital recording in MS Excel and Notion. Crack classification: Hairline (<0.1 mm), Minor (0.1–0.3 mm), Moderate (0.3–1.0 mm), Major (>1.0 mm).

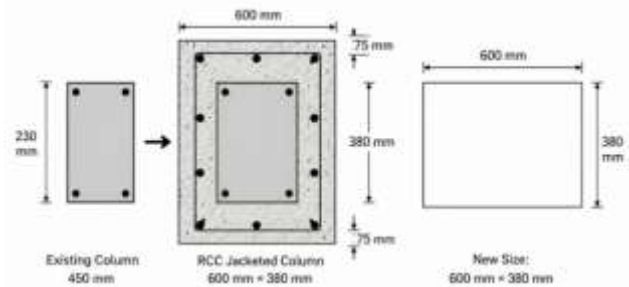
Fig. 3: RCC Column Jacketing Detail

## C. RCC Column Jacketing — Governing Columns C3 & C11

Existing capacity (Eq. 1):  $P_{u,old} = 0.4(9)(102,696) + 0.67(415)(804) = 593 \text{ kN}$ . Deficiency =  $1,300 - 593 = 707 \text{ kN} \rightarrow$  Retrofitting required.

Jacketing design: thickness 75 mm all sides  $\rightarrow$  New size  $600 \times 380 \text{ mm}$ ; M30 concrete; Fe 500 steel; 8 bars  $\times$  16 mm (Asc,jacket =  $1,608 \text{ mm}^2$ ); Total Asc =  $2,412 \text{ mm}^2$ ;  $A_{c,new} = 225,588 \text{ mm}^2$ .

Retrofitted capacity:  $P_{u,new} = 0.4(30)(225,588) + 0.67(500)(2,412) = 3,514 \text{ kN} \gg 1,300 \text{ kN} \rightarrow \text{SAFE} \checkmark$
