# REVIEW ON MINE INNUNDATION

**Abstract** — This paper looks at accidents cause by INNUNDATION which led to loss of man and machinery. It also includes data related to no. of fatalities caused due to INNUNDATION. The paper also discusses the real reasons behind major disastrous INNUNDATION in Indian mines. The no. of fatalities and teaches a lesson about how things goes wrong when laws are not followed. Concept of how to deal with old working areas are also been discussed further.

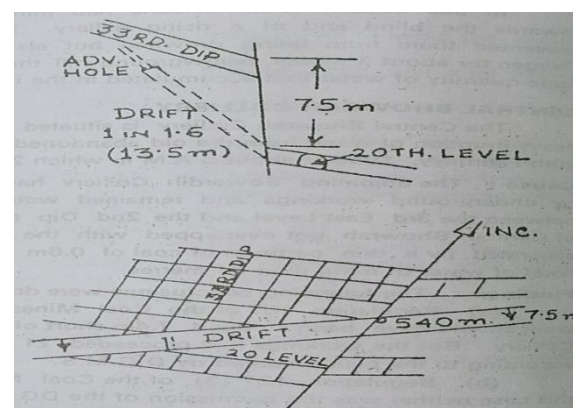
The accident happened on January 5, 1960, and 16 people drowned. The Damua colliery was processed by incline and a 7.5m throwback was met 54m from the cline's mouth. Operation on the upper side of the error was upgraded to the error

plane. Due to ventilation problems in the development of the throwing side, it has been decided to connect Level 20 on the downtown side 33 meters from the Main Dip and 33<sup>rd</sup> Dip on the upward slope rising 1 to 1.6 and check 3m in advance. Holes. By the time he had flown 6m from the faulty plane, the normal operation had stopped. A borehole was made. Several holes were drilled and several holes were drilled. This has led to the weakening of the sections. A 2-foot [2 m] gap split and suddenly water gushed from the main pool, killing all on the staff.

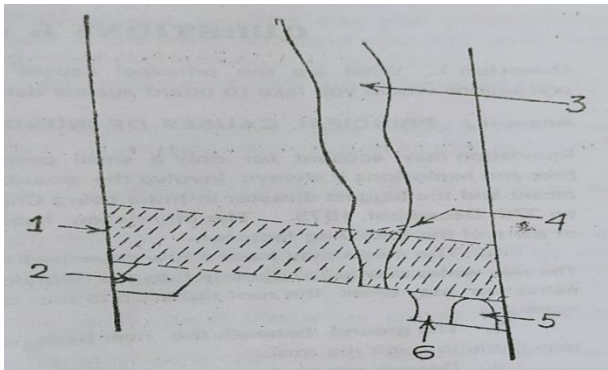
**Cause:** Managers plan to leave a barrier thick enough against older water use. At the bottom of the bar, administrators dial 2 headings, each of which is linked to a hanging wall & footwall. These drives are designed against the age-old use of water immersion thought. No. The 4 inclines of the same owner that was discontinued in 1949 were widened 38m further than that shown in the old system. The risk connection was established with this extension No. 4 incline while driving cross-cut. There was an influx of water. The power of the water was so great that the head of water accumulated that it swept everything in its path causing irreparable waste and turning the mine into a watery grave in a short time

1. Proposed Barrier
2. Footwall drive
3. Old obsolete water resources
4. An ancient class of thought included functions
5. Hanging wall drive
6. Cutting the cross
