Root Cause Analysis of Premature Failure in Reheater Bend Tube of a 700 MW Thermal Power Plant

R. K. Kumar, D. Laxman Rao

Materials Technology Division, Central Power Research Institute, Bangalore

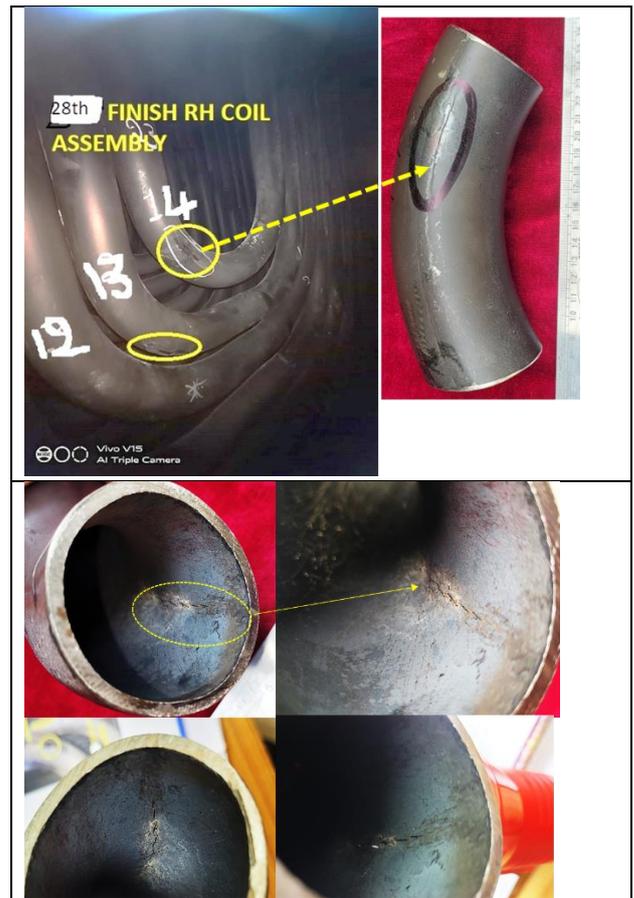
The photograph of the failed RH tube location (Coil no. 28 with tubes 12 to 14) inside the boiler showing multiple failures is shown in Fig. 1a. A total of 50 reheater tube coils were available inside the boiler. The analysis was carried out on the innermost bend loop tube which has shown radial cracking. The close-up view of the failed reheater tube showing a thin hairline longitudinal crack along the bend radius is shown in Fig. 1b. The longitudinal crack length was observed to be around 40 mm. The OD Side surface is covered with a black-coloured adherent scale. Spalling of the external scale in some areas was observed. Swelling or reduction in the wall thickness of the tube was observed near the crack opening. The cut cross sectional view of the tube confirmed the existence of the crack extending through the wall thickness (Fig. 1(b)).

Fig. 1(a) View of the Location of the failed tubes in the coils and 1(b) cross-sectional view of the ID side

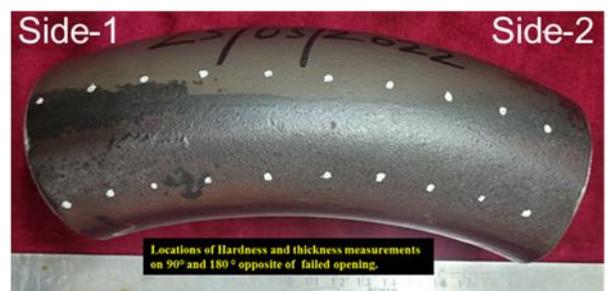
The thickness of the tube was measured on both ends as shown in Fig. 2, to account for erosion and swelling caused by any overheating issues. There was no discernible reduction in wall thickness both in the radial direction as well as the diametrically opposite region. The tube thickness was observed to be near to the design thickness value of 3.99 mm and the thickness readings were given in table -2. The dimension taken at the cross-section of the tube is shown in Fig. 3.

Fig. 2 Wall thickness measurement locations along the bend tube

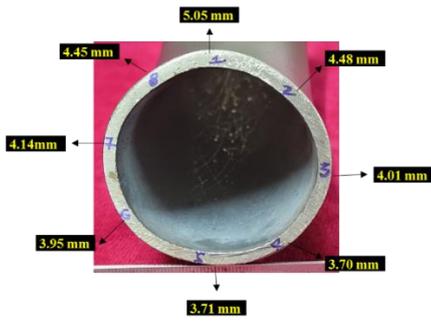
Fig. 3. Thickness measurements at the cracked end of the tube

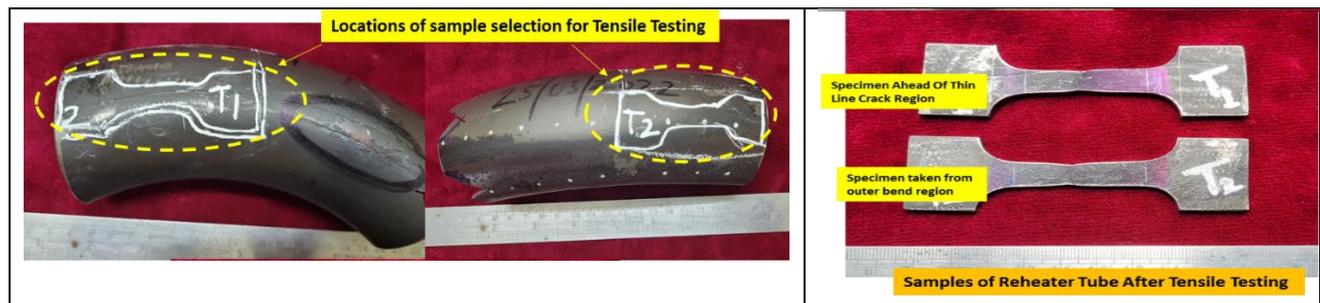
Fig. 4

Location of samples taken from the tube sample for tensile tests

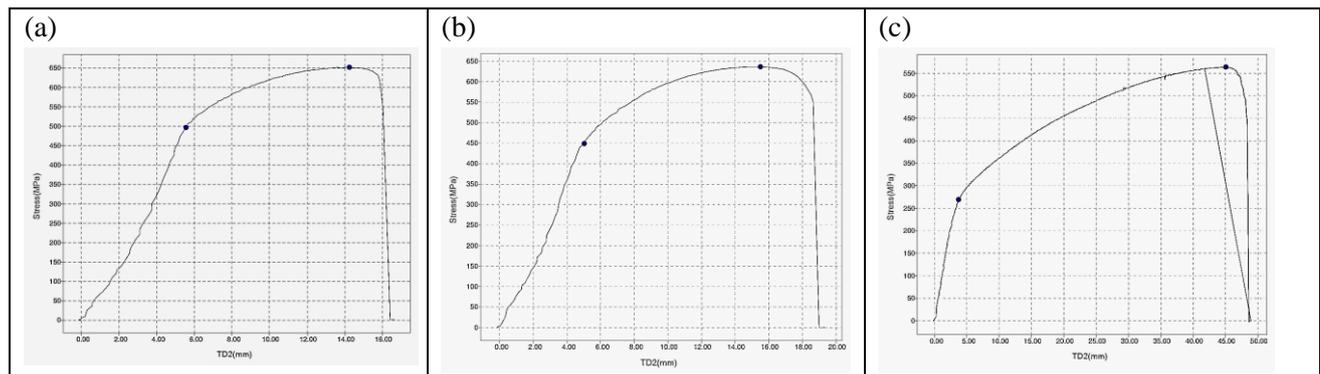
Results indicated that the yield strength of the failed tube was nearly two times higher than that of the virgin tube. This appears due to the phenomenon of strain-induced precipitation hardening of the material. However, the ultimate tensile and elongation properties are well above the minimum requirements as per ASME standards.

Fig. 5 Stress-Displacement Graph of the tensile sample taken at different regions, near thin hairline crack close to failure opening (a) outer bend region (b) virgin tube sample (c)

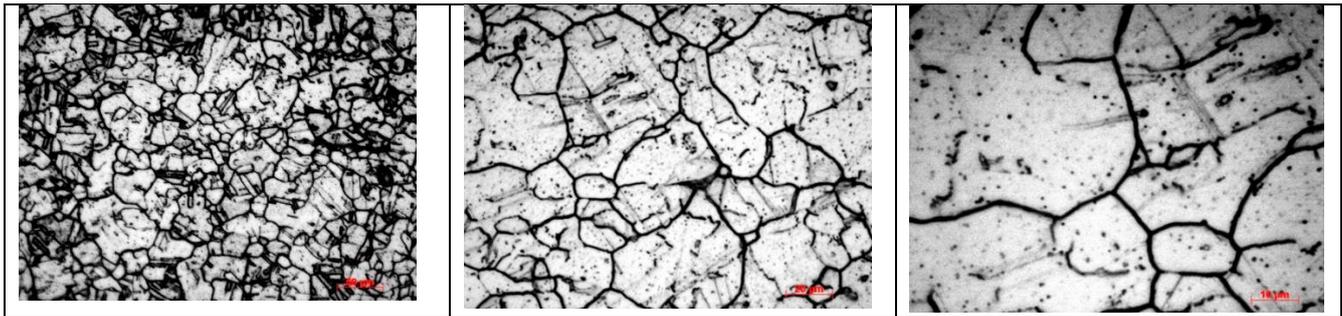
virgin tube samples are shown in Figs. 6 & 7. The microstructure of the Reheater tube revealed an austenitic structure with precipitated carbide phases along the grain boundary, typical of a sensitized structure. Sensitization of the grain boundaries with grain boundary thickening has been observed in the failed tube, typical of intergranular attack while the grain structure in the virgin tube was quite good. The precipitation of Chromium carbide ($Cr_{23}C_6$) was observed to have formed for service, indicating the fact that the tube has undergone temperature-induced phase transformation. The absence of corrosion species near the cracked edge is indicative that the material has not been subjected to stress corrosion cracking. Figures 6 & 7 show the microstructure of the failed tube at different locations and the virgin tube observed under different magnifications. The structure revealed a sensitized condition of the grain boundaries marked by the ditch structure.

Fig. 6 Microstructure of the failed tube close to the cracked region at (a) 200x (b) 500x (c) 1000x.

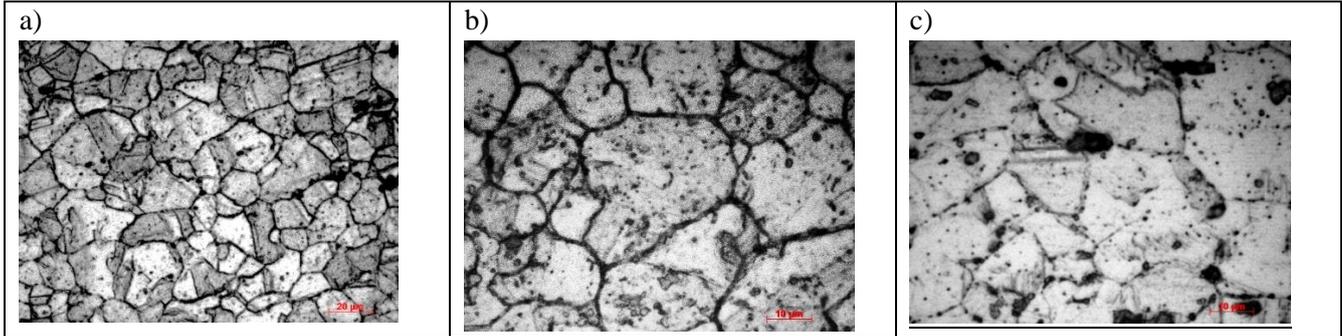
Fig. 7. Microstructure of the Failed RH tube near outer bend radius region (a) (b) revealing grain growth and sensitized structure and virgin tube micrograph (c)

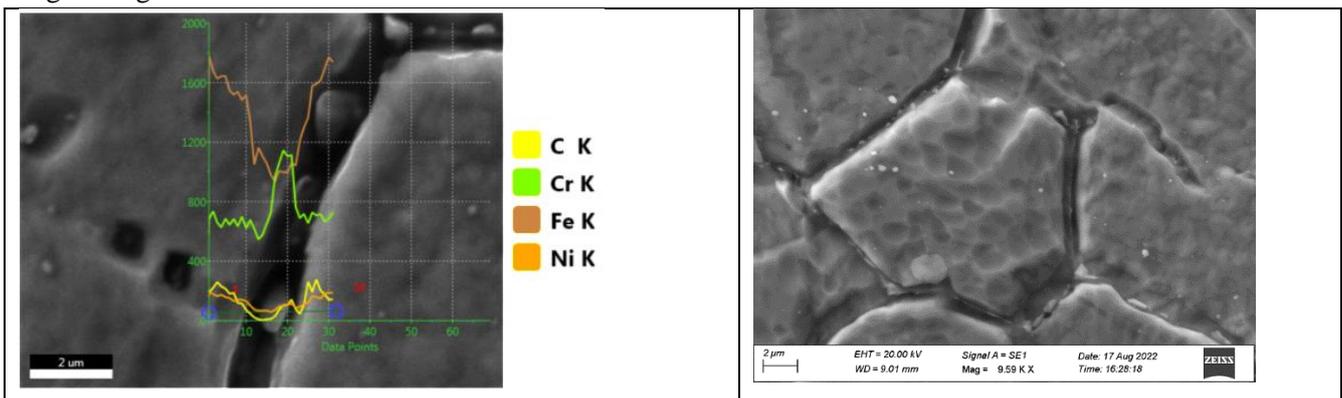
grain boundaries are shown in Fig. 8 & 9. The SE micrographs of both cracked tubes showing the austenitic grain structure along with carbide precipitation along grain boundaries are shown in Fig. 10. Depletion of chromium, carbon and nickel was observed over the grain and the precipitate showed high chromium content.

Fig. 8 Mapping of elemental concentration across grain and precipitate through Electron micrographs.

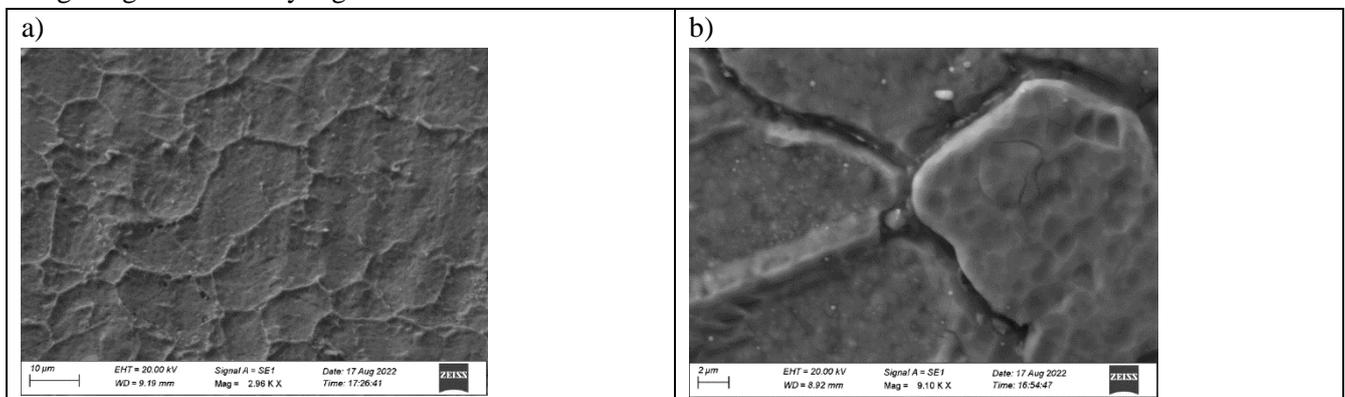
Fig. 10. Electron micrographs of Failed Reheater tube revealing austenitic grain structure (a) precipitation of carbides along the grain boundaries (b).
