## PROGRESSIVE FAILURE ANALYSIS OF BUILDING STRUCTURE

Sachin Bhalerao<sup>1\*</sup>, Rohan Choudhary<sup>2</sup>

<sup>1</sup>*M.tech Student, Department of civil engineering, Sandip University, Nashik*

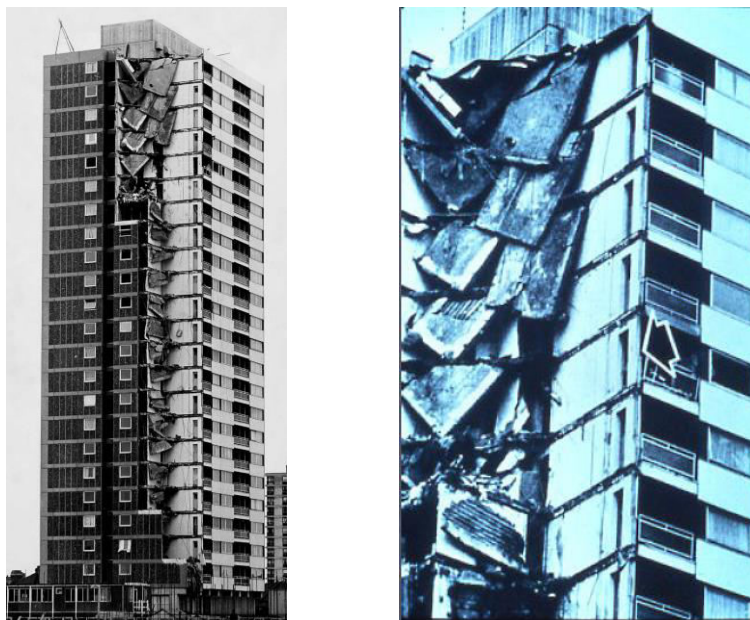
**Fig.1.2 Ronan Point, 1968 –Collapse due to gas explosion**

On 16th May 1968, a gas explosion took place on 18th floor that knocked out load bearing precast concrete panels near the corner of the building which caused the floors above to collapse [fig 1.2]. This impact set off a chain reaction of collapses all the way to the ground. The ultimate result was collapse of the corner bay of the building from top to bottom. It is believed that the weakness was in the joints connecting the vertical walls to the floor slabs

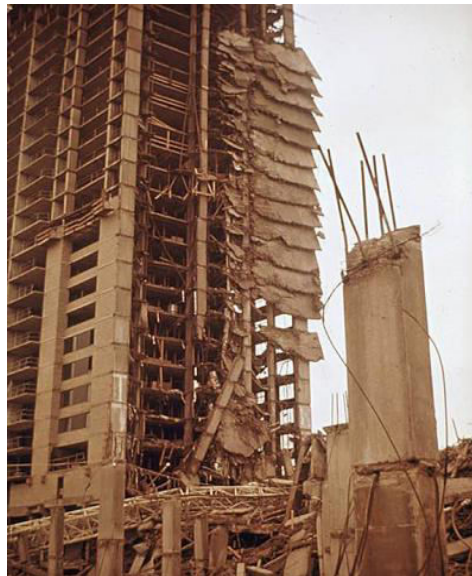
In the midst of construction on March 2, 1973, progressive collapse occurred during construction of 24<sup>th</sup> floor. The collapse involved the full height of the tower, and the falling debris also caused horizontal progressive collapse of an entire parking garage under construction adjacent to the tower [fig 1.3]. The incident occurred at around 2:30 in the afternoon and resulted in the death of 14 construction workers and the injury of 34 others. The most likely cause of the collapse was a punching shear failure of the 23rd floor slab. The two factors that contributed to this were premature removal of shores below the 23rd floor slab, and the low strength of the 23rd floor concrete in the area supporting the weight of the 24th floor slab.

### **Skyline Plaza, 1973 –Premature formwork removal**

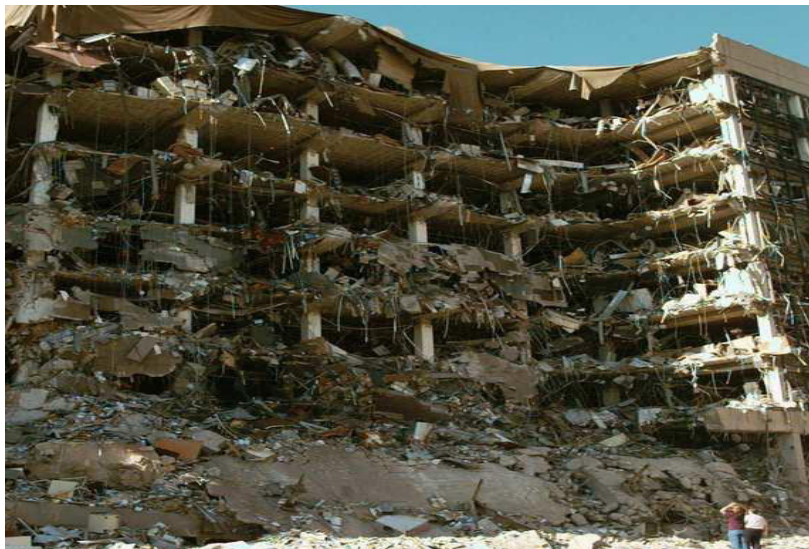
Alfred P. Murrah Federal Building in Oklahoma City was the target of terrorist attack in 1995. The truck bomb explosion caused extensive damage to the exterior columns. Suspended transfer girder resting on the exterior columns failed due to loss of support which triggered the progressive collapse of upper stories [fig1.4]. It was the most destructive act of terrorism on American soil until the September

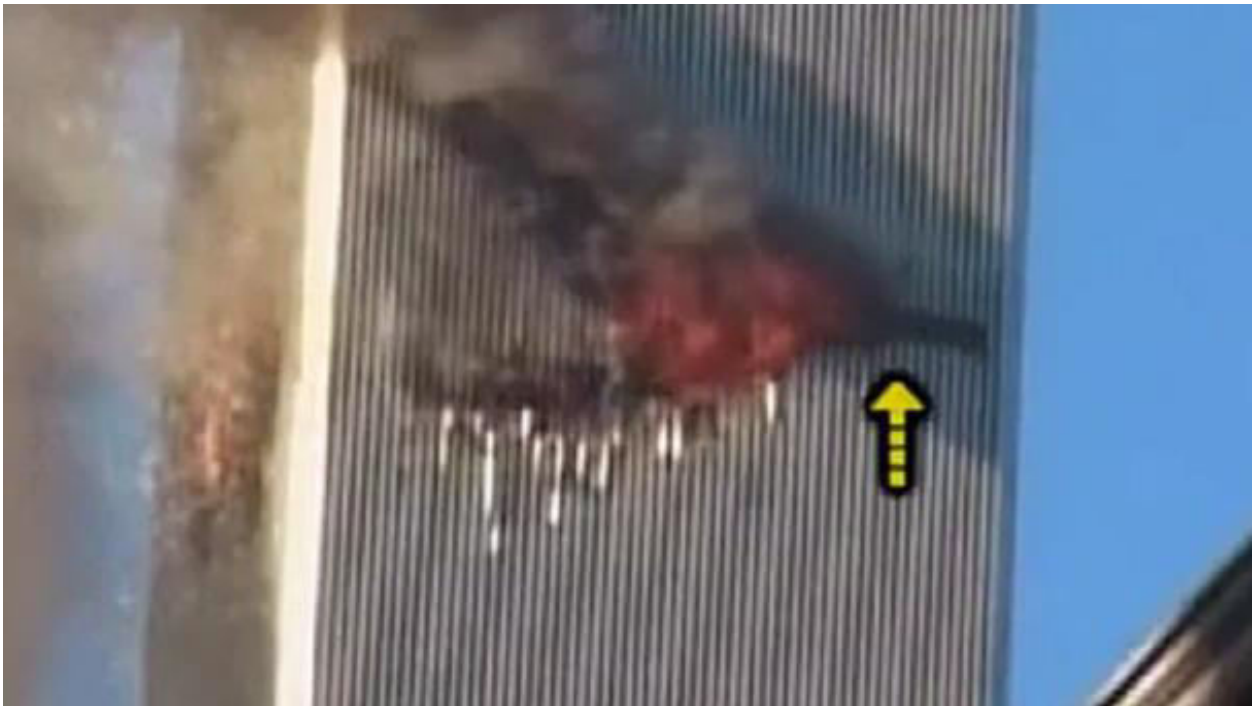
The twin towers of World Trade Center 1 and 2 collapsed on Sept. 11, 2001 following this sequence of events: A Boeing 767 jetliner crashed into each tower at high speed; the crash caused structural damage at and near the point of impact, and set off an intense fire within the building (Fig.1.5); the structure near the impact zone lost its ability to support the load above it (Fig.1.6) as a result of some combination of impact damage and fire damage; the structure above collapsed, having lost its support; the weight and impact of the collapsing upper part of the tower (Fig.1.7) caused a progression of failures extending downward all the way to the ground. Clearly, this was a “progressive collapse” by any definition. But it cannot be labelled a “disproportionate collapse.” It was a very large collapse caused by a very large impact and fire. And unlike the case with the Murrah Building, simple changes in the structural design that might have greatly reduced the scale of the collapse have not yet been identified.

**Structural damage and set off intense fire after crashing**

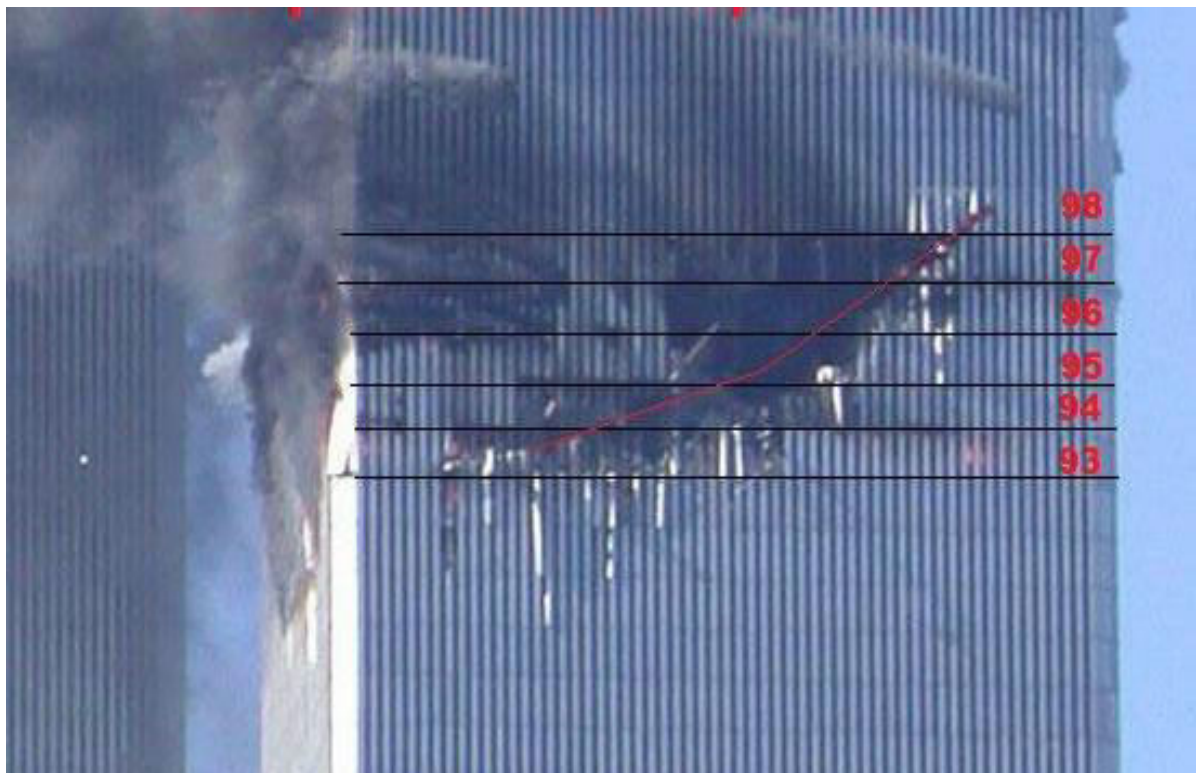
**Impact zone lost the ability to support above load**

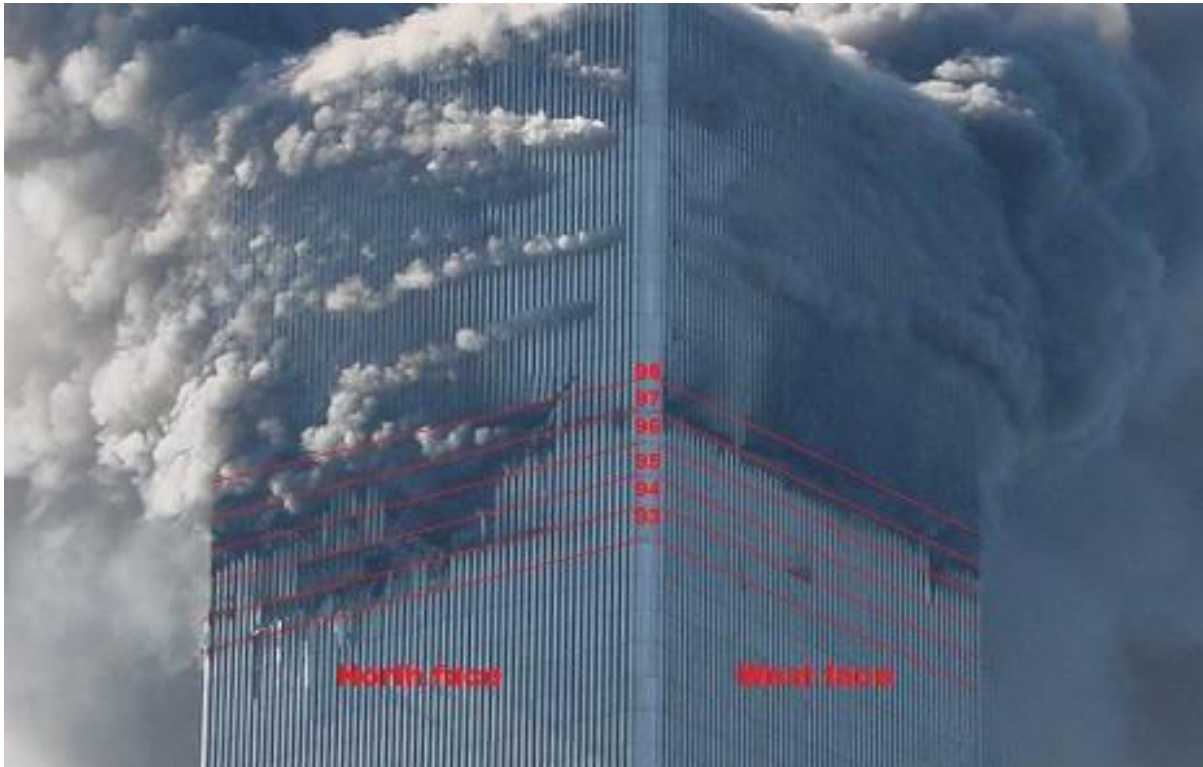
**Loss of support creates in stability ad failure of structure.**

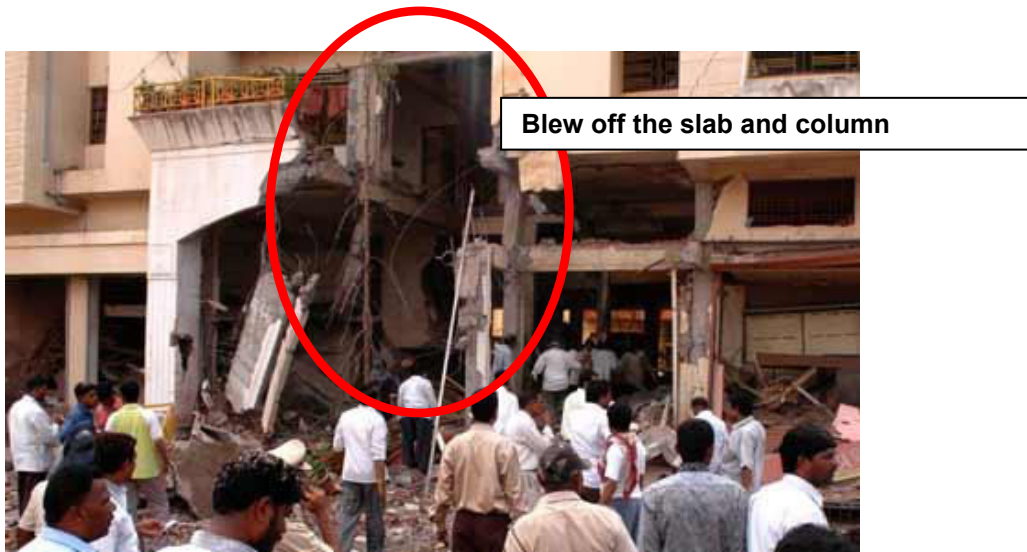
The blast was so powerful that it blew off the upper slab of this shop. It also blew of the surrounding wall and column. Even though, it blew of the column and upper slab (fig 1.8) structure wasn't collapse. Surrounding structural element were bear and pass the excessive load safely hence structure remain safe from collapse. The design of building is safe for progressive collapse. Because of this, people who residing in upper floor were not get injured. Three people were killed because they were working in shop. Progressive collapse resisting structure saved the life of residing people.

**Saptashringi building at Tarwala Nagar, Nashik, June 8, 2011**

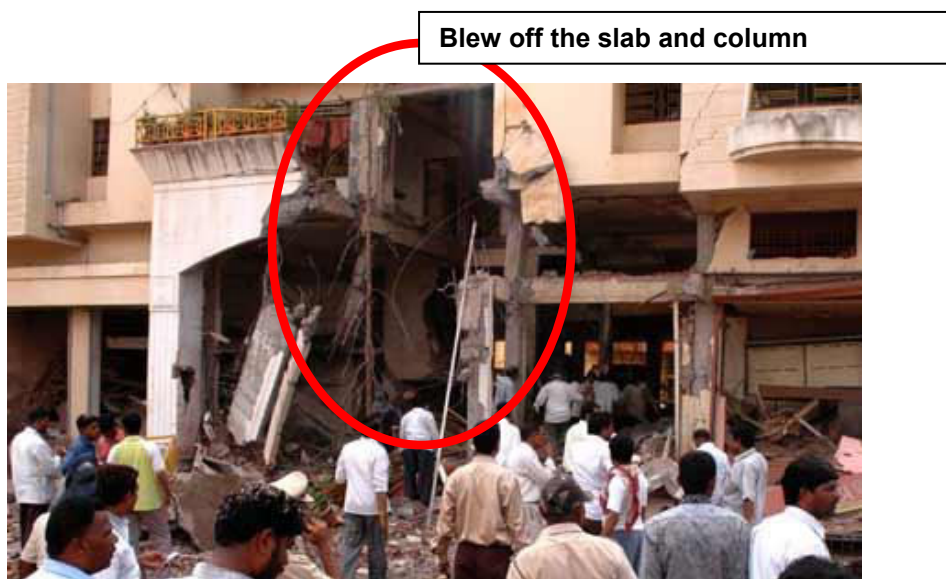
**Fig.4.9 Saptashringi building at Tarwala Nagar, Nashik, June 8, 2011**

Saptashringi Apartment was safe after blast as it blew the outer column of the building. As per analysis of the structure, structure remain safe after removing after any column of the structure. It has enough rigidity to make path for excess load and It is visible practically in figure below.

Due to lack of analysis and study of progressive collapse of structure, this structure is considered as a failed structure and it has been demolished. It could be reused if it was go through proper study and analysis.
