A study on Construction Practices of Non-Engineered Structures in Different Countries

Key Words: Non-engineered buildings, developing countries, construction practices

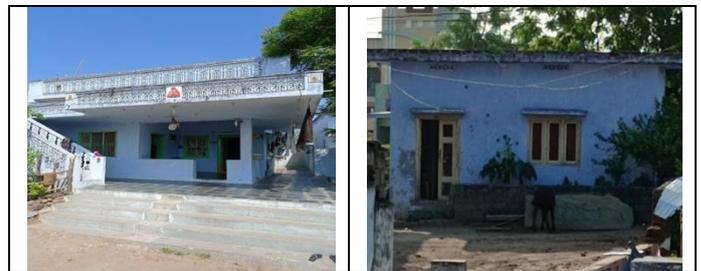
Fig -1: Typical non-engineered buildings in India

In India the most common type of non-engineered buildings are brick masonry buildings. Here most of the bricks used for the construction are fired bricks.

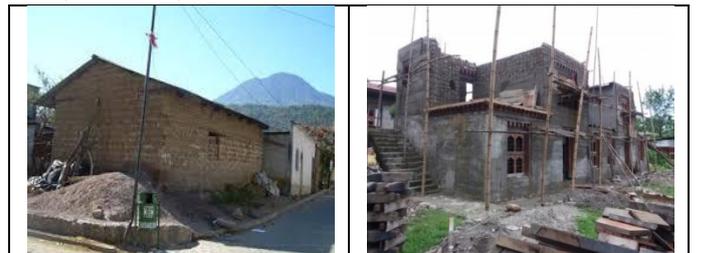
Fig -2: Typical non-engineered buildings in Turkey

Mainly in turkey there are three types of non-engineered buildings i.e. reinforced concrete frame with clay hollow brick infill wall, unreinforced brick masonry and wooden structures. These types of structures can be seen rarely in turkey.

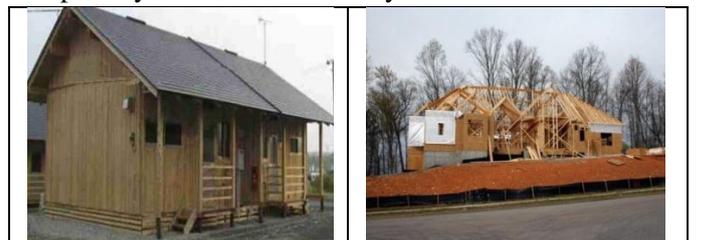
Fig -3: Typical non-engineered buildings in USA

In USA for the construction purposes mainly they give high priority to the high-quality wooden structures and less priority to the brick masonry structures.

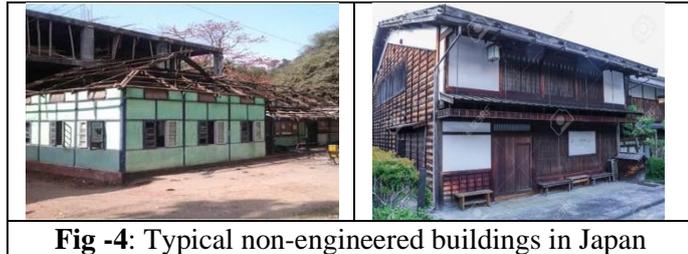
Fig -4: Typical non-engineered buildings in Japan

The main type of non-engineered structures in Japan is wooden structures. And these wooden structures are entirely earthquake resistant buildings.

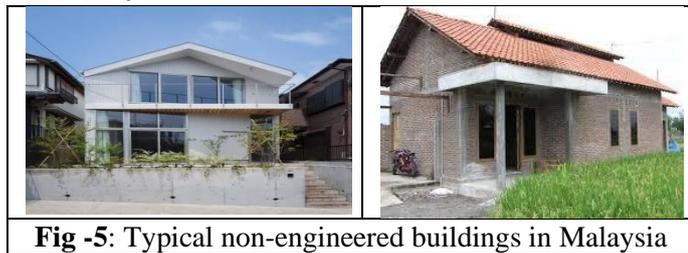
Fig -5: Typical non-engineered buildings in Malaysia

In rural area most of the non-engineered structures can be seen. The roof of non-engineered buildings varies from locality to locality and it depends on the availability of materials.

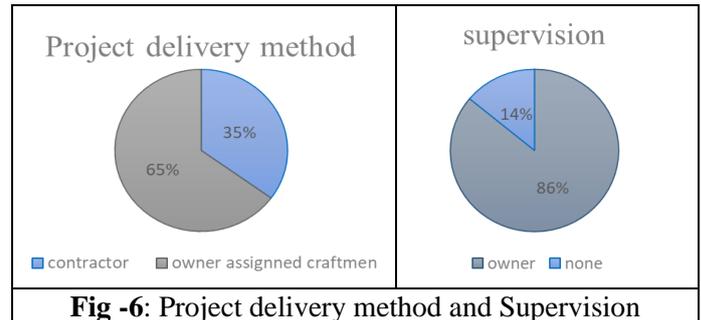
Fig -6: Project delivery method and Supervision

The majority of non-engineered buildings found in India, Turkey, Malaysia, Dubai, the United States, and Japan are created by craftsmen assigned by the owner, using simple construction tools. In general, the availability of construction materials for non-engineered buildings is not an issue or a constraint. The majority of the buildings are privately owned, and the owner is the one who makes the majority of the design decisions. The majority of non-engineered structures are discovered to be supervised by their owners. In India, Turkey, Japan, and Dubai, home owners and workers agree that earthquakes are the most common natural disasters. Other nations, such as India and Malaysia, are also

- In project site facts, project delivery method of 65% and supervision of 86% mostly depends on owners in most of the countries because the land is owned by them. Only government assigned projects are depended on the contractors.

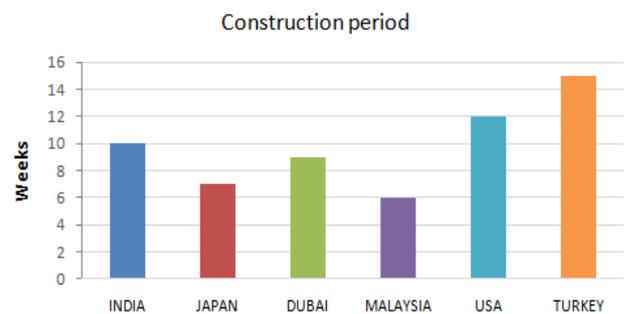
Fig -7: Construction period among various countries

affected by floods. A non-engineered building is typically completed in 6 to 17 weeks.

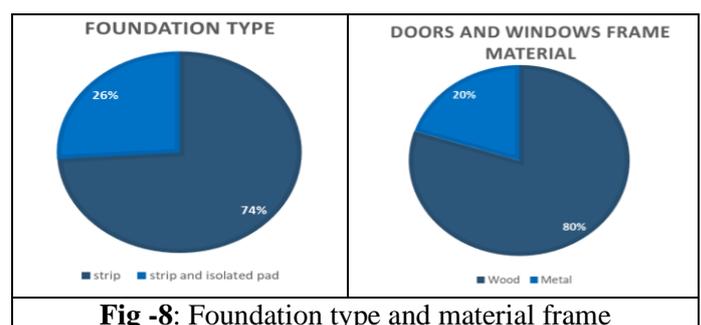
Fig -8: Foundation type and material frame

The majority of non-engineered structures are utilized as residential and small commercial structures, with some being used as school structures. The simplest foundation system, “strip and isolated pad,” is mostly seen in non-engineered buildings examined, which are made of various materials such as stone and RC. Reinforced concrete confinement is used in the majority of buildings for restricted masonry. The most prevalent material for door and window framing systems is wood. In this general building information, we are discussing about the area of building and number of rooms in a house. Building area is always depends on the owners and number of rooms division is based on the area of the building and it varies to every house. Below the graphs are about “Area of building” and “Number of rooms” depends on their average values.

- In most of the countries, strip footing is most commonly used foundation type of 74% and remaining 26% used is strip& isolated pad type. 40% of the wall materials used for constructions is sun-dried bricks and burnt bricks but the remaining 30% used is concrete masonry blocks and other 30% used is clay bricks for the construction purposes.

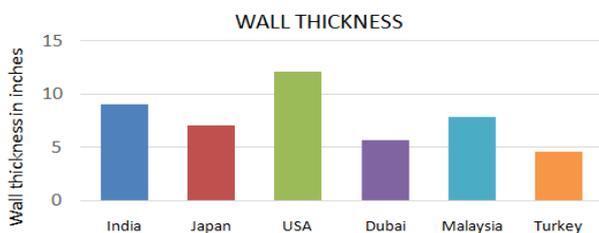
Fig -11: Wall thickness

The countries which we have chosen mostly utilizing the fired bricks. Some of them are selecting stones and concrete blocks for the construction of walls. According to the selected country thickness of the exterior wall is mentioned in the form of below bar graph.

Malaysia of 6.3MPa and 30MPa but lowest in turkey of 2.5MPa and 9MPa. Unites states is having highest wall thickness of 12inches and turkey is having lowest wall thickness of 4.5inches in the selected samples.

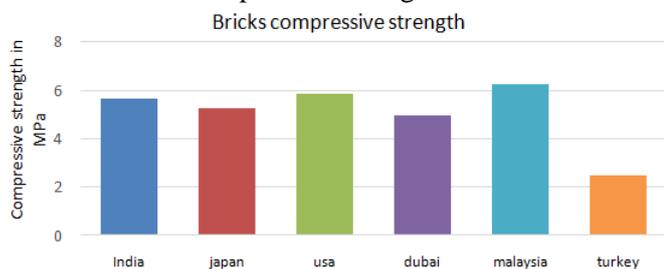
Fig -12: Bricks Compressive strength

For wall materials, the majority of non-engineered buildings in the selected countries employ baked clay or stone masonry. When compared to clay bricks, the compressive strength of brick units ranged from 4.3 to 6.9 MPa, with an average of 5.7 MPa. These bricks were found to be soft and weak. A decent mud brick has a compressive strength of 1.6 to 1.9 MPa, whereas a clay-fired brick has a compressive strength of 14 MPa.

- In the general building information, the highest area for buildings considered in United States is 185sq.m and lowest in Dubai of 94sq.m.
- As per the data collected from literature study of journals, both brick compressive strength and concrete compressive strength is highest in

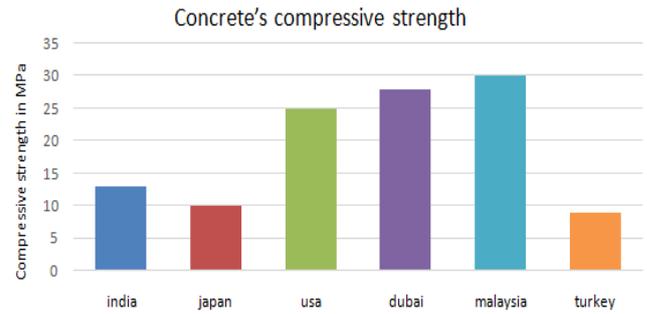
Fig -13: Concrete's Compressive strength

According to the report, some non-engineered structures have structural parts with very low concrete strength. Malaysia has the highest concrete compressive strength, over 30 MPa. Turkey has the lowest concrete compressive strength, around 4.5 MPa. Ordinary Portland cement is used in the construction of all of these countries. The majority of the aggregates come from river and mountain quarries.

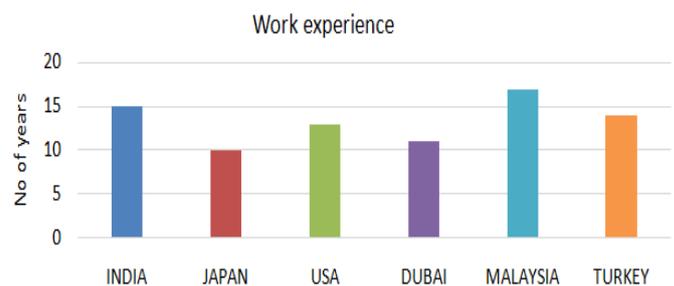
Fig -14: Work experience

In this contractor data we have gathered the matter of number of workers and their work experience. We have followed up the data of 6 countries like turkey, India, Japan, Malaysia, USA and Dubai. Based on the work in the construction site workers will be taken. In Dubai most of the workers are migrant workers and in remaining countries there is a possibility of both migrant and non-migrant workers. Here is some of the data which is being represented in the form of graph.

- The most commonly used doors and windows frame material is wood with 80% and there is less possibility of using metal for this type of purposes i.e. 20%. The highest number of workers involved in construction of structures is Malaysia (24 workers) and lowest in turkey (16 workers) and highest work experience for the workers is in Malaysia with 17 years as compared to remaining selected countries.
