Challenges and Issues with Historic Building Conservation

Abstract— The process of conservation for historic buildings is frequently complicated by number of issues. This research examines the issues and challenges that historic buildings face. The research lays out small case studies that were carried out in Thanjavur to determine the serious issues faced by conservators during the execution of conservation techniques. A survey of the literature and a case study of few structures are done to identify the issues. Some of the identified issues include environmental, financial, lack of priority, and human issues. According to the research conclusions, the biggest obstacles to conservation initiatives are financial issues, environmental issues, and a lack of attention paid to historic structures.

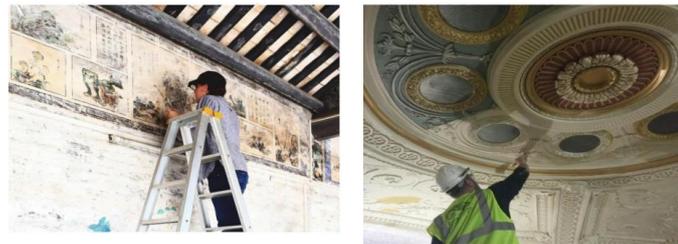
Fig 1 : Restoration

It means and includes returning the existing fabric of a place to a known earlier state by removing accretions or by reassembling existing components without introducing new materials. [3]

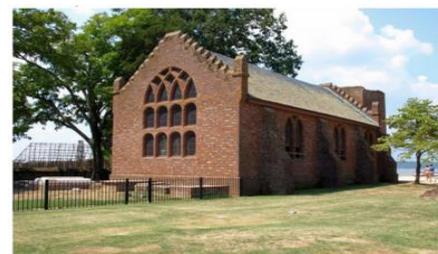
It means and includes returning a place as nearly as possible to a known earlier state and distinguished by the introduction of materials (new or old) into the fabric. New material may include recycled material salvaged from other places. This should not be to the detriment of any place of cultural significance. This shall not include either recreation or conjectural reconstruction. [4]

*Fig 2 : The reconstructed Jamestown Church, Jamestown,
Source: https://sist.sathyabama.ac.in/sist_coursematerial*

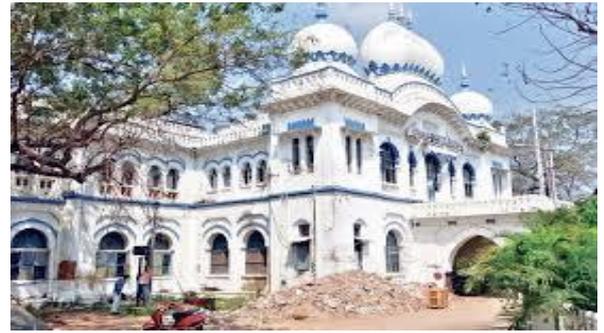
Fig 4 : Old Collector Office(Author)

- Location: Thanjavur, Tamil Nadu.
- Year: Completed - 1896.
- Architectural Style: Indo-Saracenic architecture.

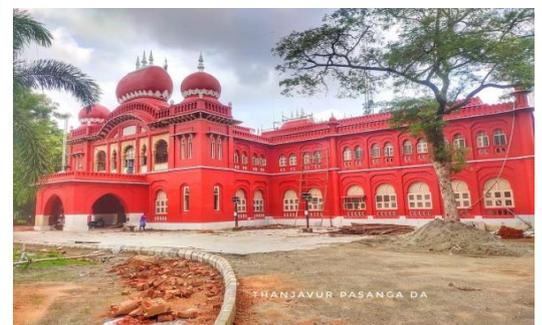
Fig 5 : Old Collector Office(Author)

- Vegetation growth, dampness due to seepage from toilet blocks, new additions of masonry walls were some of the issues observed on site.
- Ageing is the primary cause. Previously many telecommunications were housed on the terrace and above the domes, The rods got eventually rusted and minor damages were caused when these were removed during the initial stages of conservation work.
- There were minor cracks caused due to vegetation. Biological growth of algae and fungi were also observed at some places.
- Dampness and lack of maintenance were the major cause for vegetation growth.

- Granite flooring was installed immediately over the original stone flooring.
- The existing stone flooring covered with granites.

- For further expansions of bathrooms, storage rooms, etc., cement mortar was employed during the earlier renovation procedure.
- Thus the reason the government asked the conservators to continue the same cement in restoration work.
- The entire wall has now been insensitively painted with red emulsion and it's the decision of the collector and government.
- Additions such as toilet, partition, and masonry walls as a part of additional work.

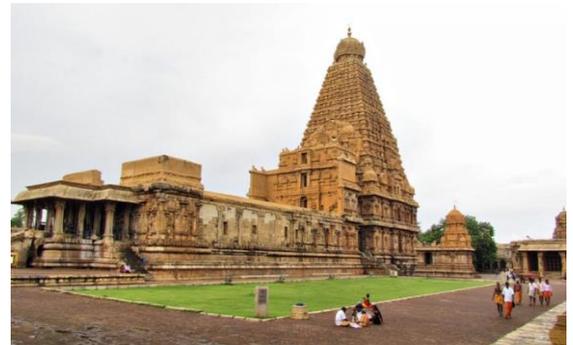
Fig 6 : Brihadeeswarar Temple (Author)

- Location: Thanjavur, Tamil Nadu.
- Year: Completed - 1010

- Architectural Style: Dravidian Architecture

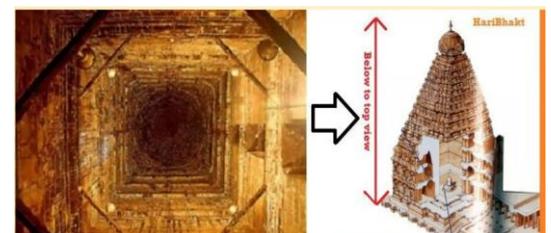
Fig 7 : Brihadeeswarar Temple (Author)

- The main Vimana, Keralanthagan Gopuram and other smaller Vimanas of this great temple affected by microbiological growth, bird droppings, dust, dirt and soot etc. have been taken up for scientific conservation measures.
- The exterior surfaces of some of these structures have been subjected to mechanical and chemical cleaning, using a mixture of ammonia solution and

non-ionic liquid detergent solution (3:1) in water, followed by the application of sodium pentachlorophenate solution (2%) in water as fungicide.

- All repairs have been carried out using only traditional materials and techniques.
- The Archaeological Survey of India has conducted routine inspections and simultaneously corrected the problems.

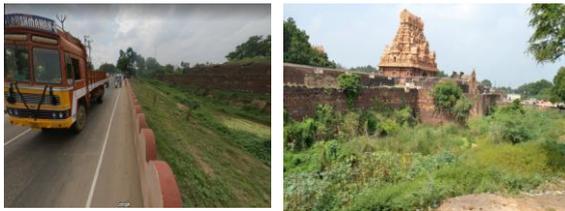
Fig 8 : Brihadeeswarar Temple fortified wall (Author)

- The outer fortification and the moat of the Sivaganga Little Fort is presently with the Thanjavur Municipality.
- The rank vegetation growth is seen all over the fortification wall and the walls have fallen in some areas.
- This adversely affects the ancient ambience of the temple complex.
- The heavy vehicular movements around the temple cause vibration and also air pollution which in course of time will affect the property.
- Impact of urbanization/illegal construction, increase in vehicular movement in general may affect the property.
- The advisory board will be approached for diverting the vehicular traffic around the property.

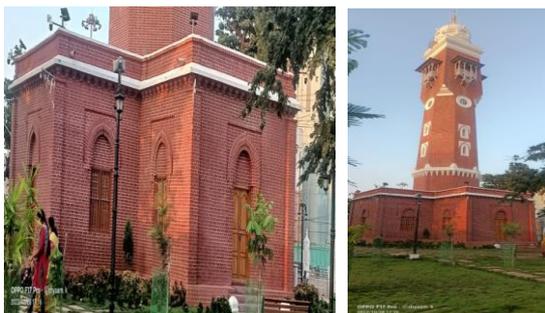
Fig 9 : Ranee’s Tower (Author)

- The heritage building, Ranee’s (Rani’s) clock tower a red painted slender octagonal brick building roughly as tall as a 8 story structure
- Adjacent to old bus stand at the busy intersection of Gandhi Road and Hospital road is a valuable heritage.
- Its green coloured wooden ornate projecting balconies with a nice roof on all four sides overlooking the roads.
- There is a spiral stairway with railing inside the tower through which those balconies could be accessed.
- The entrance doorway is on the east side at the base of the tower abetting the Gandhiji road. In particular, those wooden balconies perching close to the top need immediate attention.

- The entire wall has now painted with red emulsion and it’s the decision of the collector and government.
- The Entire conservation work done with cement mortar instead of lime mortar.
- Existing structure used lime mortar.
- All around, the four wooden balconies are painted with white emulsion paint and its decision with collector and government.
- At present red emulsion paint has been used to paint the exteriors over the cement plastered walls. Issues of capillary action and rising dampness shall pose threats to the structure in future.
