# Characterization of Harness-Induced Excitation and Fixture Resonance in Automotive Electronic Module Testing

Sumit Shukla

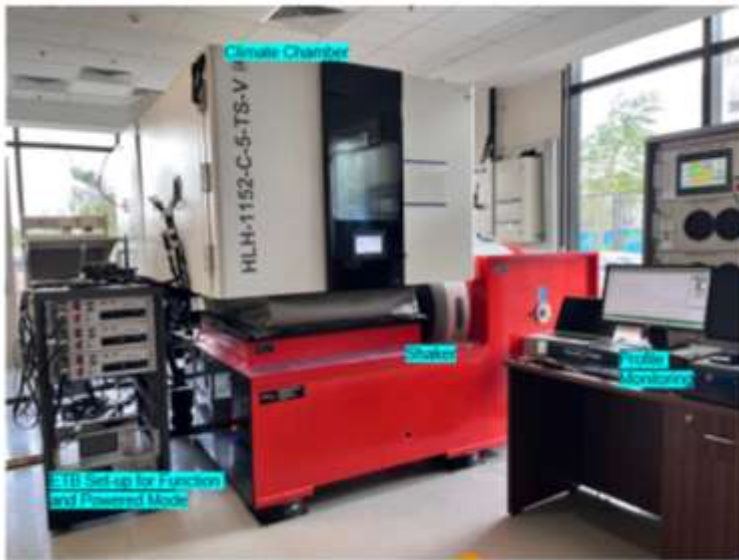
The fixture is then mounted on the vibration shaker table and then for combined temperature the complete set-up was placed in a mobile chamber.

Picture 6: Reference and representative picture of the vibration test set-up

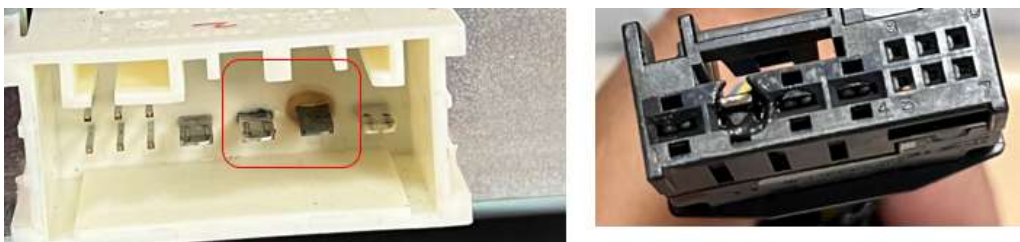
Following completion of testing, localized blackening/discoloration was observed on one connector pin and local melting of plastic and pin blackening on the female harness side.

Picture 7: Reference and representative picture of harness side local melt and terminal blackening

The condition was therefore categorized as a localized surface degradation phenomenon rather than a functional failure.

- Harness fixation relocated near the connector
- Unsupported cable length minimized
- Fixture-correlation measures removed

This outcome provided direct evidence that harness optimization alone was sufficient to eliminate the observed condition.
