## Condition Assessment of Structures

#### 2.1 Condition Assessment of Public Building at Chandur Railway

2.2 Condition assessment of residential building at Amravati city

### 5.3 Report of Assessment of Water Tank

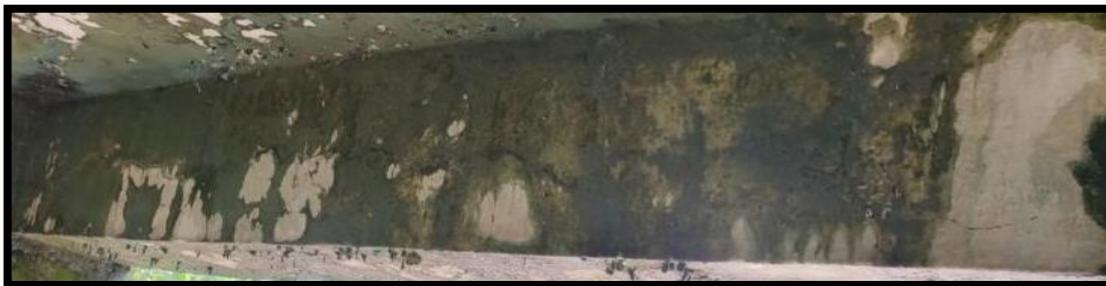
**Figure 2: Existing condition of beam**

a) **Observation of cracks in beams** – The cracks at the ground floor slab beam of building.

- 1) Flexural crack – These cracks are formed at bottom of middle span below N.A of the beam where flexural stresses are maximum.
- 2) Shear cracks – When the shear reinforcement at corners are at large spacing.

- 1) Minor cracks: Repair by injecting epoxy resins and finish it by repair mortar (polymer modified mortar)
- 2) Flexural cracks and shear cracks: Repair by injection of low viscous grout and strengthening by F.R.P wrapping.

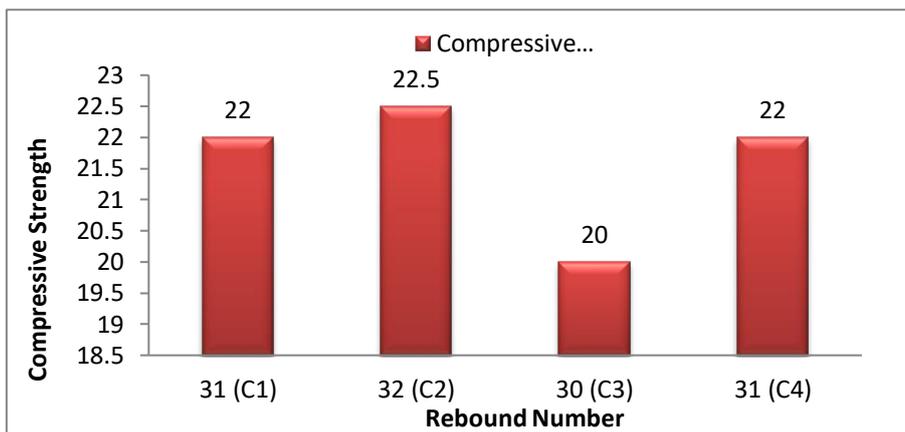
**Graph1: Relation between compressive strength and rebound number**

Column 1 <sup>st</sup>	Column 2 <sup>nd</sup>	Column 3 <sup>rd</sup>	Column 4 <sup>th</sup>
18	28	32	22
32	29	35	35
44	36	22	34
31	38	25	25
36	32	35	36
26	32	25	34
Avg-31	Avg-32	Avg-30	Avg-31

Location	Approximate Compressive strength	Quality of concrete depends on rebound value (IS 13311:1992) Part2
1 <sup>st</sup> column	22 N/mm <sup>2</sup>	30 to 40 (Good concrete)
2 <sup>nd</sup> column	22.5 N/mm <sup>2</sup>	30 to 40 (Good concrete)
3 <sup>rd</sup> column	20 N/mm <sup>2</sup>	30 to 40 (Good concrete)
4 <sup>th</sup> column	22 N/mm <sup>2</sup>	30 to 40 (Good concrete)

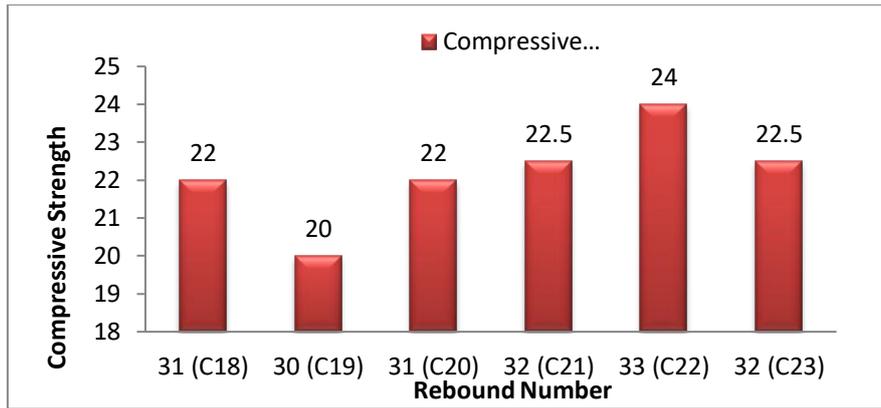
Graph2: Relation between comprehensive strength and rebound number of the interior column of the building

18 <sup>th</sup> Column	19 <sup>th</sup> Column	20 <sup>th</sup> Column	21 <sup>st</sup> Column	22 <sup>nd</sup> Column	23 <sup>rd</sup> Column
28	25	38	22	30	32
30	22	32	35	38	36
32	30	28	42	32	28
36	35	30	36	35	36
32	36	28	28	32	28
30	32	32	30	30	30
Avg-31	Avg-30	Avg-31	Avg-32	Avg-33	Avg-32

Location	Approximate Compressive strength	Quality of concrete depends on rebound value (IS 13311:1992) Part2
18th column	22N/mm <sup>2</sup>	30 to 40 (Good concrete)
19th column	20 N/mm <sup>2</sup>	30 to 40 (Good concrete)
20 <sup>th</sup> Column	22 N/mm <sup>2</sup>	30 to 40 (Good concrete)
21th column	22.5 N/mm <sup>2</sup>	30 to 40 (Good concrete)
22th column	24 N/mm <sup>2</sup>	30 to 40 (Good concrete)
23th column	22.5 N/mm <sup>2</sup>	30 to 40 (Good concrete)

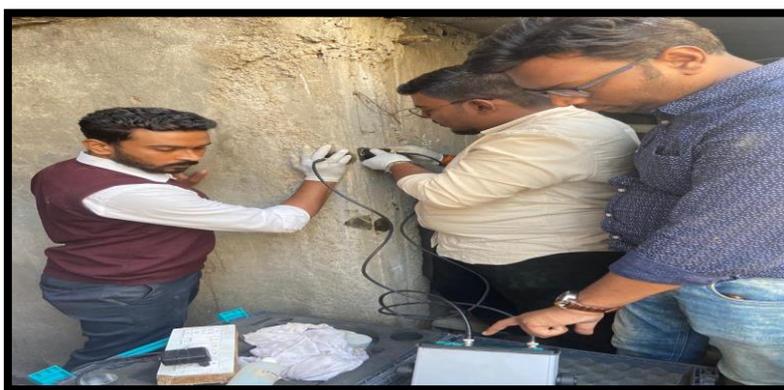
**Figure 4: Process of using Ultrasonic pulse velocity test**

Sr.no	Location	Size	Pulse velocity	Concrete condition
C1	Front elevation exterior column.	230x450	3535 m/s	Questionable
C20	Intermediate column at ground storey.	230x450	3413 m/s	Questionable
C21	Intermediate column at first storey.	230x450	4476 m/s	Good
C15	Front column west side of building at first storey.	230x450	4285 m/s	Good
C11	Front column on south west side of building at ground storey.	230x450	3362 m/s	Questionable
C3	Front column on north side of building at ground storey	230x450	4583 m/s	Good

Sr.no	Length	Pulse velocity	Classification	Compressive strength (IS 13311:1992) Part1 (table no:2)
C1	0.45 m	3.5km/sec	Medium	20 TO 25 N/mm <sup>2</sup>
C20	0.45 m	3.4km/sec	Medium	20 TO 25 N/mm <sup>2</sup>
C21	0.45 m	4.47 km/sec	Very good	30 TO 35 N/mm <sup>2</sup>
C15	0.45 m	4.28 km/sec	Very good	30 TO 35 N/mm <sup>2</sup>
C11	0.45 m	3.3km/sec	Medium	20 TO 25 N/mm <sup>2</sup>
C3	0.45 m	4.58 km/sec	Very good	30 TO 35 N/mm <sup>2</sup>

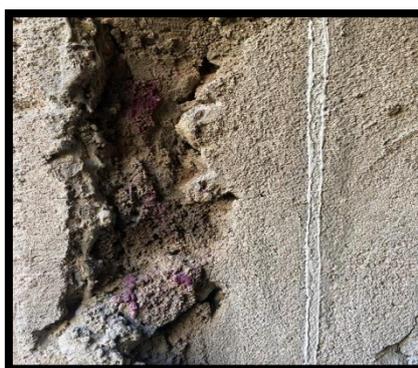
**Figure 5 Phenolphthalein solutions on concrete surface**

1. 1% phenolphthalein solution sprayed on exposed fresh surface.
2. Unaffected by carbon dioxide having surface colour pink.
3. Coloured surface represents there is still Ca (OH)<sub>2</sub> present in it.
4. The depth of carbonation can be determined as:  
d = coloured surface to the edge of specimen.
5. The carbonation depth is approximately equal to square root of time  
1mm for 1 year, 3mm for 9 years.

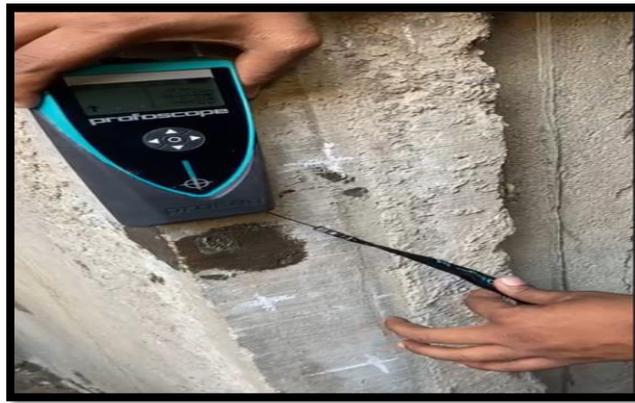
**Figure 6: Position of reinforcement in the column**  
After the load calculation the structure is design for earthquake Zone 3

- 1) Rebar locator is used for locating the number of bars in particular column and beam.
- 2) It also helps to determine the diameter of bars and clear cover.
- 3) With the help of rebar we can get the clear idea about existing reinforcement of structure without destructive testing.

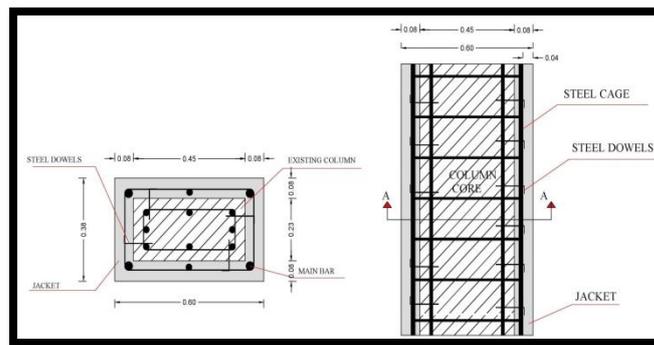
Figure 8: Cross Section of RCC Jacketed Column

Column No	Existing Column Size		Existing steel	Stirrups Details	Required Size		Required steel	Stirrups Details	Actual Steel Required	No Of Bar
	L	B			L	B				
1	230	450	905	6 mm @ 150mm	380	600	1824	8mm-130mm	919	16X4,12x2
2	230	450	905	6 mm @ 150mm	380	600	1606	8mm-130mm	701	12x6
3	230	450	905	6 mm @ 150mm	380	600	1606	8mm-130mm	701	12x6
4	230	450	905	6 mm @ 150mm	380	600	1824	8mm-130mm	919	16X4,12x2
5	230	450	905	6 mm @ 150mm	380	600	1824	8mm-130mm	919	16X4,12x2
6	230	450	905	6 mm @ 150mm	380	600	1538	8mm-130mm	633	12x6
7	230	450	905	6 mm @ 150mm	380	600	1824	8mm-130mm	919	16X4,12x2
8	230	450	905	6 mm @ 150mm	380	600	2371	8mm-130mm	1466	16X6,12x2
9	230	450	905	6 mm @ 150mm	380	600	1824	8mm-130mm	919	16X4,12x2
10	230	450	1131	6 mm @ 150mm	380	600	1824	8mm-130mm	693	12x6

2.1.3 After the design in STAADPRO the column which are having less reinforcement than required are R.C.C jacketed

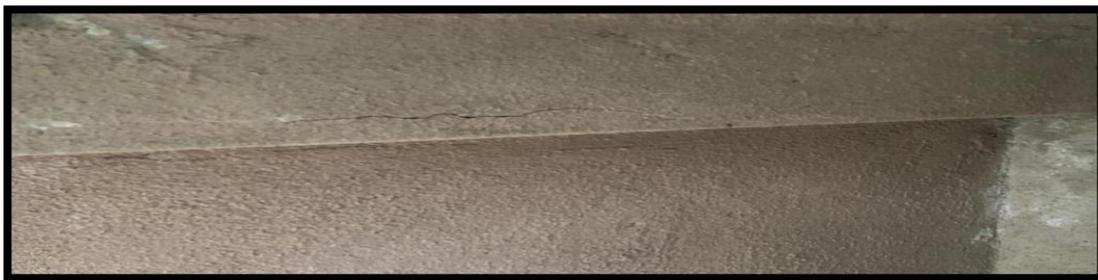
**Figure 10: Flexural Cracks in the Beam**

**A. Observation of cracks in beams** – The cracks at the first and second story of building.

- 1) Flexural crack – These cracks are formed at bottom of middle span below N.A of the beam where flexural stresses are maximum.

- 1) Minor cracks: Repair by injecting epoxy resins and finish it by repair mortar (polymer modified mortar)
- 2) Flexural cracks and shear cracks: Repair by injection of low viscous grout and strengthening by F.R.P wrapping

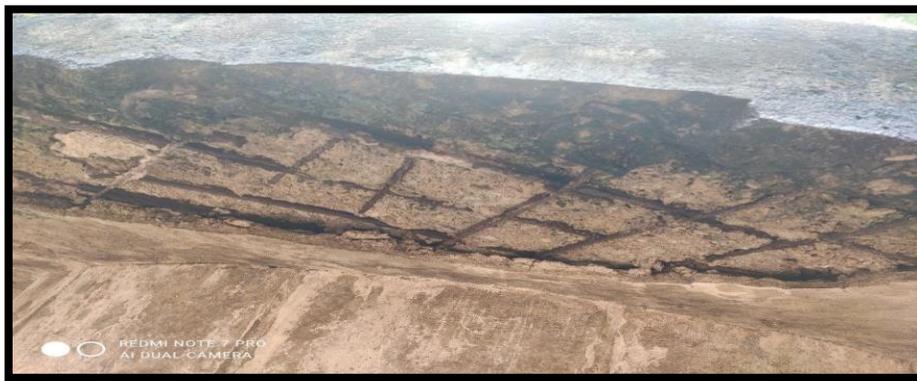
**Figure 11: Slab Plaster Pilling and Reinforcement Corroded**

- 2) **Beam**- the longitudinal reinforcement of east sided beam on first and third story has affected by corrosion due to insufficient cover and inadequate confining reinforcement.

Remedies: The F.R.P. jacketing to be done to all ground and first floor column.

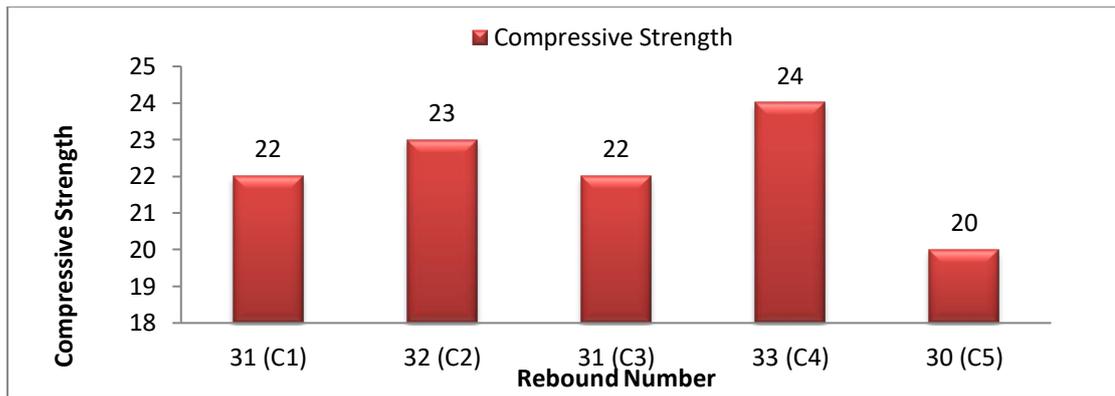
**Graph 3: Relation between comprehensive strength and rebound number of Ground floor column in east direction**

Column 1 <sup>st</sup>	Column 2 <sup>nd</sup>	Column 3 <sup>rd</sup>	Column 4 <sup>th</sup>	Column 5 <sup>th</sup>
25	32	31	33	32
35	35	33	34	33
30	26	31	34	29
28	32	30	33	32
38	34	31	35	29
32	28	32	32	28
Avg-31	Avg-32	Avg-31	Avg-33	Avg-30

Location	Approximate Compressive strength	Quality of concrete depends on rebound value (IS 13311:1992) Part2
1 <sup>st</sup> column	22 N/mm <sup>2</sup>	30 to 40 (Good concrete)
2 <sup>nd</sup> column	23 N/mm <sup>2</sup>	30 to 40 (Good concrete)
3 <sup>rd</sup> column	22 N/mm <sup>2</sup>	30 to 40 (Good concrete)
4 <sup>th</sup> column	24 N/mm <sup>2</sup>	30 to 40 (Good concrete)
5 <sup>th</sup> column	20 N/mm <sup>2</sup>	30 to 40 (Good concrete)

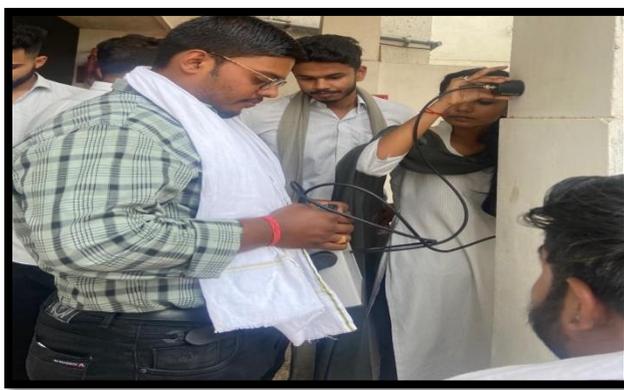
**Figure 13: Ultrasonic Pulse Velocity Test**

Sr. No	Location	Size	Pulse velocity	Concrete condition
C1	Front Elevation Exterior Column (East Side)	300x450mm	3435m/sec	Questionable
C11	Intermediate Column At Ground Storey	300x450mm	3416m/sec	Questionable
C12	Intermediate Column At First Storey	300x450mm	4142 m/sec	Good
C17	Side Column Of North Side Of Ground Floor	300x450mm	3932 m/sec	Good
C26	Side Column On North Side Of Third Floor	300x450mm	4032 m/sec	Good
C6	Side Column On South Side Of First Floor	300x450mm	3925 m/sec	Good
C22	Side Column On South Side Of Second Floor	300x450mm	3425m/sec	Questionable
C24	Rare Column On West Side Of Ground Floor	300x450mm	3245m/sec	Questionable

Sr. No.	Length	Pulse velocity	Classification	Compressive strength (IS 13311:1992) Part1
C1	0.45 m	3.435 KN/m	Medium	20 to 25 N/mm <sup>2</sup>
C11	0.45 m	3.416KN/m	Medium	20 to 25 N/mm <sup>2</sup>
C12	0.45 m	4.142 KN/m	Good	25 to 30 N/mm <sup>2</sup>
C17	0.45 m	3.932 KN/m	Good	25 to 30 N/mm <sup>2</sup>
C26	0.45 m	4.032 KN/m	Good	25 to 30 N/mm <sup>2</sup>
C6	0.45 m	3.925 KN/m	Good	25 to 30 N/mm <sup>2</sup>
C22	0.45 m	3.425 KN/m	Medium	20 to 25 N/mm <sup>2</sup>
C24	0.45 m	3.245 KN/m	Medium	20 to 25 N/mm <sup>2</sup>

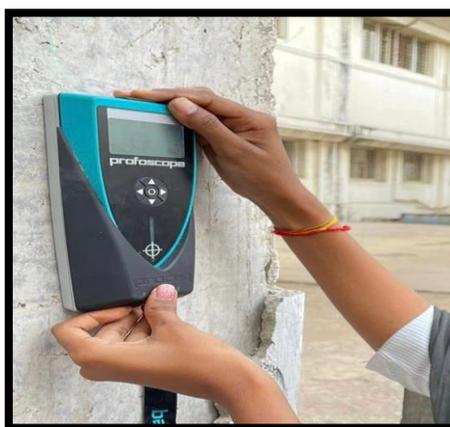
**Figure 14: Position of reinforcement in the column**

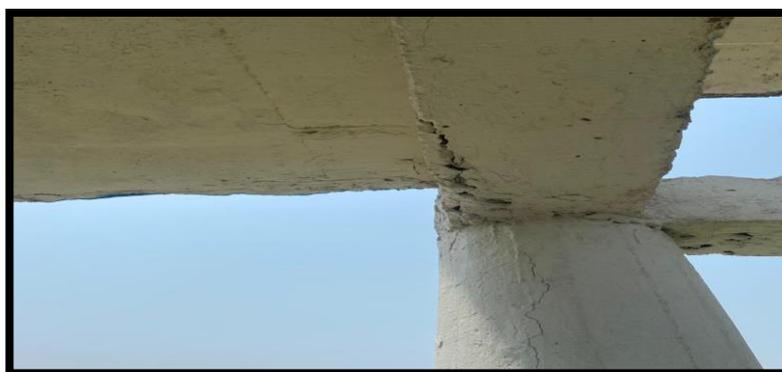
**Figure 17: Shear cracks in the beam**

**a) Observation of cracks in beams** – The cracks at the 1<sup>st</sup> level bracing.

1) Shear cracks – When the shear reinforcement at corners are at large spacing.

2) Shear cracks: Repaired by epoxy mortar and finish it by rich mix.

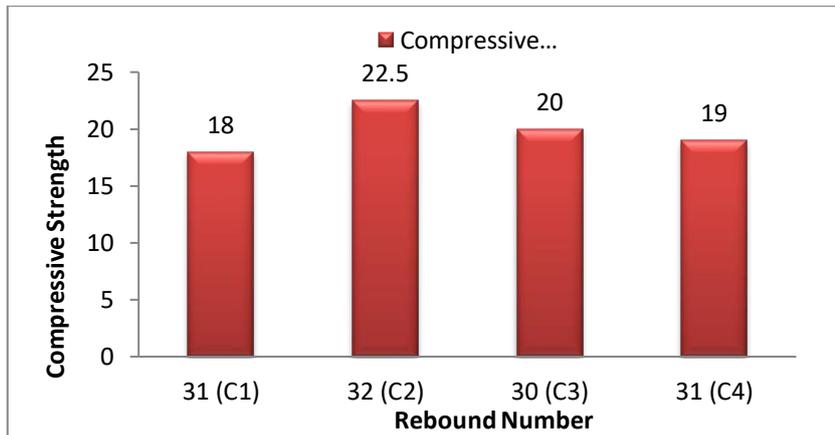
**Graph4: Relation between comprehensive strength and rebound number of 1<sup>st</sup> level column in north direction column**

Column 1 <sup>st</sup>	Column 2 <sup>nd</sup>	Column 3 <sup>rd</sup>	Column 4 <sup>th</sup>
30	32	30	31
28	33	29	26
29	34	32	30
28	29	28	26
29	28	35	31
26	30	30	28
Avg-31	Avg-32	Avg-30	Avg-31

Location	Approximate Compressive strength	Quality of concrete depends on rebound value
1 <sup>st</sup> column	18 N/mm <sup>2</sup>	20 to 30 (Good concrete)
2 <sup>nd</sup> column	22.5 N/mm <sup>2</sup>	30 to 40 (Good concrete)
3 <sup>rd</sup> column	20 N/mm <sup>2</sup>	30 to 40 (Good concrete)
4 <sup>th</sup> column	19 N/mm <sup>2</sup>	20 to 30 (Good concrete)

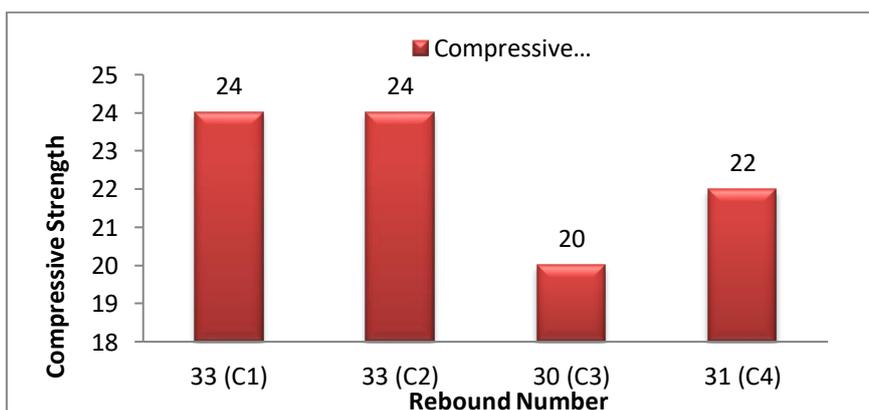
**Graph5: Relation between comprehensive strength and rebound number of Bracing**

CSB1	CSB2	CTB1	CTB2
32	35	30	28
30	36	32	32
36	33	28	30
36	30	30	34
Avg-33	Avg-33	Avg-30	Avg-31

Location	Approximate Compressive strength	Quality of concrete depends on rebound value (IS 13311:1992) Part2
2 <sup>nd</sup> level bracing CSB1	24N/mm <sup>2</sup>	30 to 40 (Good concrete)
2 <sup>nd</sup> level bracing CSB2	24N/mm <sup>2</sup>	30 to 40 (Good concrete)
3 <sup>rd</sup> level bracing CTB1	20N/mm <sup>2</sup>	30 to 40 (Good concrete)
3 <sup>rd</sup> level bracing CTB2	22N/mm <sup>2</sup>	30 to 40 (Good concrete)

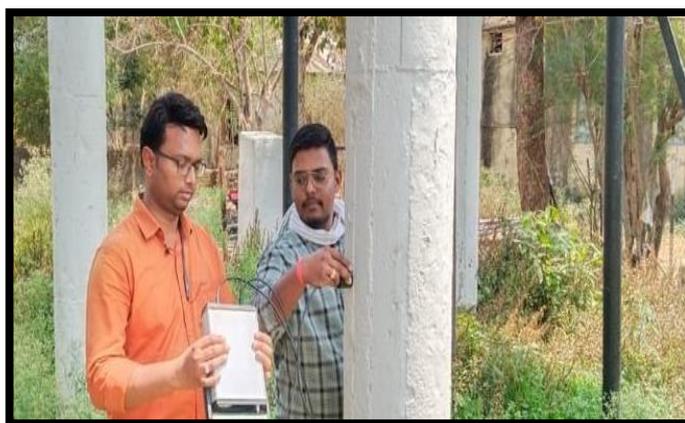
Figure 19: Ultra sonic pulse velocity test

Sr.no	Radius	Pulse velocity	Classification	Compressive strength
C1	0.23m	3.446km/sec	Medium quality	20 to 25 N/mm <sup>2</sup>
C2	0.23m	3.986km/sec	Good Quality	25 to 30 N/mm <sup>2</sup>
