Failure Analysis of Steam Turbine Blades

Aryan Singhal

Department of Mechanical Engineering

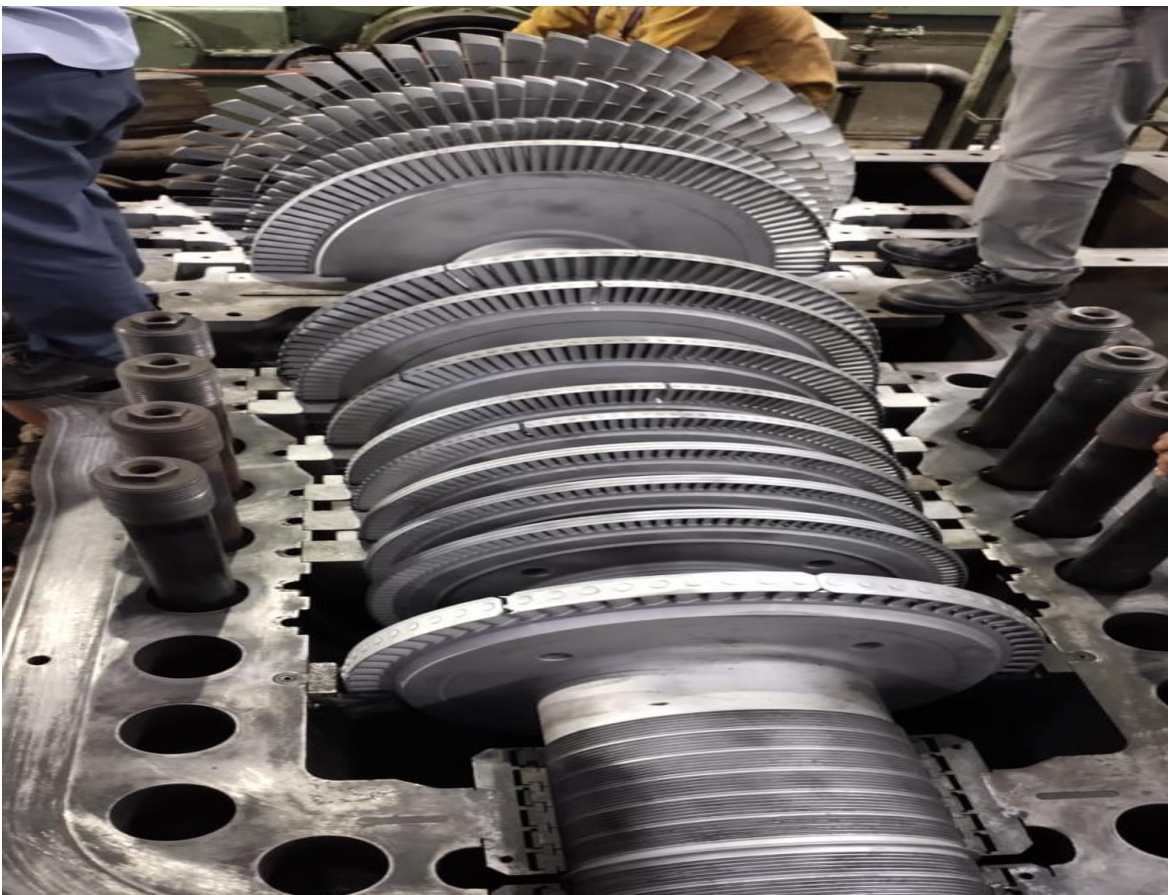
One device that could be used to extract mechanical work from the energy stored in steam is the steam turbine. The "impulse" and "reaction" turbines are the two main types. The names make reference to the kind of constraint that rotates the turbine wheel by acting on its edges. A ring of spouts and a ring of blades comprise the motivation line of action. The spout extends the high-pressure, high-energy steam to a higher-velocity, lower-weight steam fly. This stream of steam is directed into the impulse blades and exits in a variety of directions. A harsh force is created by the direction and speed changes, and this force essentially acts when the turbine edges are rotating. Only a very small conclusion is applied to the turbine shaft.

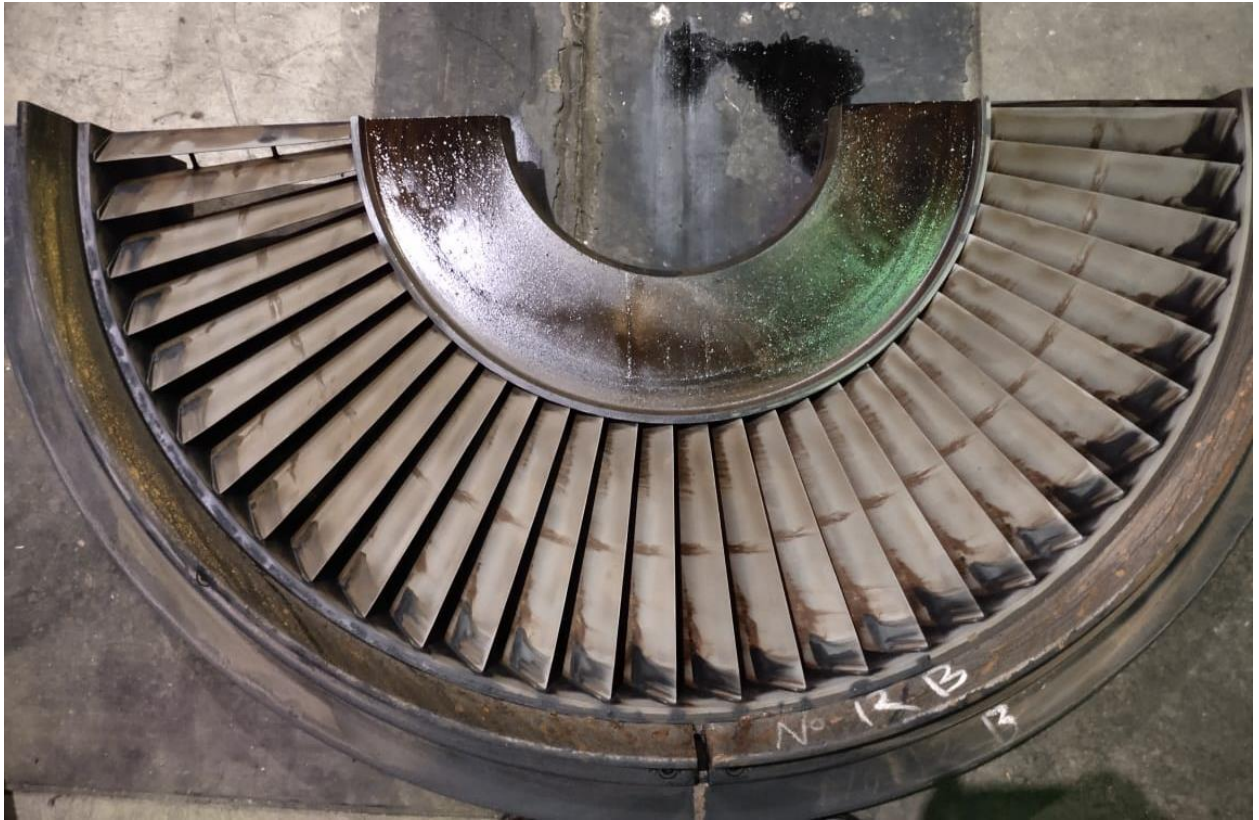
Reaction steam turbine:

The reaction path consists of a push of similar edges mounted on the rotor, or moving edges, and a ring of settling edges attached to the casing. The edges are created and mounted to provide a narrowing section that increases the

steam speed similarly to a spout. Additionally, a change in direction causes the steam to change in speed, and this kind of blading also creates an impulsive constraint. Impulse reaction is a better term to describe this risky line of action. A Response steam turbine fly is used by a response turbine:

- steam that emerges from a rotor spout.

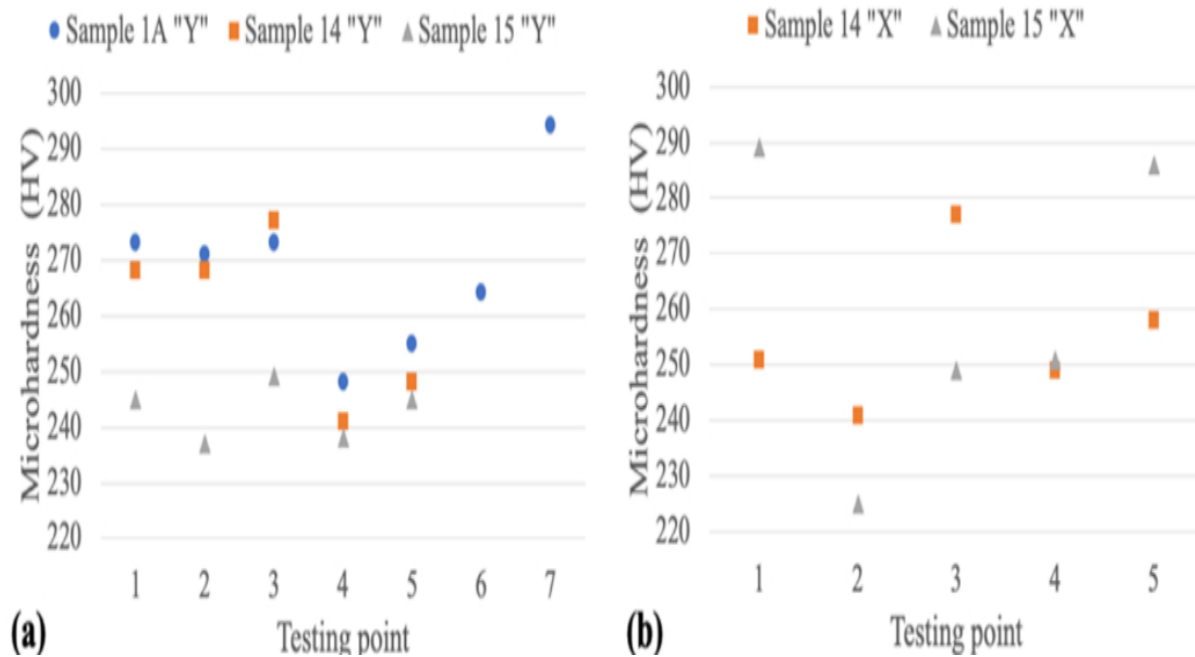
Table data indicates an average hardness range of 243 to 268 HV, which is within the Chinese National Standards (225-260 HV) range for steam turbine steel blades. The distribution of hardness values for samples 1A, 14 and 15 is shown in Figure according to the test sites and the X-Y axis direction. The posterior root blade location has the lowest hardness value. This is in line with the root blade fault pattern, where the weakest part of the blade experiences the fracture propagation fault.

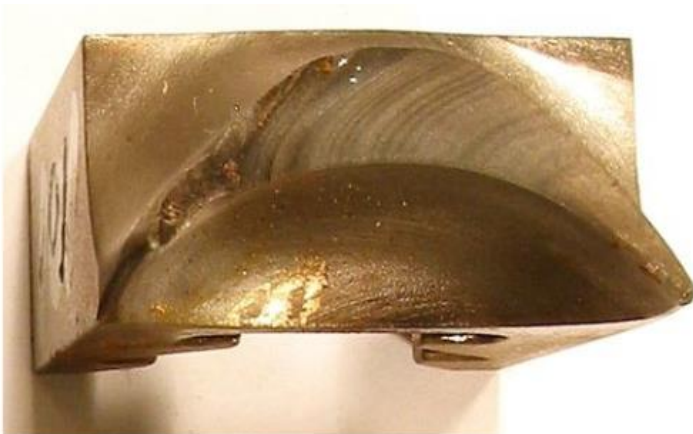
High cycle fatigue failure of steam turbine airfoil.

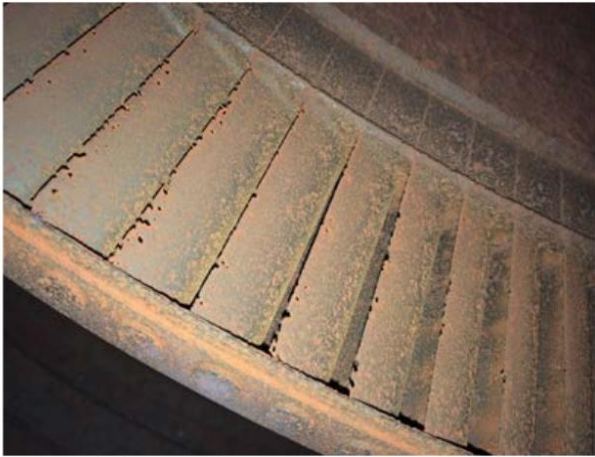
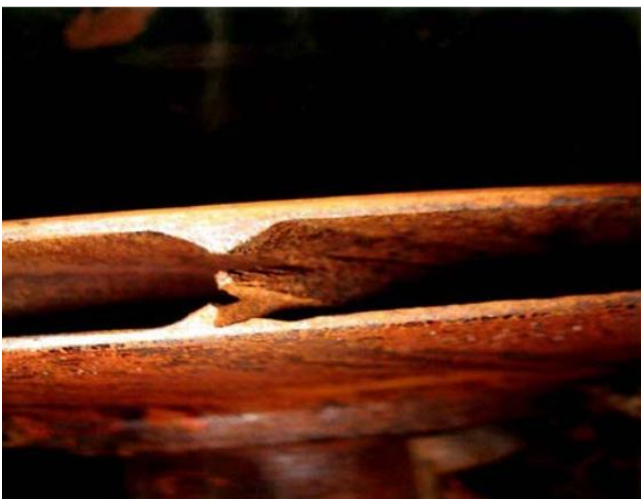
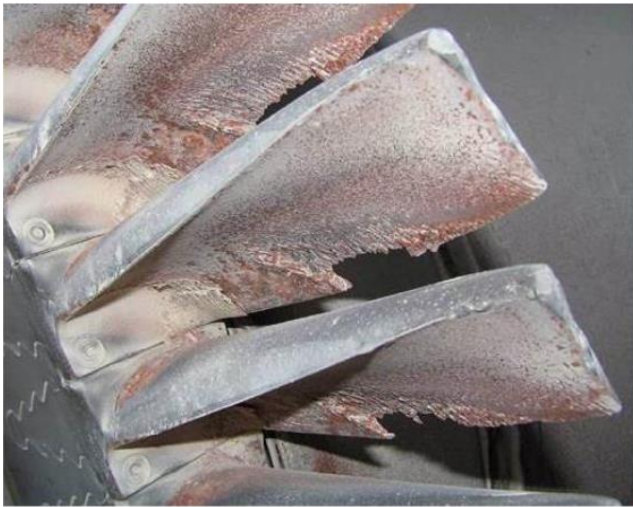
In general, damage is manifested by the removal of material from the edges of the teeth. Damage can be caused by hot oil and air compressor fan blades.

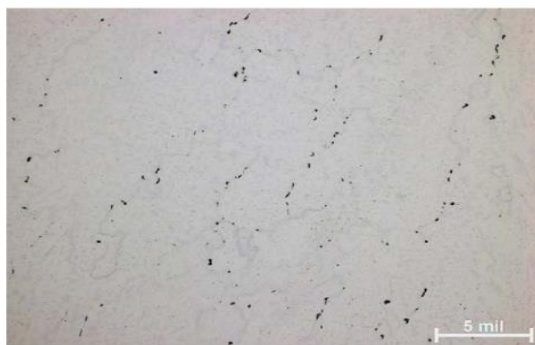
Figure 15. Oriented creep cavities in nose cone support weld

Damage caused by creep appears as a gap that eventually becomes directional and extends into cracks. This indicates conflicting clearance in the nose cone support at the hot oil expander inlet housing weld.
