## **FLOOD AS THE MAJOR EFFECT OF INDISCRIMINATE WASTE DISPOSAL: A CASE STUDY OF TUDUN ILU NEIGHBOURHOOD KADUNA-NIGERIA**

Aliyu Hassan

Department of Civil and Environmental Engineering,  
Air Force Institute of Technology,  
Nigerian Air Force,  
Kaduna  
aliyuhassan13@yahoo.com

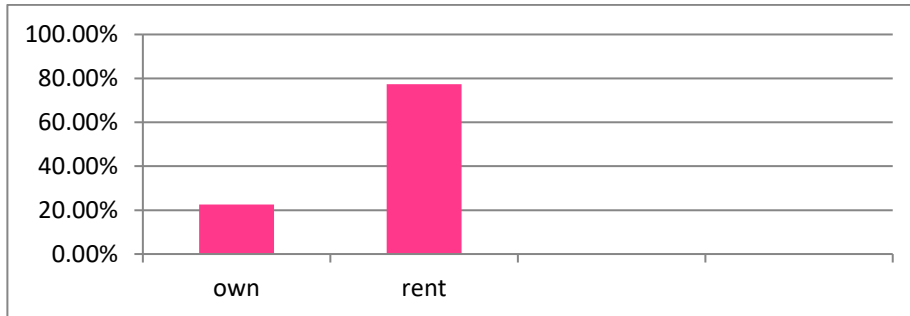
Figure 2: Percentage of House flood defect with Water

The survey indicated 77.42% are with minor defects and 22.58% are houses with major a defect that is not habitable for humans. This means that improvement can be carried out for a short period of time because the owners may want to improve the value of their property and the living conditions of the people.
