Impact Assessment of FENGAL Cyclone in Tamil Nadu By Using ARCGIS

Abstract - Cyclones are powerful natural disasters that frequently impact the coastal regions of Tamil Nadu, causing significant socio-economic and infrastructural damage. The 2024 Fengal Cyclone severely affected the Cuddalore and Viluppuram districts, highlighting the urgent need for advanced disaster risk assessment and management strategies. This study assesses the impact of the Fengal Cyclone in Tamil Nadu using Geographic Information System (GIS) techniques, specifically ArcGIS, to map and analyze cyclone vulnerability zones. By integrating key physical parameters such as slope, elevation, land use and land cover, drainage density, and precipitation, the research identifies and classifies flood risk zones along the coast. The resultant thematic maps provide spatial insights into cyclone risk, enabling more effective disaster preparedness, mitigation planning, and resource allocation. The findings support local authorities, urban planners, and disaster management teams in developing targeted interventions to reduce the adverse effects of future cyclonic events in the region.

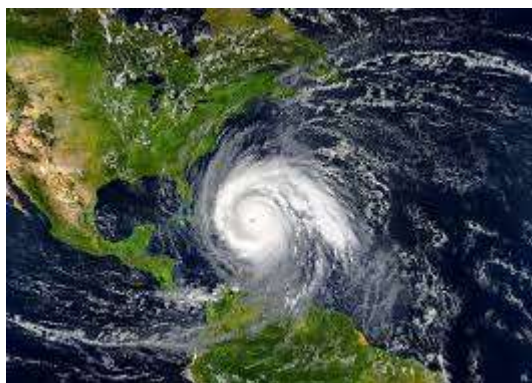
Fig 1. Cyclone

A cyclone is a large-scale rotating air mass that forms around a low-pressure center, moving counterclockwise in the Northern Hemisphere and clockwise in the Southern Hemisphere. Cyclones are categorized into extratropical, tropical, mesocyclones, subtropical, and polar types based on their origin and characteristics.

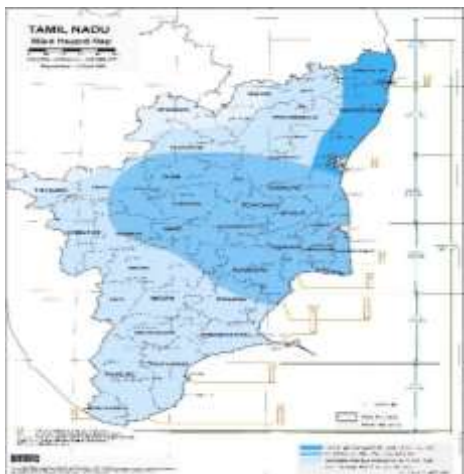
Zone	Wind Speed (km/h)	Districts Affected
High-Risk Zone	>160 km/h	Chennai, Cuddalore, Nagapattinam, Thoothukudi, Ramanathapuram

Moderate-Risk Zone	120 - 159 km/h	Thanjavur, Pudukkottai, Kanyakumari, Karaikal, Thiruvavur
Low-Risk Zone	80 - 119 km/h	Madurai, Sivagangai, Tirunelveli, Virudhunagar

Fig 3 Cyclone zoning map of Tamilnadu

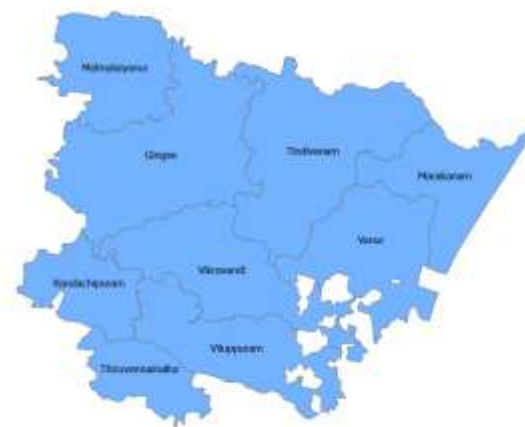
Fig 4. Viluppuram map created in ARCGIS

Viluppuram district is the largest district in Tamil Nadu, India, formed on 30th September 1993 by bifurcating the South Arcot district. It is located between latitudes 11°38'25"N and 12°20'44"N and longitudes 78°15'00"E and 79°42'55"E, covering an area of about 3,725.54 square kilometers. The district lies along National Highway 45, connecting Tiruchirapalli and Chennai, and is well connected by rail and road, serving as a major junction. Geographically, Viluppuram is bordered by Cuddalore district to the east and south, Kallakurichi district to the west, and Thiruvannamalai and Kanchipuram districts to the north. It also has a coastline along the Bay of Bengal in the east, extending about 32 km in the Marakkanam and Vanur blocks. The terrain mainly consists of plains used for agriculture, with notable hills such as the Gingee and Kalrayan hills. The district headquarters is the town of Viluppuram, located on the banks of the Thenpennai River, about 160 km south of Chennai and 35 km northwest of Cuddalore. Viluppuram town is a special grade municipality and a major railway junction. Administratively, Viluppuram district comprises 2 revenue divisions, 9 taluks, 932 revenue villages, 2 municipalities, and 8 town panchayats. The district has a rich cultural heritage with many ancient temples, mosques, and churches.

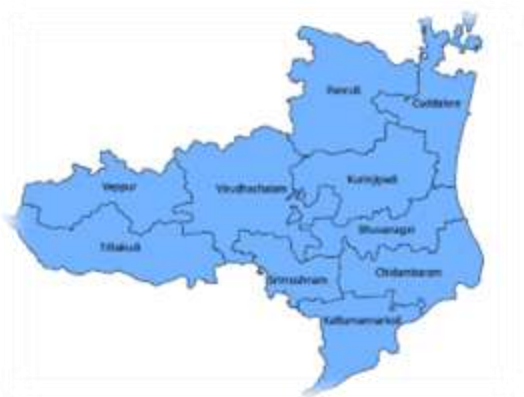
Fig 5. Cuddalore map created in ARCGIS

Cuddalore is a coastal district in the northeastern part of Tamil Nadu, India, with the Bay of Bengal to its east. The district headquarters is Cuddalore town, located at the confluence of the Gedilam and Pennaiyar rivers, about 200 km south of Chennai and 22 km from Puducherry. The district spans approximately 3,678–3,703 square kilometers and features a 68 km coastline stretching from Puducherry in the north to the mouth of the Coleroon River in the south. The region is characterized by coastal plains, sandy beaches in the north, and mangrove swamps in the south. Cuddalore is historically significant, having been ruled by various dynasties such as the Cholas, Pallavas, Pandyas, and later by the Dutch, French, and British. It was notably the site of the 1783 Siege of Cuddalore during the Seven Years' War. Economically, Cuddalore is known for agriculture (especially cashew and jackfruit), fishing, and industries including chemicals and energy. The district is also home to a large fisher population and has small lignite deposits supporting local industries. Cuddalore is considered multi-hazard prone due to its long coastline, making it vulnerable to cyclones, floods, and events like the 2004 tsunami. The city is administered as a municipal corporation and is an important industrial and educational hub in the region.

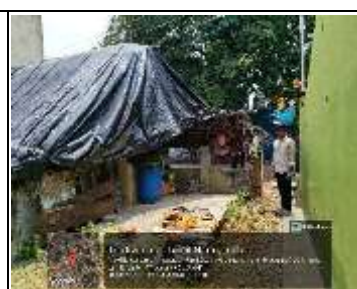
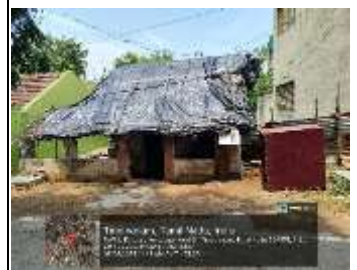
TINDIVANAM SURVEY NO: A1

1	Type	Non-Engineered
2	Size	8m × 6.5 m
3	Roof	Thatched Roof with Wooden Support
4	Walls	Brick wall
5	Foundation	Stone or Mud Foundation (Shallow)
6	Plinth	0.30m above ground
7	Estimated Age	10 years
8	Estimated Cost	₹80,000
Structural Damage Summary

1	Roof	Major Damage
2	Front & Side Walls	Major Damage
3	Foundation	Weak
4	Columns	None
5	Doors, Windows & Ventilators	Minor Damage
6	Cracks in Walls	Minor
7	Erosion Due to Flooding	Significant Erosion Around Foundation

The building has major wall damage, weak shallow foundation with erosion, and lacks supporting columns. Minor roof and wall cracks are present. Stability can be improved by strengthening walls with cement plaster and bracing, reinforcing foundation with stone/concrete, upgrading drainage, raising the plinth, and adding vertical supports for flood resistance.

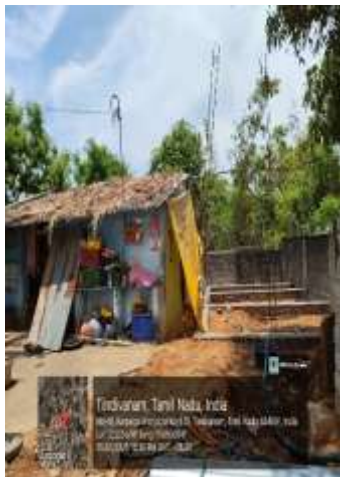
2. TINDIVANAM SURVEY NO: B1

1	Type	Semi-Engineered
2	Size	10m × 6m
3	Roof	Asbestos sheet

4	Walls	Brick Masonry
5	Foundation	Random Rubble Masonry
6	Plinth	0.50m above ground
7	Estimated Age	20 years
8	Estimated Cost	₹1,00,000

1	Roof	ModerateS Damage
2	Front & Side Walls	Moderate Damage
3	Foundation	Minor Damage
4	Columns	None
5	Doors, Windows & Ventilators	None
6	Cracks in Walls	Minor Damage
7	Erosion Due to Flooding	Significant Erosion Around Foundation

The building requires timely repairs to ensure long-term stability. Walls should be strengthened with cement reinforcement and bracing, broken roof tiles replaced, and a water-resistant coating applied. Foundation settlement needs monitoring and reinforcement, while drainage channels should be improved to prevent water pooling. The retrofitting priority is medium.

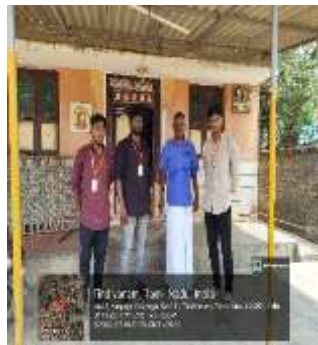
3. TINDIVANAM SURVEY NO: C1

1	Type	Engineered
2	Size	10m × 8m

3	Roof	RCC Slab with Proper Waterproofing
4	Walls	Reinforced Brick Masonry with Cement Plaster
5	Foundation	Reinforced Concrete Footing
6	Plinth	0.80m above ground
7	Estimated Age	18 years
8	Estimated Cost	₹3,00,000

1	Roof	No Damage
2	Front & Side Walls	No Major Cracks
3	Foundation	Stable
4	Columns	Stable
5	Doors, Windows & Ventilators	No Damage
6	Cracks in Walls	Very Minor
7	Erosion Due to Flooding	Major Damage

Regular inspection and maintenance are recommended. Continue annual roof waterproofing checks and monitor the foundation for settlement. Keep storm drainage clear to prevent blockages. Overall, the building is well-built and needs only routine upkeep.

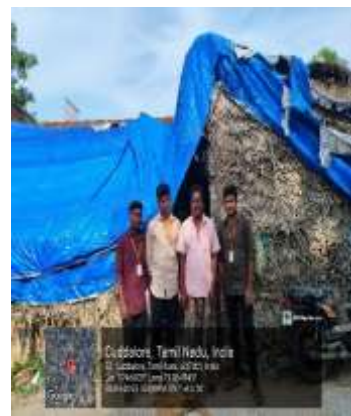
DEVANAMPATTINAM SURVEY NO: A1

1	Type	Non-Engineered
2	Size	12m × 5m
3	Roof	Thatched Roof
4	Walls	Mud Wall
5	Foundation	None
6	Plinth	None
7	Estimated Age	5 years
8	Estimated Cost	₹50,000
Structural Damage Summary		
1	Roof	Major Damage
2	Front & Side Walls	Major Damage

3	Foundation	None
4	Columns	None
5	Doors, Windows & Ventilators	None
6	Cracks in Walls	None
7	Erosion Due to Flooding	None

The building has major wall damage, weak shallow foundation with erosion, and lacks supporting columns. Minor roof and wall cracks are present. Stability can be improved by strengthening walls with cement plaster and bracing, reinforcing foundation with stone/concrete, upgrading drainage, raising the plinth, and adding vertical supports for flood resistance.

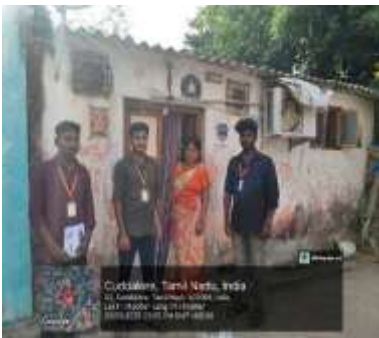
2. DEVANAMPATTINAM SURVEY NO: B1

7	Estimated Age	15 years
8	Estimated Cost	₹1,20,000

1	Roof	Moderate Damage
2	Front & Side Walls	Moderate Damage
3	Foundation	No damage
4	Columns	No damage
5	Doors, Windows & Ventilators	No Damage
6	Cracks in Walls	Minor—Hairline Cracks
7	Erosion Due to Flooding	Some Soil Erosion

1	Type	Semi-Engineered
2	Size	8m × 5.3m
3	Roof	Asbestos sheet
4	Walls	Brick Masonry
5	Foundation	Random Rubble Masonry
6	Plinth	0.50m above ground

The building requires timely repairs to ensure long-term stability. Walls should be strengthened with cement reinforcement and bracing, broken roof tiles replaced, and a water-resistant coating applied. Foundation settlement needs monitoring and reinforcement, while drainage channels should be improved to prevent water pooling. The retrofitting priority is medium.

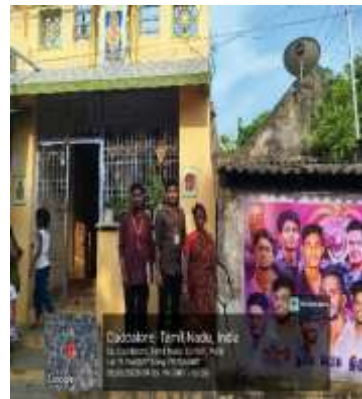
3. DEVANAMPATTINAM SURVEY NO: C1

1	Type	Engineered
2	Size	8m × 5.5m
3	Roof	RCC Slab
4	Walls	Reinforced Brick Masonry with Cement Plaster
5	Foundation	Reinforced Concrete Footing
6	Plinth	0.80m above ground
7	Estimated Age	12 years
8	Estimated Cost	₹12,00,000

1	Roof	No Damage
2	Front & Side Walls	No Major Cracks
3	Foundation	Stable
4	Columns	Stable
5	Doors, Windows & Ventilators	No Damage
6	Cracks in Walls	Very Minor
7	Erosion Due to Flooding	No Significant Erosion Observed

Regular inspection and maintenance are recommended. Continue annual roof waterproofing checks and monitor the foundation for settlement. Keep storm drainage clear to prevent blockages. Overall, the building is well-built and needs only routine upkeep.

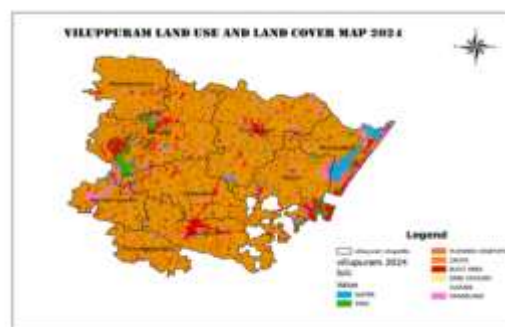
both irrigated and rainfed cultivation. Major crops include paddy, sugarcane, groundnut, and pulses, which vary seasonally. Built-up areas are expanding, especially around Villupuram town and along major transport routes, due to increasing population and infrastructure development. The district also contains forested regions, particularly in the Kalrayan Hills, which contribute to biodiversity and act as important ecological zones. Barren lands and wastelands are scattered across the district, mainly in dry or rocky regions unsuitable for farming. Water bodies such as rivers (notably the Pennaiyar and Gingee), irrigation tanks, and ponds play a vital role in agriculture and local livelihoods. Additionally, seasonal wetlands are present in low-lying areas, supporting both agriculture and ecological balance.

Fig 6. Land use Land cover map for Viluppuram district

The land use and land cover (LULC) of Villupuram district is predominantly agricultural, with vast areas under

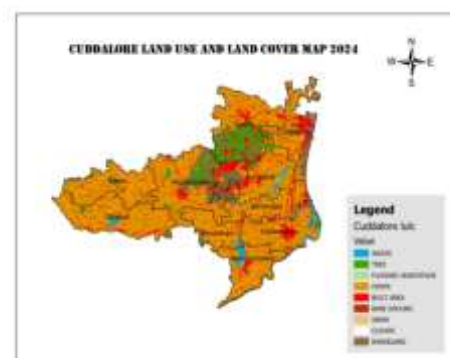
Cuddalore District's land use is shaped by its coastal setting, agriculture, urban growth, and natural ecosystems. Agriculture remains dominant, with about 313,000 hectares under crops like rice, groundnut, sugarcane, and pulses, aided by major rivers for irrigation. Urban areas have grown rapidly, expanding from 1.72% in 1993 to over 7.4% in 2023 due to population and infrastructure growth. The district contains important ecological zones, such as the 1,400-hectare Pichavaram mangroves, and moderate forest cover. Wetlands and water bodies have sharply declined, dropping from 3.89% to 0.9% of the area over three decades. Land use change analysis shows a decrease in agriculture and grasslands, with increases in barren land and mining, highlighting a shift towards urbanization and industrialization and raising new environmental challenges for sustainable management.

Fig 7. Land use and Land cover map for cuddalore

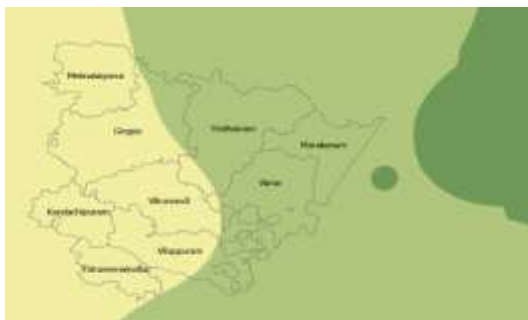
A wind speed distribution map was developed for Viluppuram district to assess the storm's impact. This map utilized a color-coded scheme: dark green indicated areas experiencing wind speeds up to 45 miles per hour (approximately 72 km/h), light green represented zones with wind speeds ranging from 35 to 40 mph (56–64 km/h), and yellow denoted regions with wind speeds between 20 to 25 mph (32–40 km/h). The analysis revealed that the northern and coastal regions of Viluppuram were subjected to higher wind intensities, correlating with the cyclone's trajectory and the India Meteorological Department's reports of gale winds reaching 70–80 km/h, gusting up to 90 km/h in the area.

Fig 16. Wind density map for Viluppuram district

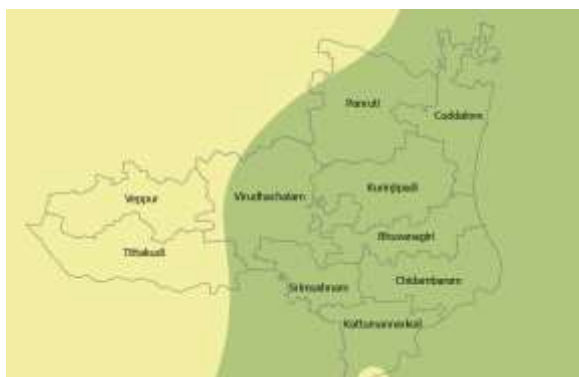
A wind speed distribution map was developed for Cuddalore district to assess the storm's impact. This map utilized a color-coded scheme: dark green indicated areas experiencing wind speeds up to 45 miles per hour (approximately 72 km/h), light green represented zones with wind speeds ranging from 35 to 40 mph (56–64 km/h), and yellow denoted regions with wind speeds between 20 to 25 mph (32–40 km/h). The analysis revealed that the coastal and central regions of Cuddalore were subjected to higher wind intensities, correlating with the cyclone's trajectory and the India Meteorological Department's reports of gale winds reaching 75–85 km/h, gusting up to 95 km/h in the area.

Fig 17. Wind density map for Cuddalore district

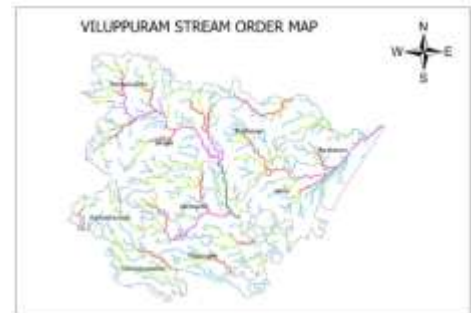
Fig 18. Stream order map for Viluppuram district

Stream order is a system for classifying streams by size and branching complexity, with higher-order streams formed as smaller ones merge. Stream order maps are crucial for flood risk assessment, as higher-order streams have larger catchments and greater flood potential. These maps help identify flood-prone areas and guide flood management and planning without complex modeling. Here is the stream order maps for Viluppuram and Cuddalore, useful for identifying areas at risk of flooding.
