Implementation of Bronze Bushings to Resolve Galling in High-Tonnage Injection Molding Tools

Author: Dhrudipsinh Dabhi (Senior Technical Program Manager)

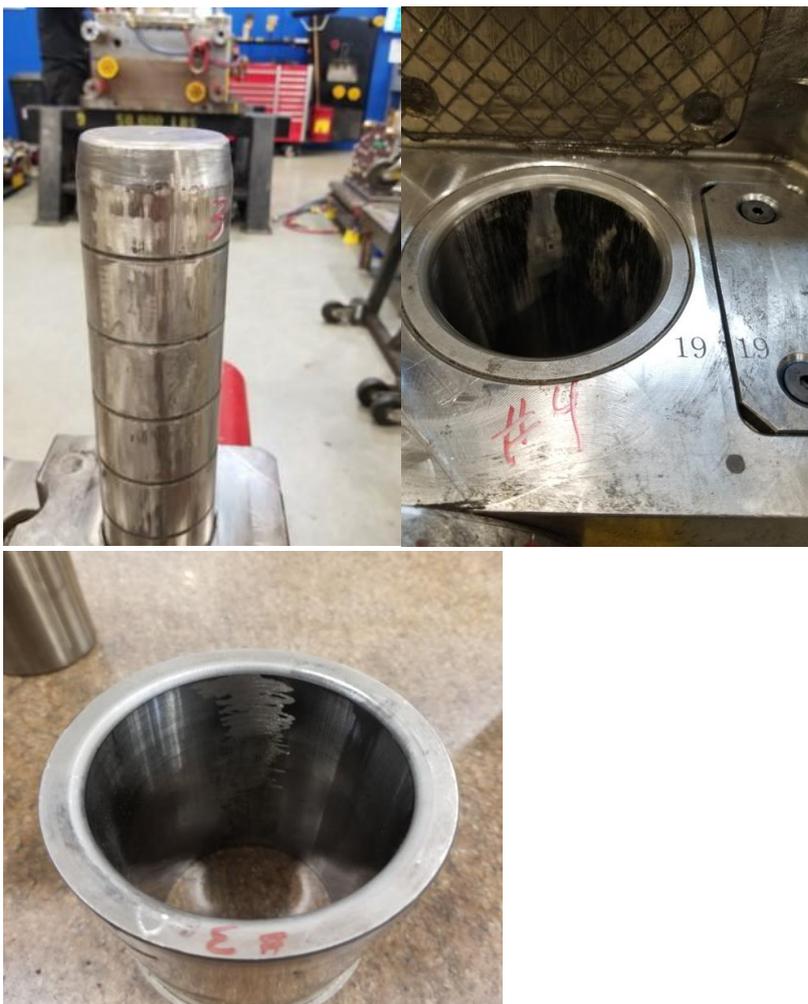
- Material Properties of Steel:** The steel bushings were made of AISI 4140, with a hardness of approximately 30-35 HRC. While this material provides excellent tensile strength (~655 MPa) and wear resistance, it lacks the self-lubricating properties necessary to prevent galling in high-load applications. The leader pins, also made of steel (AISI 4340, ~40-45 HRC), exhibited similar properties but demonstrated less severe galling due to their polished surface finish.

- Galling Mechanism:** The analysis revealed that the steel-on-steel interface in the bushings experienced adhesive wear due to the high cyclic loads and sliding motions inherent to the mold's operation. The repetitive movement caused micro-welds to form between the contacting surfaces, which, upon breakage, resulted in material transfer and roughening. This progressively increased friction and heat generation, ultimately leading to seizure.

(Figure 1, 2 and 3: Steel Pin and Steel-Bushings showing Excessive wear due to Friction)

1. Replacement of Steel Bushings with Bronze Bushings:

The steel bushings were replaced with bronze bushings (CuSn12 alloy, also known as phosphor bronze), chosen for their superior tribological properties. Phosphor bronze has a Brinell hardness of approximately 100 HB and a tensile strength of ~300 MPa, significantly lower than steel but well-suited for reducing friction and preventing galling. Key advantages of bronze include:

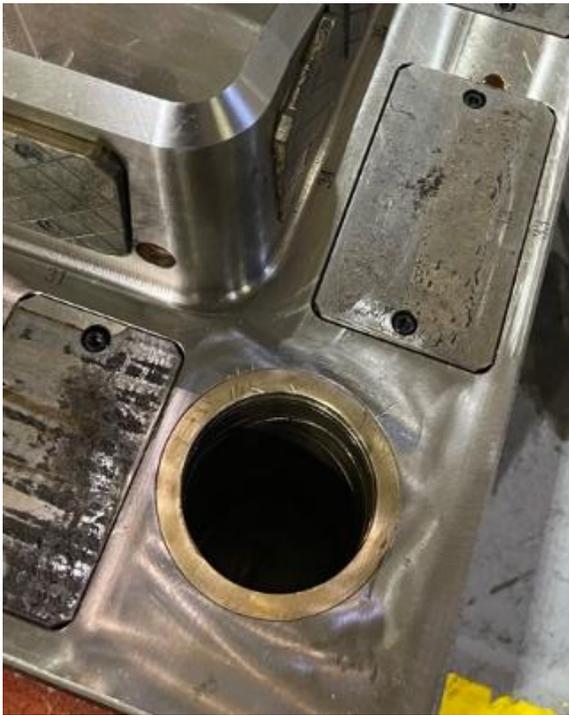
(Figure 4: Shows the Brass-Bushing we installed.)

The new bushings were machined with a surface roughness of Ra 0.4 μm to optimize lubricant retention and minimize friction. After installation, the tool was tested under full load conditions, confirming smooth operation with no signs of galling or seizure.

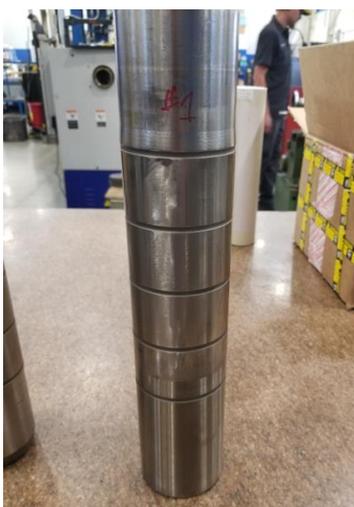
Figure 5: Polished the Steel-Pin before re-installing back into the Mold.

The steel leader pin exhibited surface galling due to adhesive wear but was not severely damaged. Polishing was performed using progressively finer abrasive papers (starting at 400 grit and ending at 1,500 grit) to achieve a final surface roughness of $Ra\ 0.2\ \mu m$. This restored the pin's smoothness and ensured proper alignment and motion within the bushings. The polishing process preserved the pin's original dimensions, maintaining a clearance of 0.005 inches with the bushings.
