PRACTICAL APPROACH FOR THE SAFETY IN I - GIRDER CASTING AND STRESSING IN CASTING YARD

Ravinder Kumar (General Manager)

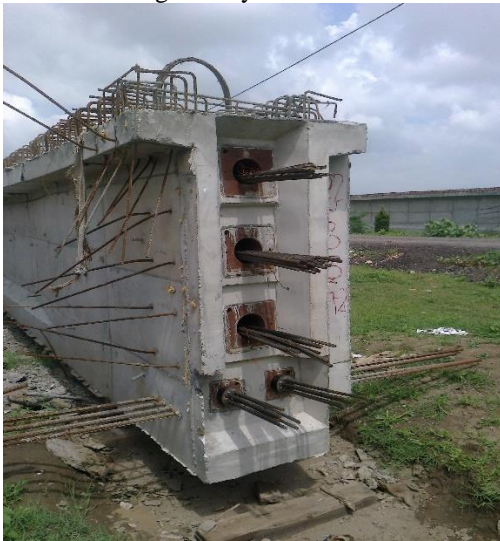
Photo 1 Good example for how to keep the end portion free before stressing activity.

- i. Design of entire support system should be proper and with accepted factor of safety. In case of prestressed girder, the special care shall be taken for the end supports under bearings locations. Because after stressing hogging in girder may occur and the middle portion of bottom bed will free. Due to stressing effect the load shall be transferred on both ends due to the bottom supports near bearings.

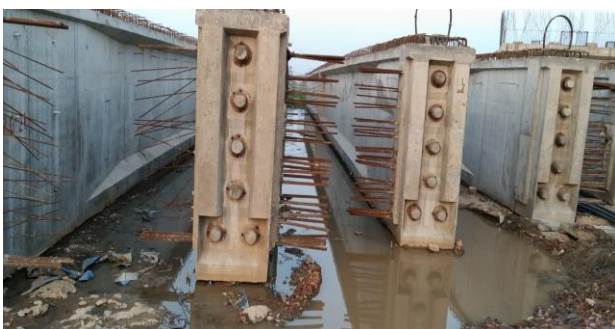
Photo 2 Casting Yard ground is well compacted and covered with thin concrete layer

- ii. Base of Girder shall be on firm and well compacted ground to avoid any settlement causes failure. In no case, girder bottom shall rest directly on soil. PCC under the girder is the best option with thin aluminum sheet or another releasing material for good quality work.

- iii. if there is any drain, manhole, covered pipeline or any utility passing underneath in the casting yard then special care shall be taken.
- iv. A thin layer of PCC or Granular material shall be laid on the compacted ground to avoid any mud formation during curing period resulting in settlement.

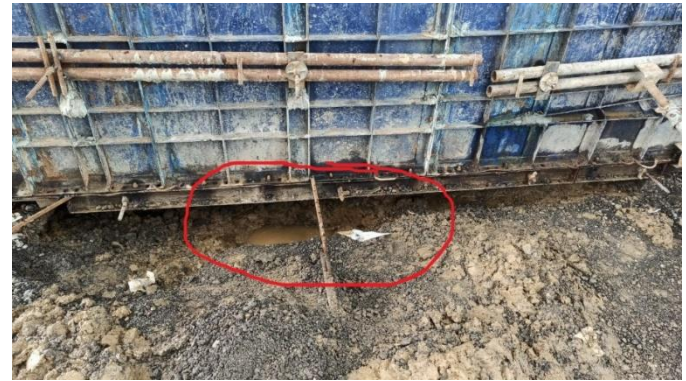
Photo 3 Casting Yard ground is not provided any ground cover/protection and which resulting cavity under the bottom PCC of Girder. The girder is in position to pour the concrete. At the first occurrence of an acronym, spell it out followed by the acronym in parentheses, e.g., charge-coupled diode (CCD).

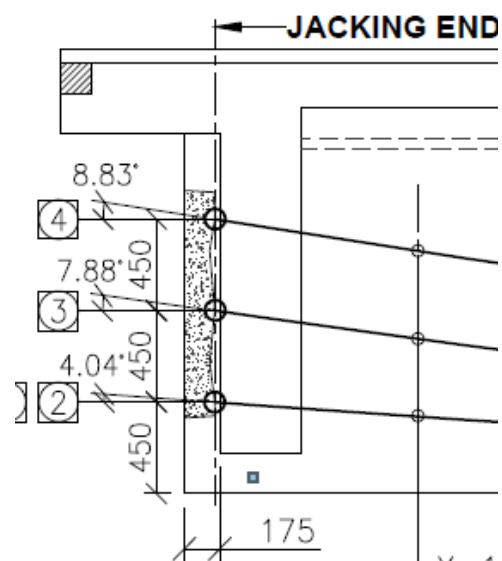
Figure - 1

- The Anchor fixing should be fixed in true line and level with great care of angle fixing as mentioned in the drawing.

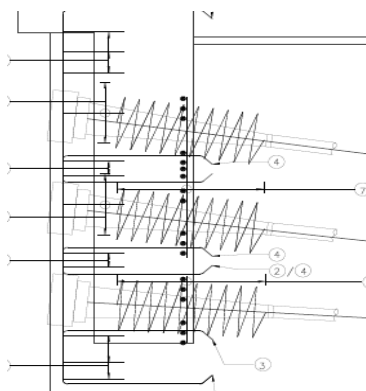
Fig. 2

- Sometime the engineer may not able to understand the importance of spirial

reinforcement, which may cause failure of end blocks during or after stressing.

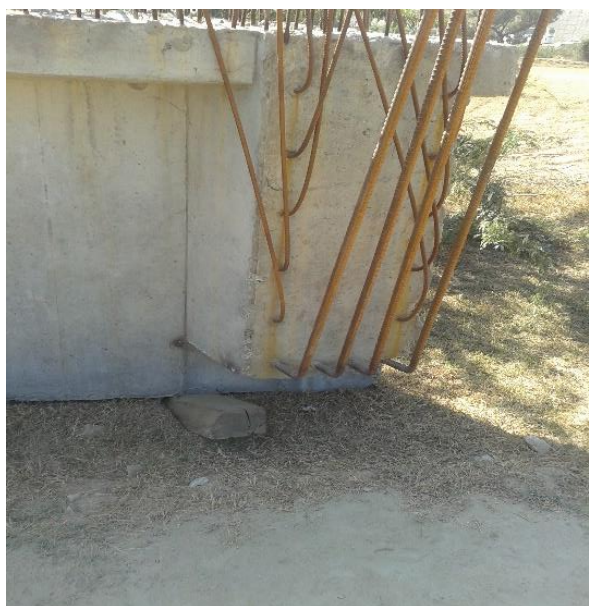
Photo- 4 Placement of PSC girder at erection site after stressing in safe manner as the wooden block provided adjacent to the bearing location.

- After stressing the placement of girder bottom support not provided on proper location. By not providing a proper location bottom support the eccentricity of load shifted which causes the damage of girder.

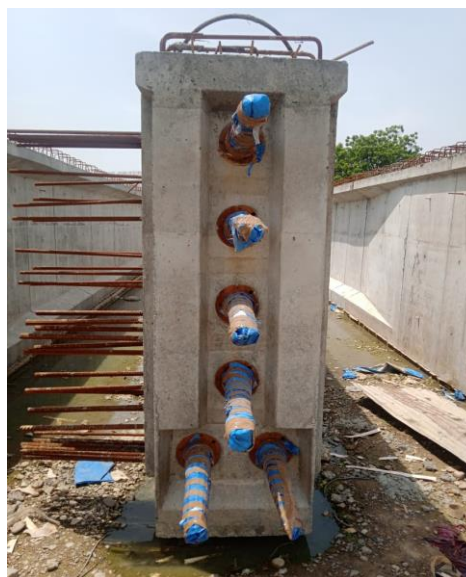
Photo 5 Protection of HT strands by covering with PVC sheet to protect from rust/corrosion. If a small amount of rust

encountered, which may lead to slip during stressing and cause accident.

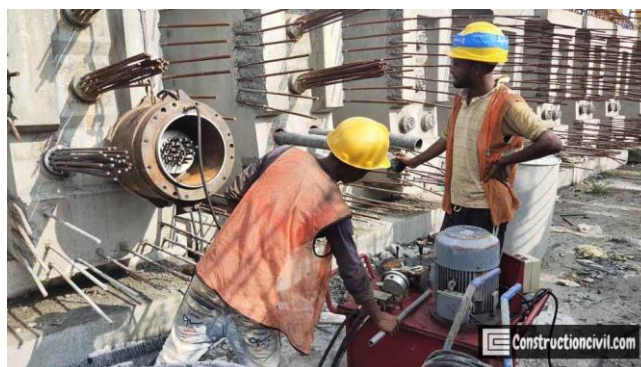
Photo 6 Unsafe act because the workers are standing in front of stressing jack.

- Length of HT strands not provided in the ducts, which may cause slip of wedges during stressing or ply of HT strands may separate from the coil.
- During stressing no shield protection provision behind the stressing jacks. Sometime the worker stands in front of stressing jack during stressing activity which cause a fatal accident.
