Progressive Collapse of Tall Buildings

Mr.Sajid K.V¹, Ms.Anila Dani D.A² Mr.Justin Raj³

¹PG Student, RVS Technical Campus, Coimbatore

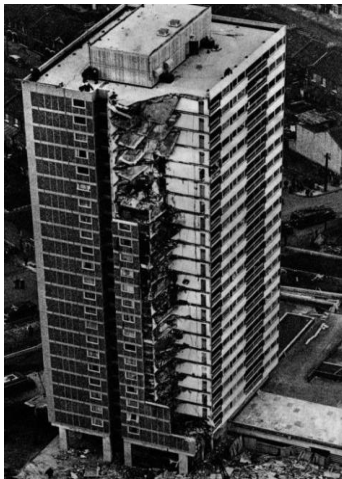
Fig 1.1 Ronan Point Collapse ^[29]

The partial collapse of the Ronan Point Apartment building in London, England in 1968 generated a widespread concern for progressive collapse of buildings in chainreaction mode, triggered by a local failure. The Ronan Point collapse was brought about by a gas explosion in an apartment on the 18th floor of a 22-story precast concrete building. The gas explosion blew out the exterior bearing wall of the apartment that caused the upper floor slab to fall.

The falling debris of upper floor triggered the collapse of the floor below. As a result, the collapse of one corner of the building almost to the ground takes place as shown in Figure 1.1.

Since the Ronan Point collapse was considered as —progressive collapse" both in the vertical and horizontal directions that led to a total or a disproportionately large failure relative to an initiating local failure

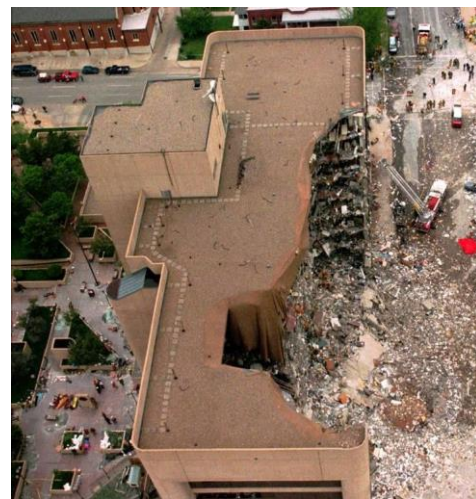
Fig 1.2 Alfred Murrah Building Collapse ^[30]

The Murrah Building had a 9-story reinforced concrete ordinary moment frame as its structural arrangement. The Murrah Building was the target of a terrorist attack on the morning of April 19, 1995, when a truck bomb exploded in front of its north side. The building suffered substantial structural damage as a result of the explosion.

The Murrah Building's north side, which was immediately hit by the blast, suffered major structural damage. The north half of the rectangular footprint was destroyed in its entirety. The damage spanned the full length of the structure. The blast immediately destroyed three columns that supported the transfer girder on the third floor, causing the top stories to fall. It was believed that around half of the building's usable space had collapsed (Figure 1.2).

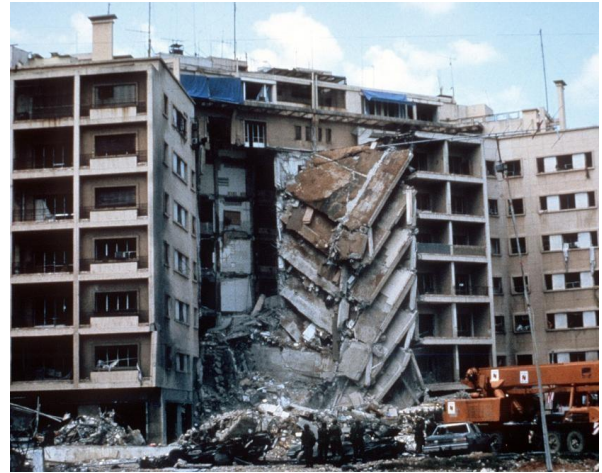
Fig 1.3 U. S. Marine Barracks Collapse ^[31]

Terrorist activity caused the collapse of the US Marine Barracks in Lebanon (Figure 1.3). The structure was hit by two truck bombs, which caused the American embassy to gradually collapse. The blast destroyed the horseshoe-shaped building's whole central front, leaving balconies and offices in stacked levels of rubble and flinging masonry, metal, and glass pieces across a wide expanse. Aside from these, there are a number of other important events that contribute to the progressive collapse of structures, including:
