# Retrofitting of Buildings in Cyclone Prone Areas at Thanjavur District, Tamil Nadu, India

**Abstract** - Cyclones pose a significant threat to rural housing in coastal regions of Tamil Nadu, particularly in the Thanjavur district. This study investigates the vulnerability of different building typologies-non-engineered, semi-engineered, and engineered structures-to cyclonic hazards through field surveys conducted in Mallipattinam and Pudhupattinam villages. The research reviews relevant literature on cyclone damage assessment, reliability-based structural design, and cost-effective retrofitting techniques, highlighting importance of both scientific and local approaches to disaster resilience. The study also examines Indian codal provisions (IS 875, IS 15498, IS 15499) for cyclone-resistant construction. Field data reveal that non-engineered houses, often built with thatch and mud without proper foundations, are highly susceptible to wind and flood damage, resulting in major structural failures. Semi-engineered buildings, while incorporating some engineered elements, still exhibit vulnerabilities due to weak connections and partial reinforcement. Engineered structures, designed a

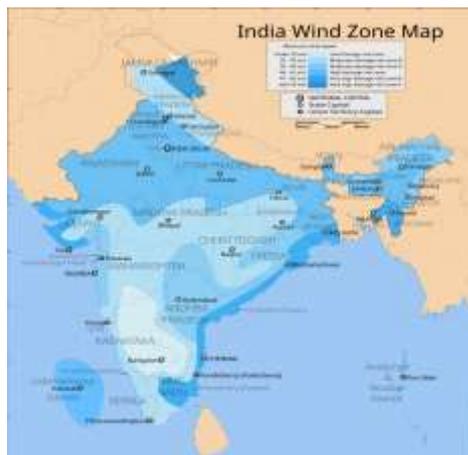
Fig 2 Cyclone zoning map of India

Zone	Wind Speed (km/h)	Districts Affected
High-Risk Zone	>160 km/h	Chennai, Cuddalore, Nagapattinam, Thoothukudi, Ramanathapuram
Moderate-Risk Zone	120 - 159 km/h	Thanjavur, Pudukkottai, Kanyakumari, Karaikal,

Tiruvarur
Low-Risk Zone	80 - 119 km/h	Madurai, Sivagangai, Tirunelveli, Virudhunagar
