# **RETROFITTING THE EXISTING: RESIDENTIAL BUILDINGS**

**PRIYANKA BARODIA**

#### 4. CASE STUDY-

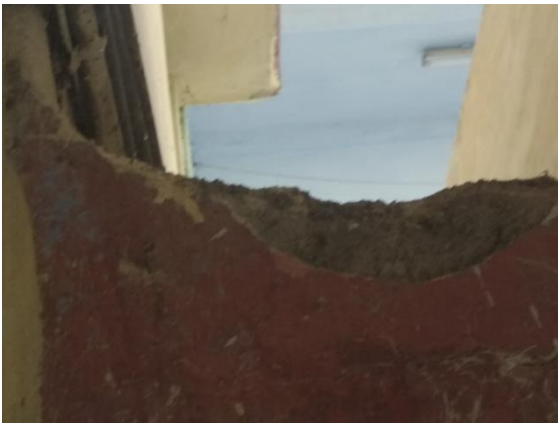
**Fig no .1** Gap

- Load distribution and water proofing of structure causing cracks-

Measures- In order to use epoxy injection to patch the crack, the crack is first cleaned by vacuuming or flushing with water to eliminate any debris or contaminants. The holes on the surface are then covered with an epoxy gel to prevent the epoxy being applied from leaking out. in joints of brickwork

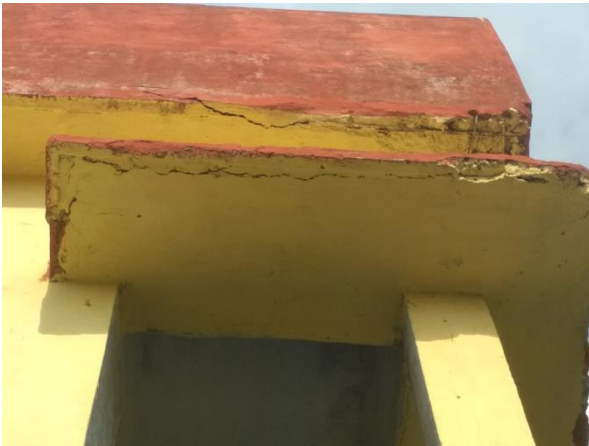
**Fig no.3** Breakage in slab

- Crack in the brickwork and slab-

One of the key reasons for this is the uneven movement of columns and masonry due to temperature variation. This difference can be either expansion or contraction depending on the temperature. Terracotta tiles were lay under the limeconcrete and which is clear from lower part.

Measures- These fractures may be covered by a gap between a reinforced concrete column and a masonry junction. Alternatively, the placement of chicken wire on the plaster between the intersection of the columns and the masonry will also assist with this difference.

Weakened stones have been repaired. Steel parts were welded and steel pieces broken were repaired.

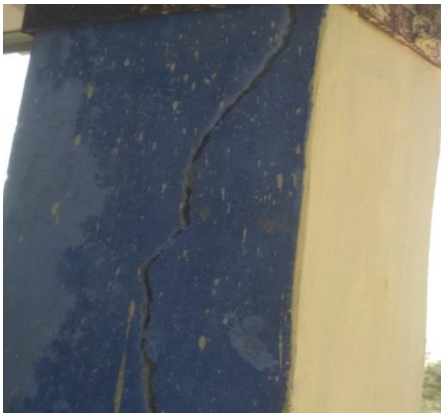
**Fig no.5** Collapsing column (Source: Author)

Collapsing of column-The length of the overlap of steel rods at the junction of the pile and column is inadequate. Structure is fragile due to the number of columns used and Unsymmetrical wall loads on the structure.

Remedial Measures - Encasing or enlarging the cross section of the collapsed column (Source: Author) and the corrosion of steel. Re-alkalization of reinforced steel to avoid corrosion. Extraction of chloride to prevent the degradation of stainless concrete. Confinement use materials such as steel plate, paper or glass fiber.

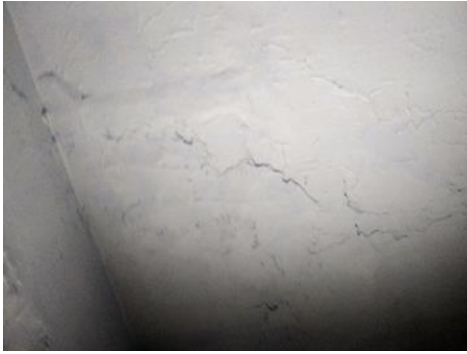
**Fig no.7** Roof members (Source: Author)

- Roofing leakages –

Leaks caused by inadequate construction may include roof insulation, roof lighting, roof vents or chimneys, and they can be punctured by a number of issues. The most frequent issue with these areas is the poor application of materials. Falling branches or trees, hail or other objects can cause significant damage to the roof.

Measures - Cut the groove or chipping any 10 mm of concrete around the crack axis. For this reason, the dust may be absolutely cleaned from the crack line, brush or void cleaner. Cleaning is very important as the dust prevents the bonding of materials and therefore the repair will become weak.
