# **“Study the Causes of Failure of Major Bridge Across Wainganga River in Down Stream of Bhimgad Dam at Seoni (M.P.) And Its Remedial Design Solution Using Staad -Pro V8i”**

This study investigates the causes of distress in Bridge SEY02-03 across the Wainganga River, located downstream of Bhimgad Dam in Seoni District, Madhya Pradesh. The research adopts an integrated approach by combining hydraulic analysis, geotechnical investigation, structural assessment, and remedial design to evaluate the overall performance of the existing bridge and to recommend suitable rehabilitation measures.

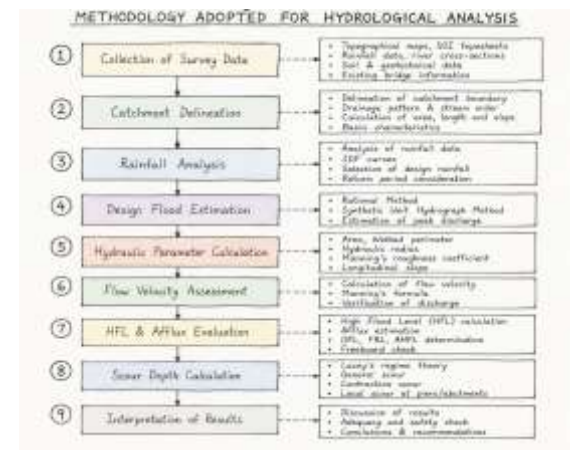
Figure 2 Methodology Adopted for Hydrological Analysis

The methodology adopted for the experimental investigation is illustrated in Figure below which presents the sequence followed for data collection, engineering evaluation, analytical modelling, and interpretation of results.

The experimental investigation has been divided into three major components: geotechnical investigation, hydraulic failure analysis, and structural failure analysis. The geotechnical investigation evaluates the subsurface conditions and adequacy of the existing pile foundation. Hydraulic analysis examines flood characteristics, flow behaviour, and scour potential around the bridge foundations, while structural analysis evaluates the response of the bridge under the prescribed loading combinations. The combined interpretation of these investigations provides a comprehensive understanding of the mechanisms responsible for bridge distress.

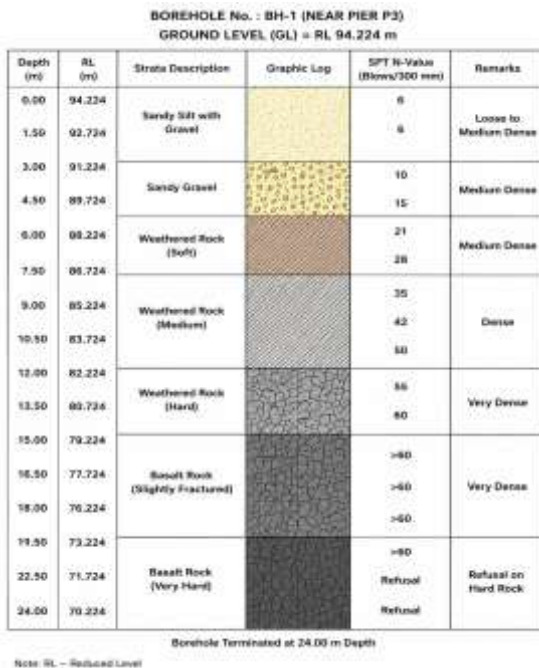
Figure 3 Representative Borehole

The borehole investigation identified the sequence of soil and rock layers beneath the bridge. The upper strata mainly comprise sandy gravel and weathered material, while competent basalt rock was encountered at greater depths, providing the primary bearing stratum for the bored cast-in-situ pile foundation.
