Rectification of Building Tilt (Skyscrapers)

(Millenium Tower SanFrancisco)

Harshit Srivastava¹, Anukaran Kamboj²

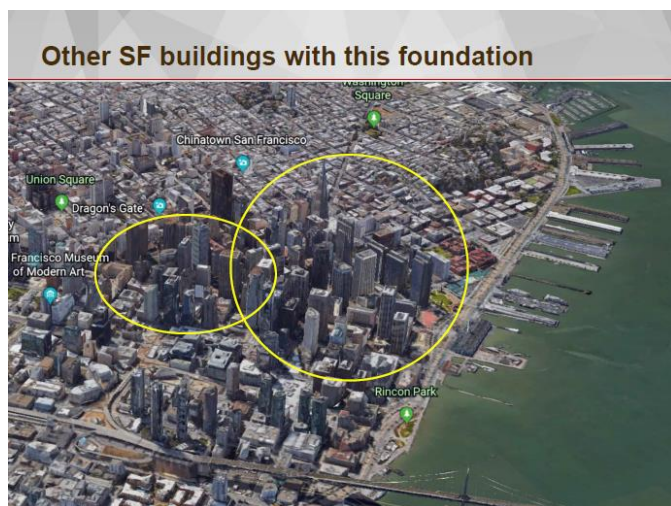
History of problem, Ground breaking happened in 2005 (Settlement Predicted 4"-6"), Construction completes 2009 (Settlement reached 10") & Transbay Terminal excavation starts, Last Unit sold in 2013 (settlement 13"), SGH Retained in 2014 (Settlement 15"), Litigation initiated in 2016 (Settlement 17") Adjacent construction completed in 2017 (Settlement reached 18" & Tilt 17" to NW), The building land falls under infirm soil band on SF general Plan.

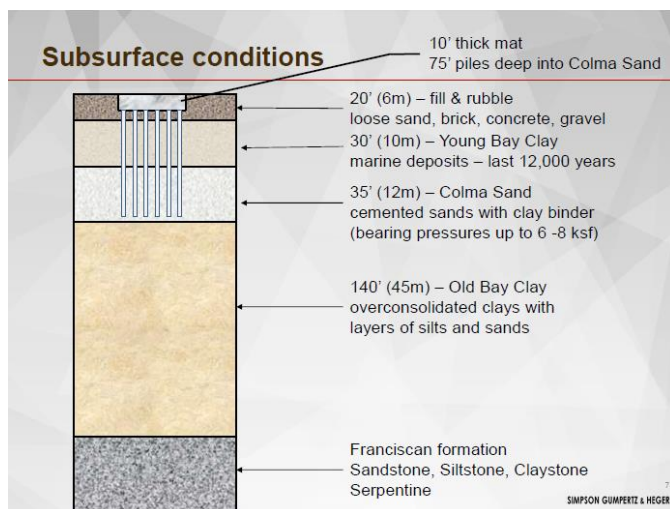
History of problem, Ground breaking happened in 2005 (Settlement Predicted 4"-6"), Construction completes 2009 (Settlement reached 10") & Transbay Terminal excavation starts, Last Unit sold in 2013 (settlement 13"), SGH Retained in 2014 (Settlement 15"), Litigation initiated in 2016 (Settlement 17") Adjacent construction completed in 2017 (Settlement reached 18" & Tilt 17" to NW), The building land falls under infirm soil band on SF general Plan.

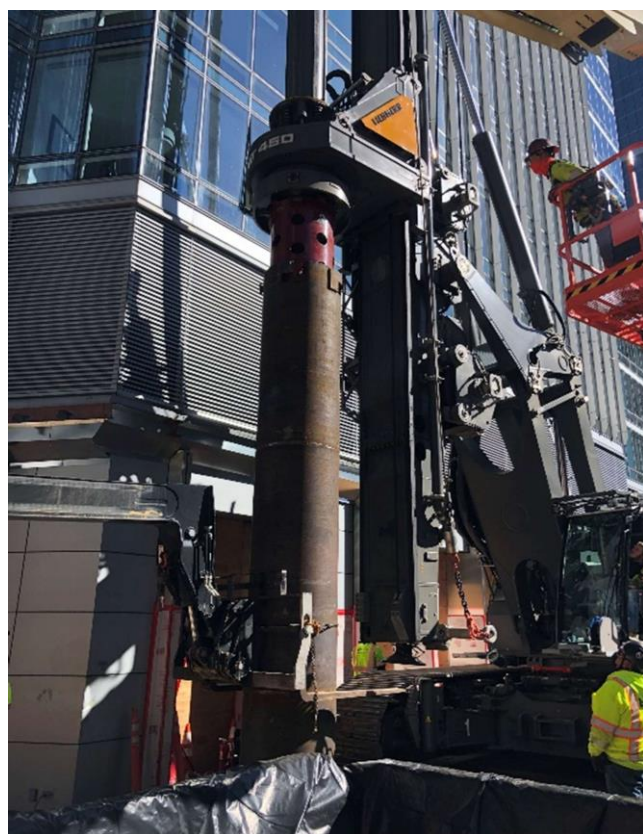
Axial Forces in the Piles: As expected, the nonlinear analyses indicate that the differential pile settlement causes a significant redistribution of axial forces under gravity loads. This redistribution is enabled by the large strength and stiffness of the concrete mat, combined with the fact that the compressive strength of the piles is limited by the soil resistance (as opposed to the crushing

strength of the pile itself), such that any of the piles that are heavily loaded in compression will naturally redistribute loads to neighboring piles. Results of the analyses under combined settlement and gravity loads indicate that the piles can sufficiently resist the applied loads, which is further substantiated by the pattern of the observed building settlements.

Results of the NLRHA under the combined effects of settlement, gravity and earthquake ground motions further indicate that the piles have sufficient compressive and tensile strength to resist the imposed forces that would occur during the MCE ground shaking. The analyses of pile capacities under earthquakes takes into account the fact the effective stiffness of the soil is higher during the transient earthquake loading than during long-term gravity loading.

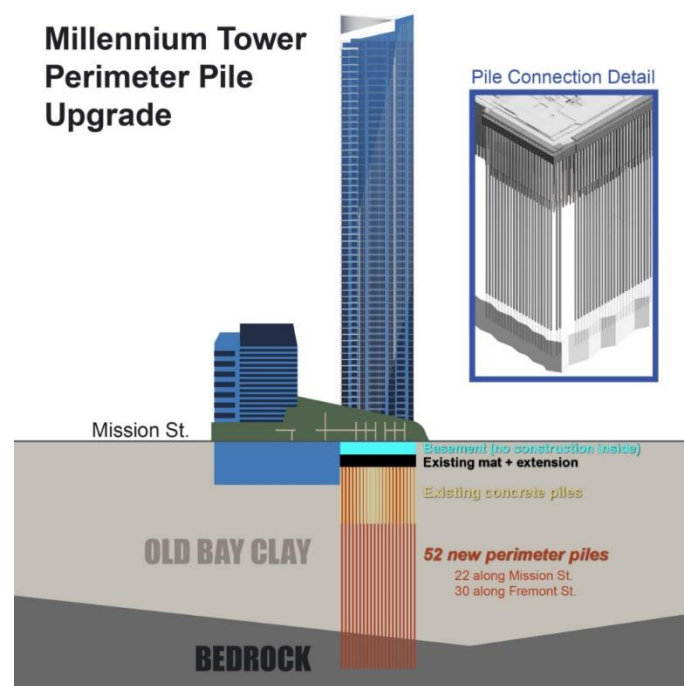
The 58-story high-rise part of the Millennium Tower complex has settled around 17 inches vertically since construction began in 2006, with approximately 11 of the 17 inches occurring since completion of the tower superstructure in 2008 (ARUP, 2017). This is more than three times what the structure's designers had planned for over its lifetime (Treadwell & Rollo, 2005). The data show that the settlement has been advancing at a reasonably constant pace of roughly 1 inch per year since 2010 (ARUP, 2017), even if it is less than the peak rates seen during construction.

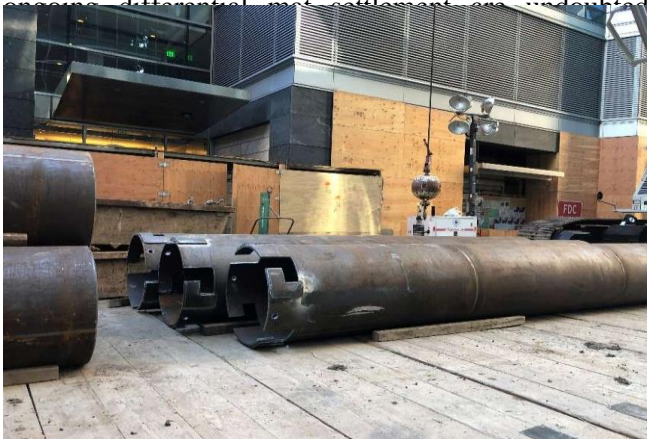
The settlement has not proceeded uniformly, resulting in some distortion (dishing) and tilting of the mat base (ARUP, 2009, 2016, 2017), some of which continues to occur. Building out-of-plumb measurements taken by independent sources show that the structure is leaning to the north-west. Current measurements show an out-of-plumbness at the top of the facade of roughly 14 inches to the west and 6 inches to the north. This exceeds by two times the tolerance for out-of-plumb construction that would be deemed acceptable. Building tilt and the ensuing differential mat settlement are undoubtedly
