COMPREHENSIVE ANALYSIS OF WIND TURBINE BLADE DAMAGE

Mr. SHYAM SUKHADEO SORMARE ¹

ANJUMAN COLLEGE OF ENGINEERING AND TECHNOLOGY,

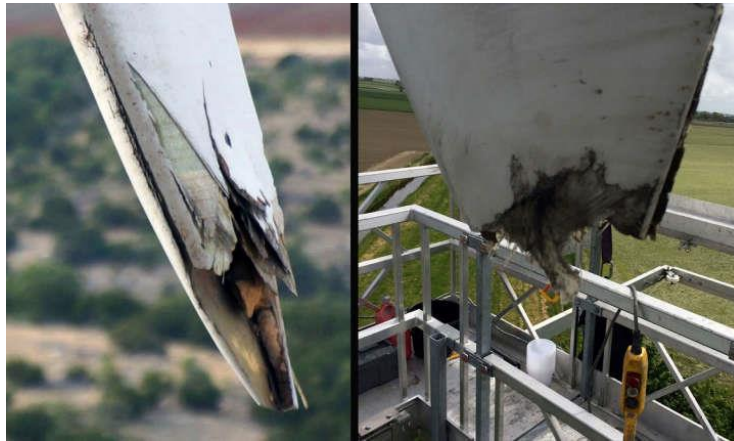
Figure 2: Damaged Turbine Wind Blade due to lightning

- The most common types of damage caused by lightning strikes are delamination, debonding, shell detachment, and tip detachment.
- Delamination occurs when the pressure and temperature generated by lightning cause the piles of laminate to detach from each other.

- Debonding refers to the separation of the upper and lower shells of the blade, usually caused by the expansion of air and vaporization of trapped moisture inside the blade.

- Tip detachment is the complete detachment of several meters of the blade tip from the rest of the blade, which can be considered the most critical type of damage caused by lightning strikes.

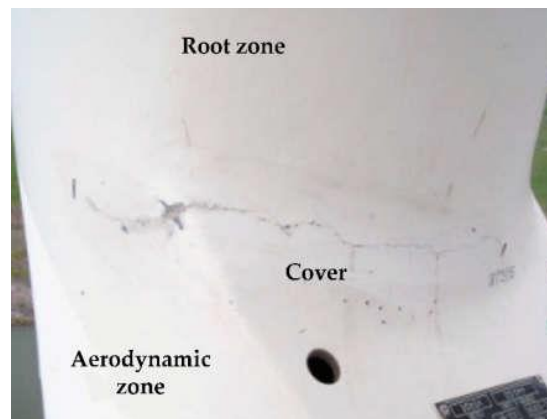
Figure 3: Damaged Turbine Wind Blade due to Fatigue

Wind turbine blades, which experience repeated bending, are the most vulnerable components to fatigue damage due to fluctuating forces. The blade joints with the turbine's hub are the most likely places for fatigue damage to appear, regardless of the source of the fatigue conditions. Factors such as stress concentration, bolt holes, built-in stresses, offsets, changes of section, and the use of different materials contribute to fatigue damage in this area.

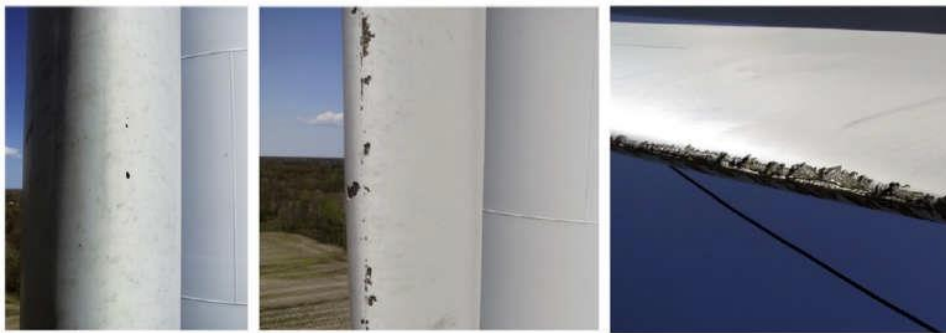
Figure4: Damaged Turbine Wind Blade due to Edge Erosion

Wind turbine blades are exposed to various environmental factors, including wind, rain, sand, and dust. Over time, these elements can cause erosion and degradation of the blade's leading edge. Leading edge erosion occurs when the protective coating or material on the front edge of the blade wears off or becomes damaged. This erosion can reduce the aerodynamic performance of the blade, leading to decreased power output. Regular maintenance and repair of the leading-edge coating is necessary to prevent significant erosion. Leading edge erosion of wind turbine blades is primarily caused by exposure to airborne particulates, such as rain, hailstone, sea spray, dust, sand, as well as UV light and humidity/moisture. This exposure gradually increases the surface roughness of the blade, resulting in higher friction drag and aerodynamic loss. The aerodynamic performance of the blade is negatively impacted, leading to reduced lift and increased drag, especially as erosion levels become more severe. In extreme cases, leading edge erosion can even affect the structural integrity of the blade.

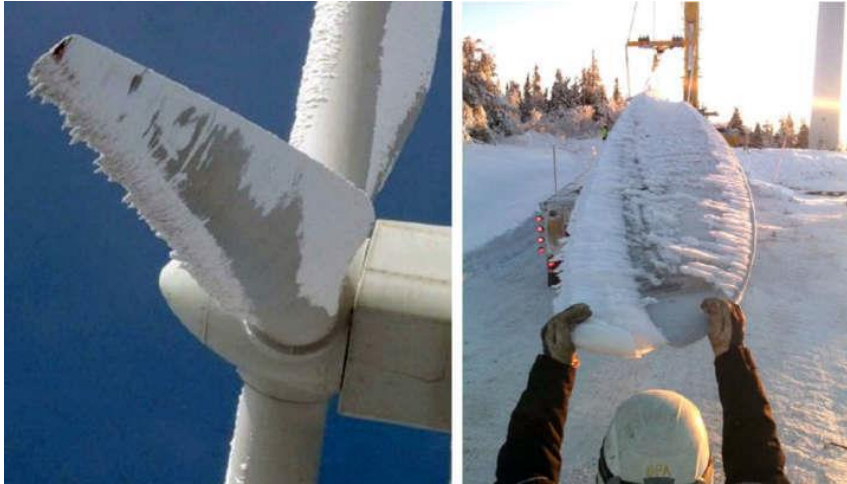
Figure5: Damaged Turbine Wind Blade due to Icing

In colder climates, wind turbine blades are susceptible to icing, especially during winter months. Ice accumulation on the blades can add substantial weight and alter the aerodynamic balance of the rotor. This imbalance can cause increased stress on the blades and the entire turbine structure. Additionally, as the ice melts and freezes, it can lead to the formation of ice dams, which further impacts the blade's performance. De-icing systems or other measures, such as heating elements or specialized coatings, are often employed to prevent or remove ice buildup and minimize the associated damage. Atmospheric icing can have significant

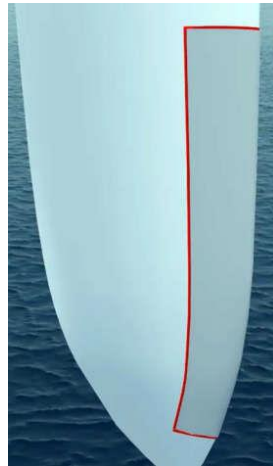
Figure9: Application of anti- corrosion coating on wind turbine blade leading edge

Applying specialized coatings and surface treatments to wind turbine blades can enhance their durability and resistance to environmental factors. Protective coatings can provide corrosion resistance, UV protection, and erosion resistance. Surface treatments, such as leading-edge erosion protection systems, can help mitigate

damage caused by rain, sand, or other particles impacting the blades during operation. Protection against leading edge erosion on wind turbine blades can be achieved through various techniques and coatings:
