Maintenance and Repair of Existing Building

Abstract - The review of Repair and Maintenance of Residential buildings. In the current situation of Residential buildings research, repair, and maintenance play an important role as they serve important in Residential buildings. Residential buildings and other structures have a useful life. In Residential buildings various defects are happened due to different causes e.g. in some cases defects are caused after the structure has been completed for a few years which results in a shortening of the life and strength of the structure. We have visited and studied the various defects that occurred in the "Sai Nivas" Residential building at Kharadi which is located in the district of Pune, state Maharashtra.

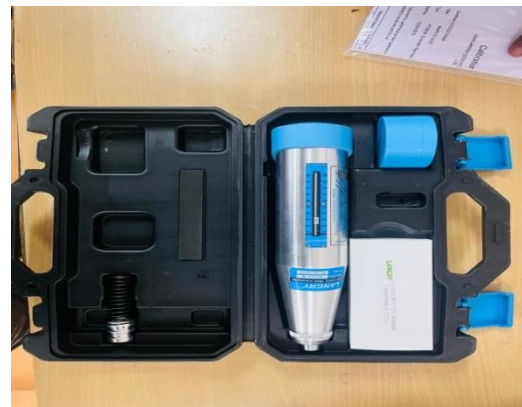
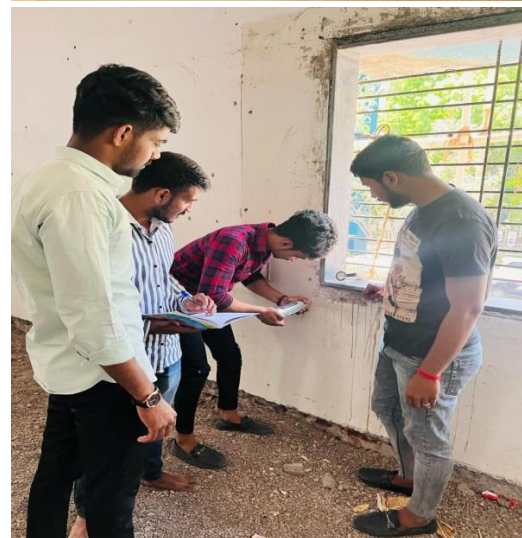
(12) Find out the compressive strength of concrete against each rebound number

(13) The relation between compressive strength and rebound number was shown directly proportional
